Hoffmann
Architects

What Went Wrong?

Diagnosing Building Envelope Distress

John J. Hoffmann, FAIA and Deborah J. Costantini, AIA

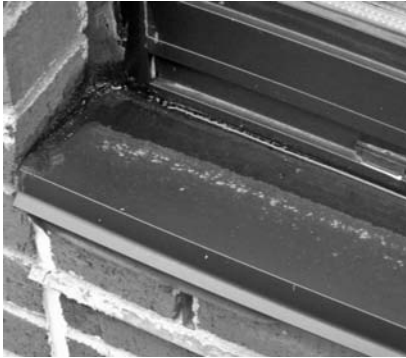
jamb, aluminum sills bent upward at the front edge (Figure 1a), and, most notably, significant gaps between the head of the window frame and the opening (Figure 1b). Concerned that the windows may have fallen in their openings, the project team conducted a follow-up window investigation to find out what had gone wrong.

▲ Figure 1a: Masonry expansion led this sill to bend upward at the front edge.

Unfortunately, this building was designed without relieving angles or horizontal expansion joints. Although there are other ways to accommodate movement, these are limited to low-rise buildings, and no such provisions were made here. As a result, the cumulative expansion of all of the brick masonry over the entire four-story building led to substantial differential movement, particularly at the top floor, where the brick had expanded so much that the window sills were now sloped inward, toward the window, allowing water to collect along

the frame (Figure 1a).

With the window units anchored to the concrete back-up, which shrinks over time as it dries out, and no provision for the expansion of the face brick, the window units remained in place while the brick veneer grew, making it appear on first glance that the windows were sinking. Only through a comprehensive masonry and window investigation could the real problem be uncovered.

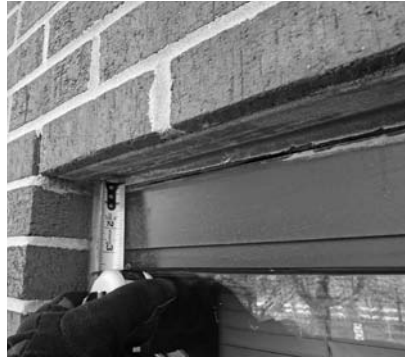
What we found is that rather than the windows falling into the wall, the opposite was true – the wall was moving upward around the windows.

Building materials expand and contract at different rates. Brick, for example, expands over time, whereas concrete shrinks. In this fairly typical cavity wall construction, the brick masonry is only a one-brick-thick veneer. Behind it is an open cavity space to allow for drainage, along with insulation and an air/vapor barrier. On the other side of this cavity is concrete masonry back-up, which provides the structure of the wall; unlike solid brick masonry

▲ Figure 1b: As the brick veneer expanded, it pulled upward away from the window.

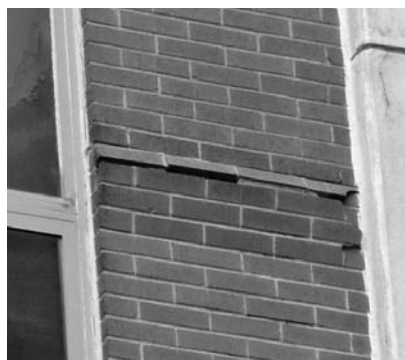
In the example presented in Figure 2, relieving angles are present, unlike in our previous example. However, here we found displaced and spalled brick courses immediately above and below the relieving angle. The question was: why?

A test probe into the distressed brick revealed asphaltic sheet flashing that was lapped but not sealed, which allowed water to travel between the overlapping layers. In addition, the flashing had deteriorated and was no longer providing much protection at all. As water migrated through the porous brick and lingered in the deteriorating flashing, it led to corrosion of the steel relieving angle. As steel corrodes, it expands, placing outward pressure on the surrounding brick and leading to cracks and spalls.

As the outside temperature rose and fell, trapped water underwent successive freeze/thaw cycles, expanding as it froze and contracting as it thawed. These changes in temperature and pressure forced off pieces of the outer surface of the brick, and led to the displacement visible in Figure 2a, in which the face brick is nearly detached from

▲ Figure 2a: Brick displacement due to poor flashing design and freeze/thaw cycling.

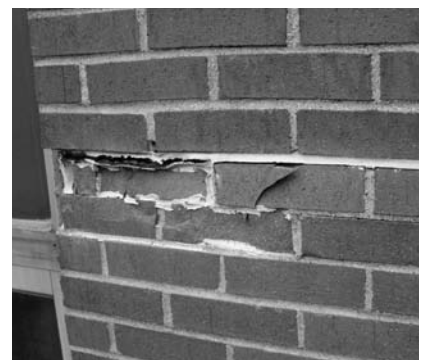
Observing the beginnings of damage at the wall surface, a well-meaning soul with a caulk gun went around and sealed up the open joint at the relieving angle. Unfortunately, this joint was open for a reason: the porous mortar above the relieving angle is meant to allow any moisture inside the wall to discharge. Once this escape route was covered over with impervious sealant, water collected inside the cavity wall.

▲ Figure 2b: An attempt to fix spalled brick with sealant made matters worse.

the facade. As deterioration worsened, the same good intentions that led the maintenance staff to apply sealant to the mortar joint brought them back again, caulk gun in hand, to fill in more sealant in and around the spalled brick, inadvertently making the problem worse (Figure 2b).

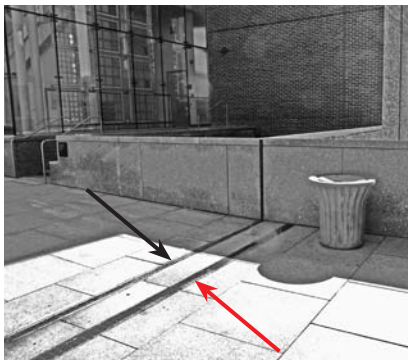
The corroded steel beam in Figure 3b sits directly under an expansion joint in the plaza, where the main entrance ramp meets a level surface; Figure 3a shows this expansion joint from above, with the ramp extending upward to the left of the joint. Notice that the trench drain, at the right (red arrow), is downhill from the expansion joint (black arrow). Every time it rains, water runs down the ramp toward the bottom, where, traveling along the first available path, it meets the

open expansion joint and travels into the occupied space below. With the only drain situated downhill from the expansion joint, much of the water has already found its way into the building before it ever gets there.

▲ Figure 3a: The only drain (red arrow) was downhill from an expansion joint (black arrow).

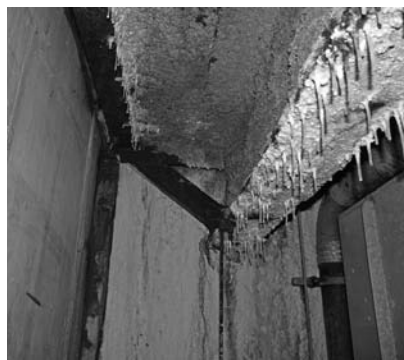
▲ Figure 3b: Plaza leaks corroded steel and melted fireproofing beneath the faulty joint.

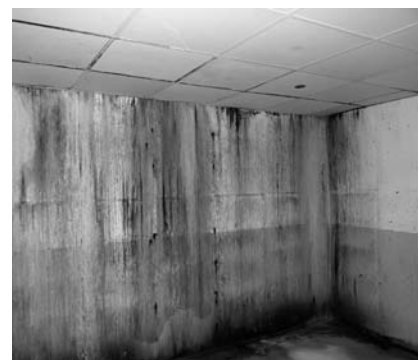
From the outside, the main entrance ramp and plaza shown in Figure 3a looked great: the plaza surface was clean and even, with no heaved pavers or uneven joints. Visitors to the building would have no idea of the horrors within: the spaces one and two levels below the ramp were so riddled with water damage that they became virtually unusable (Figures 3b and 3c). What was going on?

▲ Figure 3c: The plaza looked great, but leaks left rooms below looking anything but.

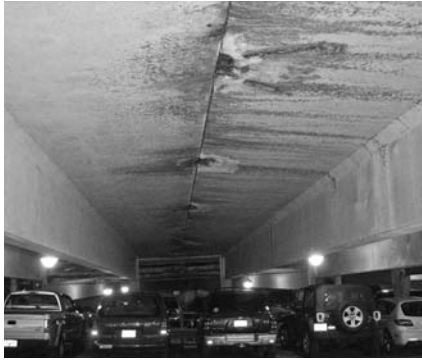
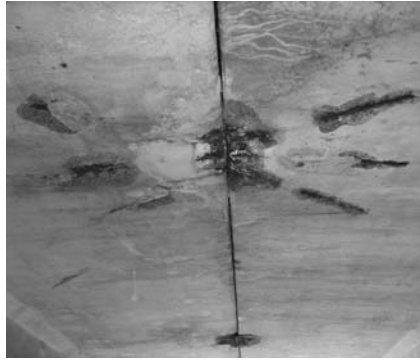
The garage pictured in Figure 4 is a typical four-level freestanding parking structure constructed of precast concrete units in a double-tee (TT) configuration. The distinctive star-shaped pattern of corrosion and spalling in Figure 4b occurred at regular intervals along many of the connections between precast members (Figure 4a). With steel reinforcing present throughout the concrete deck, why was corrosion concentrated at these locations?

An investigation into the garage conditions, including test probes at areas of corrosion and spalling, provided some answers. As moisture penetrated through failed sealant joints at the double-tee connections, it encountered the embedded steel elements that connect one flange to the next. In addition to weld defects that ranged from poor configuration to faulty execution, the garage was constructed with mild carbon steel connections, rather than stainless steel. Despite a coat of anti-rust paint, the connections at this thinnest part of the concrete flange succumbed to corrosion, which extended outward from the welded plate, along the embedded structural steel.

▲ Figures 4a (left) and 4b (right): Corrosion concentrated at flange connections in this precast concrete garage due to inappropriate materials, weld defects, and sealant joint failure.

More concerning, the fractured welds, combined with the missing concrete and loss of embedment area at the beam flanges, mean that the connection capacity at many of the intersections between precast units was significantly compromised. Although the distinctive reddish-brown rust stains and chipped concrete are obvious indicators of, at a minimum, a maintenance issue, what they don't immediately reveal is the serious nature of the damage from a structural standpoint.

Previously, a misguided repair attempt applied patching material to the surface (some of the remaining repair compound is visible in Figure 4b). Not only were these patches performed poorly, with insufficient surface preparation, they failed to address the

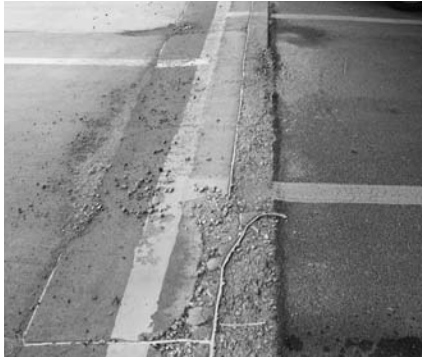
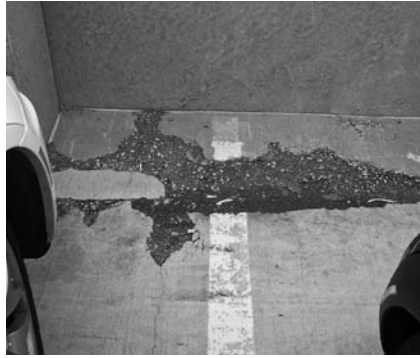
▲ Figures 5a (left) and 5b (right): Insufficient air entrainment of this concrete surface left freezing moisture no room to expand, leading to severe disintegration.

Precast garages often have some cast-in-place elements, and the way in which these different types of concrete interact can impact the longevity of the garage, particularly at parking surfaces. In Figure 5, portions of a tri-level precast garage became quite an eyesore—and presented hazardous conditions for pedestrians—when crumbling concrete led to uneven surfaces. Scaling was so severe in some locations that all that remained of the cast-in-place topping was loose aggregate and sand.

In this case, however, petrographic testing revealed that air entrainment of the cast-in-place concrete at curbs and washes was insufficient. As freezing moisture in the concrete expanded, it had nowhere to go, so it pressed outward, leading to cracks, spalls, and eventually, to near total disintegration of the parking deck surface. Previous repair efforts temporarily improved concrete integrity, but even in these new areas, cracks had been left unaddressed, indicating that these locations, too, would likely deteriorate unless the poorly prepared concrete was completely replaced.

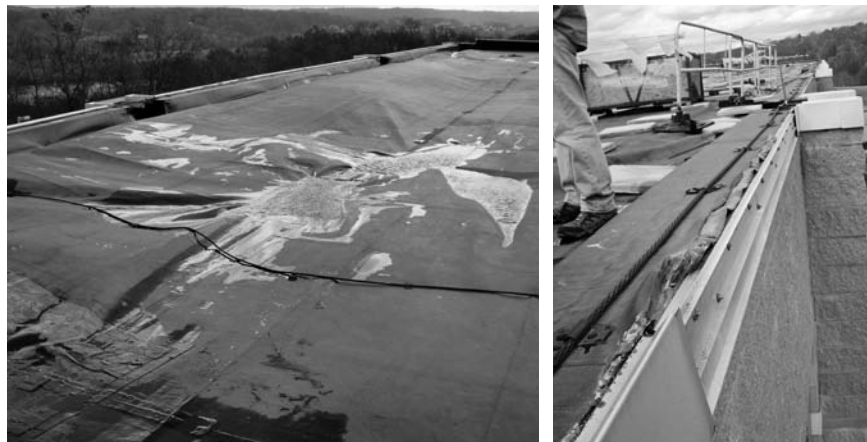
In October 2012, during Hurricane Sandy, a catastrophic roof failure occurred at a suburban data center (Figure 6). Situated on a ridge overlooking a river, the facility's relatively open terrain left it exposed to the full force of the high storm winds. Although the roof structure and membrane assembly were designed

Having ruled out design error as the cause of the failure, the project team then looked to workmanship and detailing of the roof installation. Field investigation revealed several factors at play; one was that insulation boards could be easily lifted from the roof deck, and were not fully adhered. In some cases, asphalt adhesive coverage below the boards was a scant 25

At the roof edge, the EPDM membrane had been cut off at the top of the parapet, rather than extending over and down the outboard face of the blocking (Figure 6b). In addition, wood blocking in the areas of failure was of insufficient depth to engage the fasteners. Compounding this lack of securement were voids beneath the edge metal where it extended over split-face concrete masonry units. These openings, along with the disengaged fasteners, allowed positive pressures to penetrate the underside of the edge metal.

Other construction defects, including large voids in the concrete roof deck and faulty cricket construction that allowed moist air to accumulate under the membrane, also contributed to the roof blow-off. Although any one of these conditions might in itself have caused the problem, the likely source was some combination of all of them. Despite the sound design of the structural deck and roofing assembly, a host of preventable errors during

▲ Figures 6a (left) and 6b (right): Roof blow-off caused by insufficient insulation adhesion, poor edge detailing, and other construction defects.

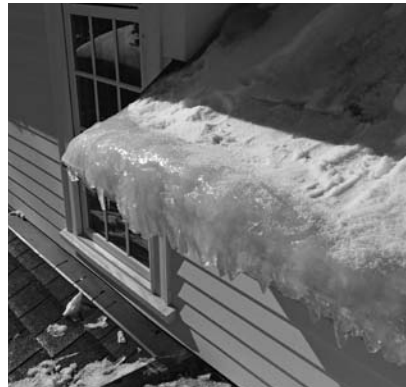
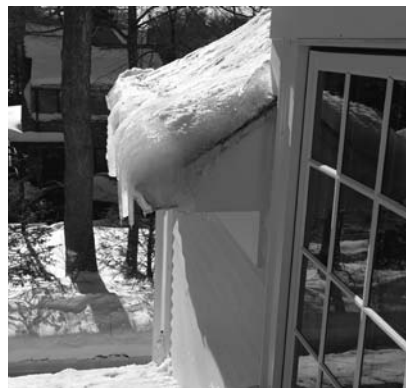
At a residential building on a college campus, severe ice dams at the roof led to leaks at both above-grade levels and the basement ceiling (Figure 7). During a very cold winter, one might expect to see some ice damming on older structures, but this was new construction, just a few years in service. Clearly, more than just bad weather was to blame for the persistent leaks and hazardous ice formation.

Our investigation uncovered several problems in both design and construction. Unbalanced ridge and soffit venting, combined with thermal penetrations in the attic insulation, allowed warm air to collect at the underside of the eaves, warming the roofing materials sufficiently to melt the snow. Once this snow melt reached the gutter and drip edge, it re-froze (Figure 7a). Over time, this repeated thawing and freezing created an accumulation of ice at the gutter, which allowed water to back up under the roofing shingles and penetrate to the building interior (Figure 7b).

▲ Figures 7a (top) and 7b (bottom): Ice dams at eaves led to extensive leaks at the building interior and required replacement of the roof just a few years after it was installed.

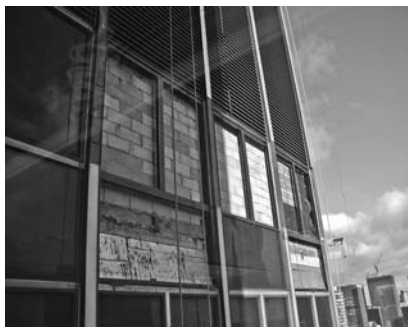
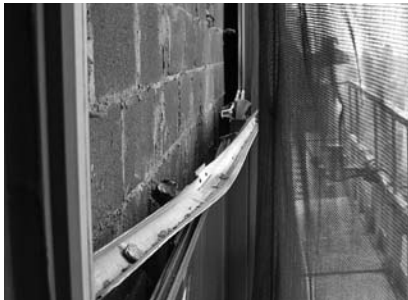
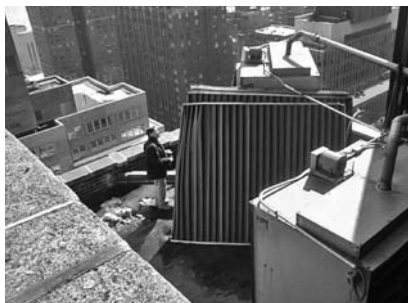
Winter weather was also the catalyst for building envelope failure at a very different type of building in a very different type of setting: a glazed curtain wall in the middle of Manhattan (Figure 8). During a blizzard, a portion of the louver and frame system detached and fell from the building (Figure 8a and 8b), landing on a roof setback (Figure 8c), as well as on the roof of an adjacent building and the street below. Fortunately, no one was injured.

interviewed the curtain wall manufacturer to complete the picture of the probable cause of failure. Constructed in 1962, the curtain wall system employed a series of bolts and clips to secure the framing to the building structure. Newer curtain wall buildings use locking nuts to counteract vibration, but in buildings of this vintage, nuts and bolts working loose was not uncommon, even when some type of lock-washer was used. During the investigation, we found enlarged holes on some outrigger clip connections, which was consistent with fastener loosening.

to prevent galvanic action between dissimilar metals, between steel and aluminum outriggers, as well as failure to weld mullion splice sleeves. The expansion joint in the area of failure was only about ¼ inch wide, yet calculations and manufacturer data predicted an estimated ¾ to 1 inch of expansion over the twenty-foot aluminum mullion.

❏ **Figures 8a (top), 8b (middle), 8c (bottom):** A portion of this glazed curtain wall detached and fell dozens of stories.
