Treating Distress and Failure in Historic Terra-cotta Façades

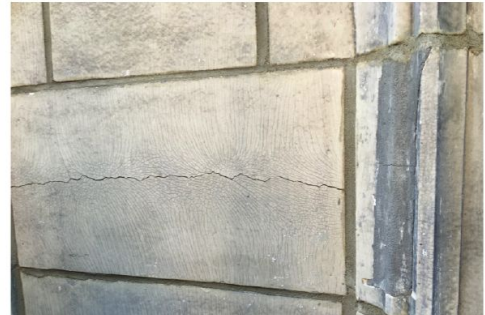
Typical glaze crazing, which compromises water penetration resistance. Cracking indicates where stress exists, often due to corrosion of anchorage. On top, an inappropriate repair is failing, as the underlying deterioration mechanism was unaddressed, and the incorrect material was used.

In-situ repairs can include patching spalls, grouting cracks, pinning displaced units, or coating units with failing glazing. Although replacement of existing terra cotta units in-kind is the safest and longest-lasting approach to addressing deterioration, it can be costly and have long lead times, given the limited capacity of restoration terra cotta manufacturers.
