Hoffmann Architects

Quarterly

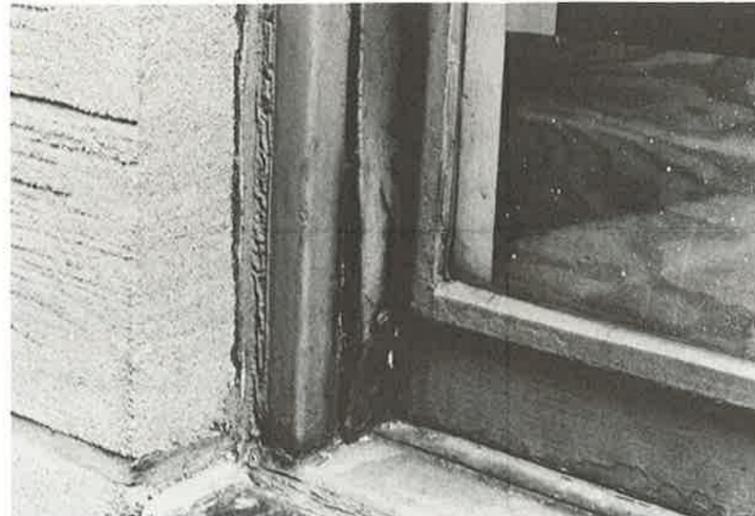
Steel double hung windows show signs of corrosion where the jamb section meets the sill.

Weep holes, put in the steel sections to allow moisture to escape, are plugged by dirt and debris that have blown in through the sash track opening. The moisture, over time, attacks the protective coatings on the steel and corrodes the metal.

Severely corroded window jamb

With the sash raised, remove the parting strip and inside jamb cover. Clean dirt and loose scale from the inside of the jamb using a vacuum and scrapers. Open up the weep hole. Treat the corroded area inside the jamb with a rust inhibitive primer and top coating. If the window is not required to be operable, the sash track should be sealed with a neoprene gasket.

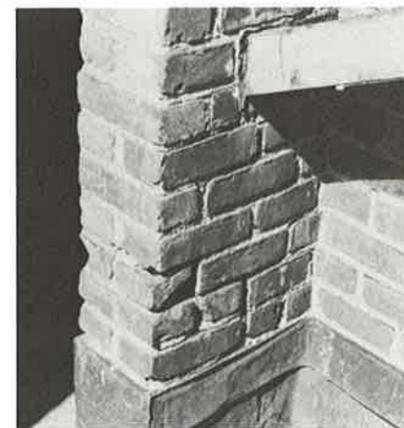
A masonry wall enclosing a cooling tower and mechanical enclosure was found to be severely deteriorated, as evidenced by spalling and cracking of brick.

Interior of 8" wall consists of common brick which is too soft to resist the harsh effects of weather. Water absorbed by the soft brick freezes, causing spalling. Movement of the wall and frame causes minor crack-

deteriorated section of common brick wall

ing which allows more water to enter the wall and corrode the steel spandrel beams. The rust expands, causing further cracking.

Clean and paint corroded steel spandrel beams. Apply two inches of pneumatically placed concrete with reinforcing mesh to inside of wall. Not only does this provide protection from weathering, but also strengthens the wall. The alternative solution to this problem would have been to completely disassemble and rebuild the masonry wall.

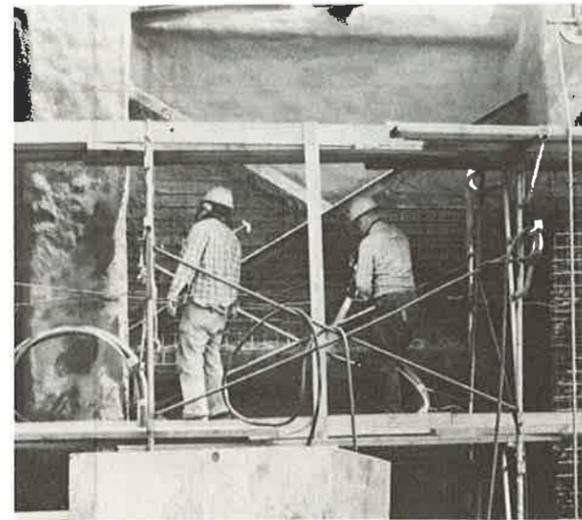
application of shotcrete over wire mesh reinforcing.
