Journal of architectural
technology published by
Hoffmann Architects, Inc.,
specialists in the rehabilitation
of building exteriors.

Design Guide for Parapets: Safety, Continuity, and the Building Code

Juan Kuriyama, AIA and Eric Au, LEED Green Associate

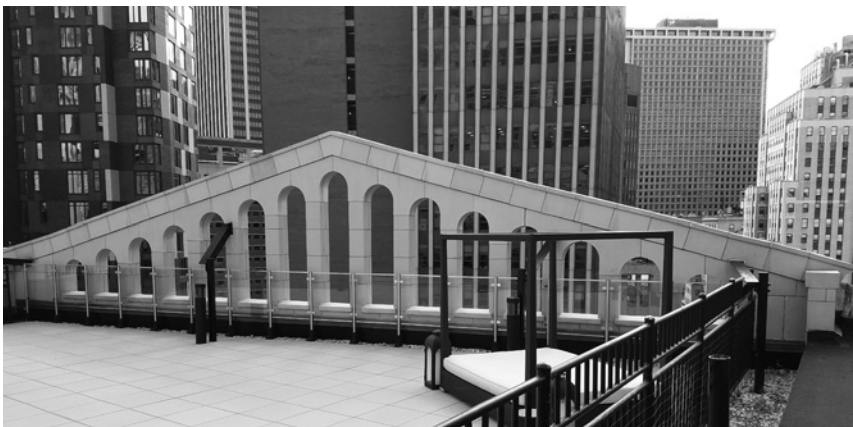
▲ Parapets vary from plain to ornate, but all must provide stability and moisture protection.

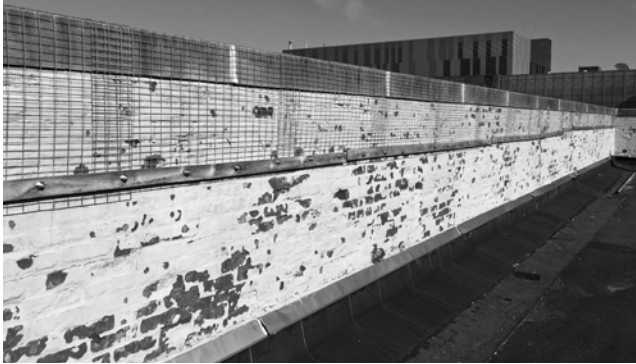
▲ Unstable parapets may be secured temporarily with netting.

Where parapet deterioration is acute, temporary stabilization may be necessary to protect the public from loose or unsecured materials. Nylon netting and metal straps are commonly used to stabilize a parapet wall until a more permanent solution can be implemented. Additional public protectives, such as sidewalk sheds, may be mandated for certain repairs, especially in urban locations, where a deteriorated parapet poses a threat to public safety.

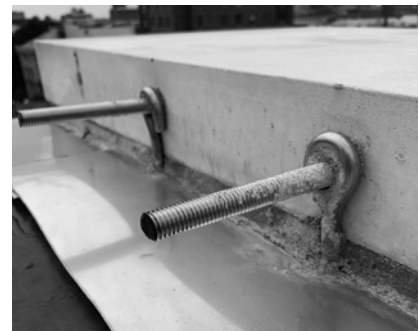
▲ Stainless steel anchors secure coping stones against displacement.

Insufficient or deteriorated coping anchors represent a potential fall hazard in parapet wall assemblies. For example, traditional clay camelback copings rely on the weight of the coping, the interlocking connection between units, and the mortar bond between the coping and wall to secure the

coping in place. Other older parapet walls use steel anchors, which tend to corrode and expand when exposed to moisture. The force of the corroding metal causes displacement and cracking in the surrounding masonry, a process known as **rust-jacking**. Stainless steel anchors offer an ideal solution, as they resist corrosion when exposed to moisture, while securely anchoring the coping against sliding or blowing off. For metal copings, non-corroding fasteners and cleats should be used in securing the sheet metal, including proper cover and under plates at joinery. It is important that all penetrations through the flashings be sealed to prevent moisture infiltration.

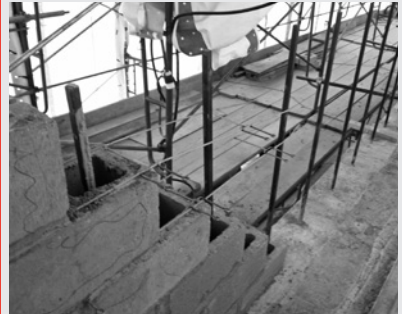
▲ Steel bars reinforce the concrete masonry unit core of the new parapet.

Often, parapets require incorporation of steel reinforcement bars to deliver the necessary structural stability. Alternatively, structural piers or pilasters built out from the walls can provide additional lateral support. For much taller and thinner walls, installation of steel bracing secured to the structural roof deck may be necessary. The bracing system should be designed by a qualified engineer or architect to resist the required design loads, based on the geometry and construction of the parapet.

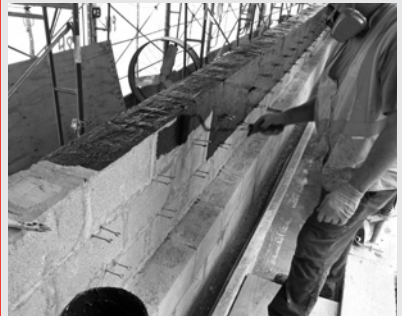
▲ A liquid-applied air barrier provides a continuous layer of moisture protection.

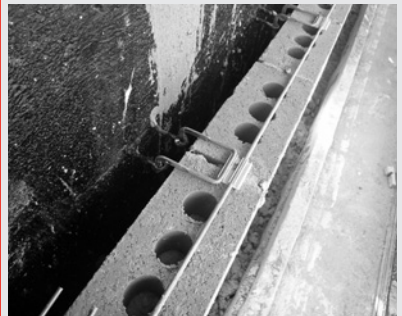
▲ Brick ties anchor the cladding to the CMU structural core.

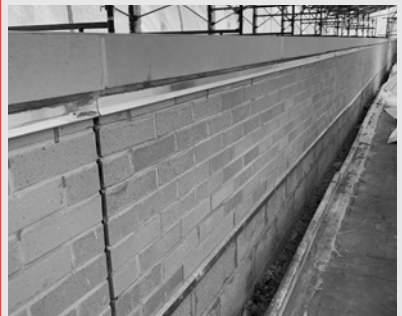
▲ With the copings and flashing in place, the parapet is nearly complete.

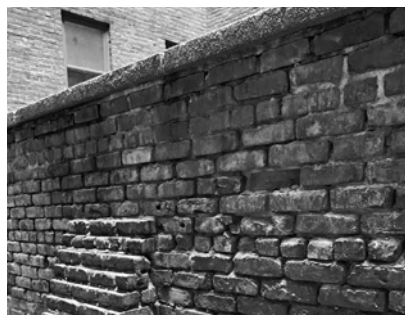
A Open mortar joints lead to deterioration.

Masonry construction is especially susceptible to moisture. In the case of brick masonry parapets, architects and engineers will often look for signs of mortar joint deterioration as indicators that there may be underlying issues within the parapet. Often, mortar

that has softened, broken apart, or cracked is caused by thermal movement of masonry elements and/or freeze/thaw cycles. Openings in the joints admit further moisture and generate an ongoing problem that could proliferate.

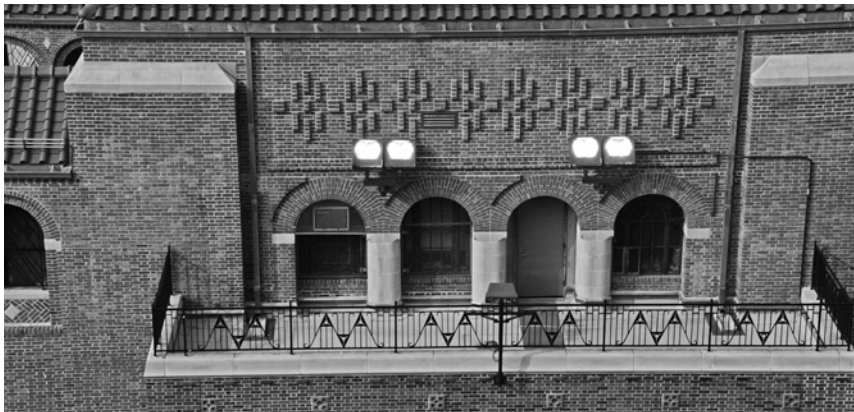
▲ Historic parapets, such as this brick masonry parapet with stone copings and ornamental railings, demand historically appropriate strategies that balance preservation with performance.
