# Journal

## Separating Fact from Fiction: Insurance Claims and Building Envelope Failure

Russell M. Sanders, AIA

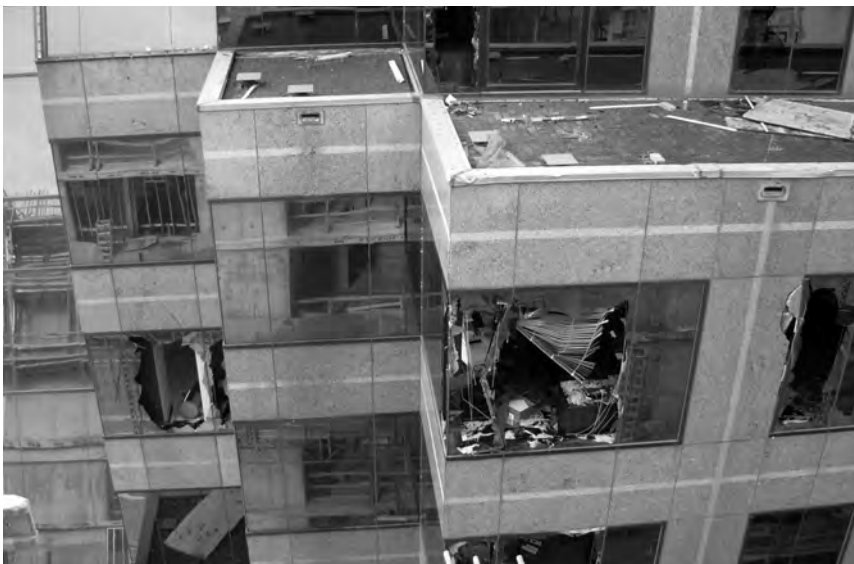
**A** In the wake of a natural disaster, architectural investigation helps reconstruct the chain of events to accurately attribute the cause of damage.

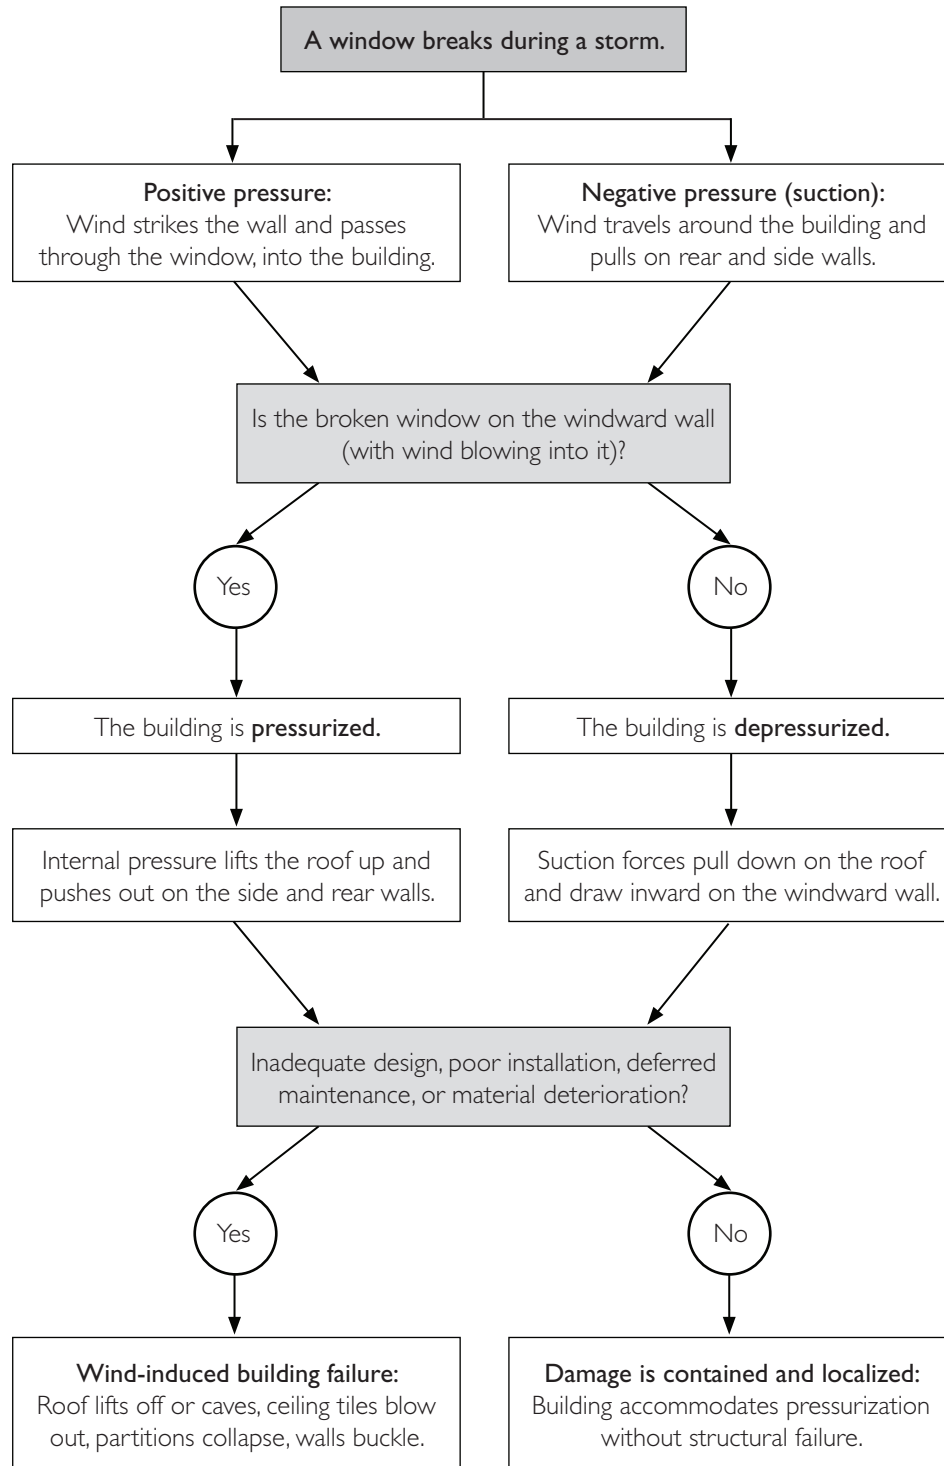
## Internal Pressure and Building Envelope Damage

Once a breach occurs in the building envelope, damage can quickly escalate due to the sudden shift in pressure. Because of the rapid build-up of internal pressure, a single wall panel blow-off or broken window can permit a surprising volume of water and debris to enter the building interior.

Because even small building envelope openings, such as weak sealant or doors that are not airtight, can cause a change in pressure within a building, it is impossible to prevent pressurization

completely. However, well-maintained seals, joints, and intersections can help to minimize pressure differentials. The critical difference between a building with adequate wind loading design, sound construction, and good upkeep and one that is ill-prepared for severe weather is in the effect pressurization has on building integrity.

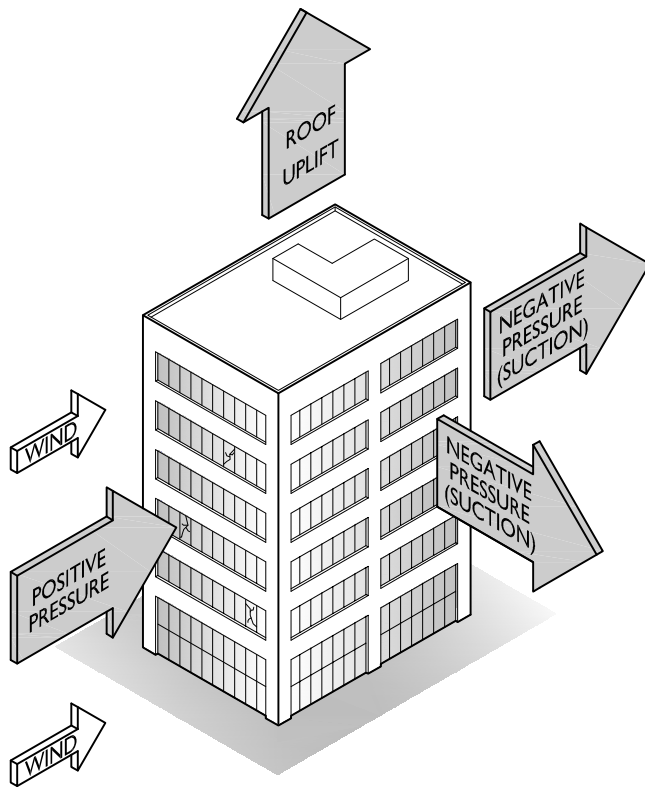
**Wind Loads on the Building Envelope**

The magnitude of pressure exerted on the building envelope during a storm is dependent upon a number of factors, including:

- Exposure, such as proximity to water or rough terrain;
- Building height, with taller buildings subjected to greater wind pressure;
- Building aerodynamics, a function of building shape and configuration; and
- Wind speed.

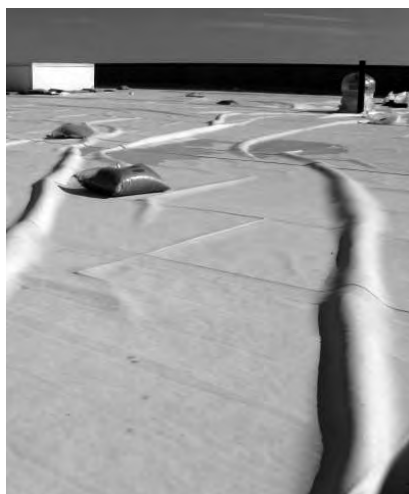
**A** Sandbags temporarily secure this roof membrane, which detached during a storm.

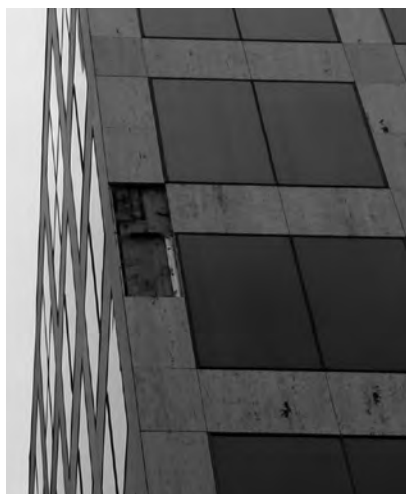
**A** Insufficient anchorage allowed this stone panel to blow off in a hurricane.

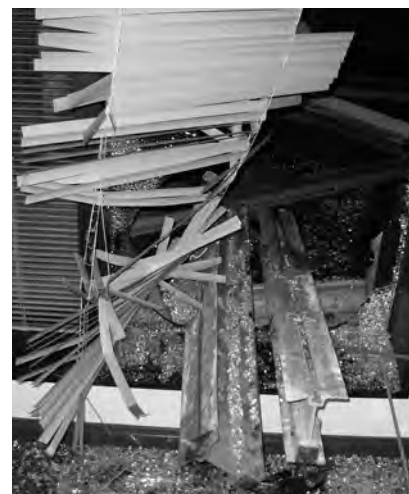
**A** In high winds, these steel beams became dangerous projectiles.

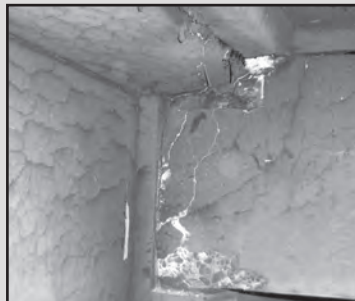
**A Sharp edges and color differences** were clues that these cracks hadn't been there before the fire.

Cracks in the precast concrete structure were sufficient to compromise structural integrity. But were they new or old? Sharp edges, rather than rounded or weathered ones, were evidence that these cracks happened recently. Additionally, the color of the concrete

inside the cracks differed from the color of the concrete surface, a sign that the cracks had not been open for long. Therefore, the project engineer concluded that the cracks were caused by the fire and could be legitimately included in the insurance claim.

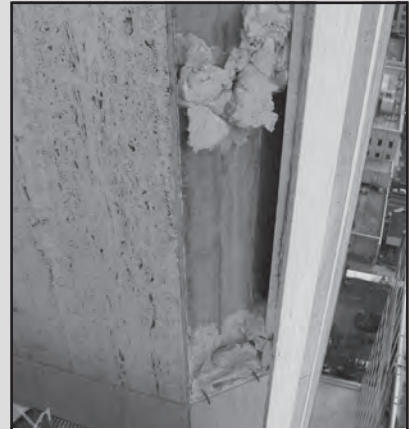
**A Insufficient load capacity** compromised the wind resistance of these panels, which otherwise might have remained intact.

During Hurricane Katrina, a New Orleans high-rise suffered damage to the anchoring system that secures marble panel cladding to the concrete structure. Some panels were blown off entirely, while others sustained cracks, breaks, or dislodgement.

meet current requirements for wind loading with an acceptable factor of safety. Although more stringent codes were adopted in the wake of Katrina, the investigation found that the designed anchorage of the panels not only failed to meet new requirements, it did not comply with the building code in effect at the time of the event.

To make this determination, the project engineer calculated wind loads to be resisted by the marble panels for various heights, building positions, and panel sizes. A sampling of 372 individual marble panels was also evaluated in place. Although the storm was violent enough to have caused pervasive damage, it turns out it wasn't entirely to blame for the extent of the destruction at the high-rise office tower. Had the renovation effort upgraded panel anchors to conform to wind load requirements, the panels would have stood a chance of weathering the storm.

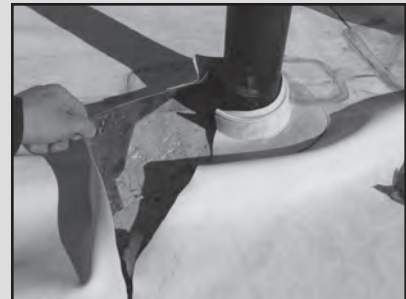
▲ **Poor anchorage and weak membrane adhesion** were signs that this roof failure could have been avoided.

Why did the storm lead to such extensive roof failure? Weather history data indicated that wind speeds, while significant, were insufficient to cause a complete blow-off. Examination of the roof system revealed inadequate adhesion of roof assembly components, likely due to poor substrate preparation and inappropriate bonding compound selection. As the weather turned colder, weak adhesion permitted the membrane to pull away from the roof edge, leaving an air pocket. This partial delamination then facilitated further separation when wind gusts struck, with the membrane eventually catching the sharp edge of a fastening plate or termination bar. Bent plates and torn securement strips provided further evidence for this chain of events.

Once the membrane ripped, the path to complete roof failure was as swift as it was inevitable. Under optimum conditions, membrane separation might have been localized to the area around the tear. Here's where good

building practice makes the difference: failure to adequately anchor drains during installation allowed them to lift the membrane in several locations. Other poorly secured components opened additional voids, admitting still more air. As wind forced its way under the membrane, more of the membrane lifted. The result: what could have been an isolated problem became a near-total roof failure. ■

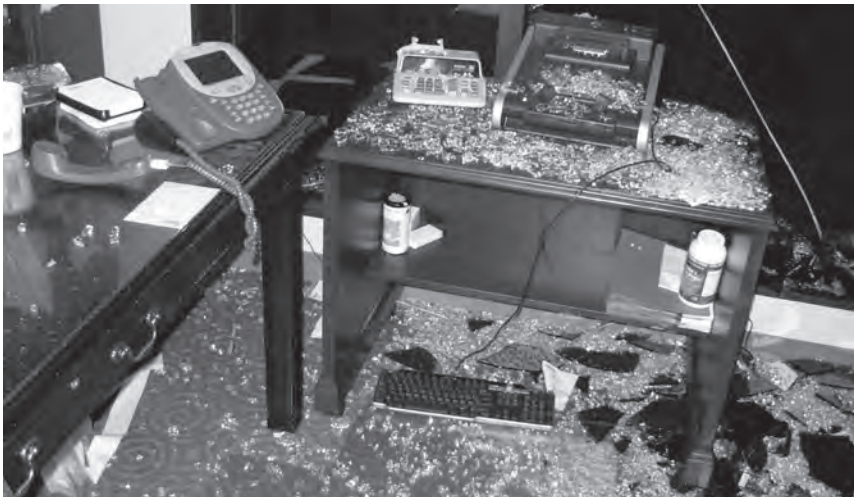
▲ Even a small breach in the building envelope can lead to serious devastation as tremendous wind pressures build inside the structure.
