Hoffmann
Architects

Journal

Preventing and Treating Distress in Brick Veneer Cavity Walls

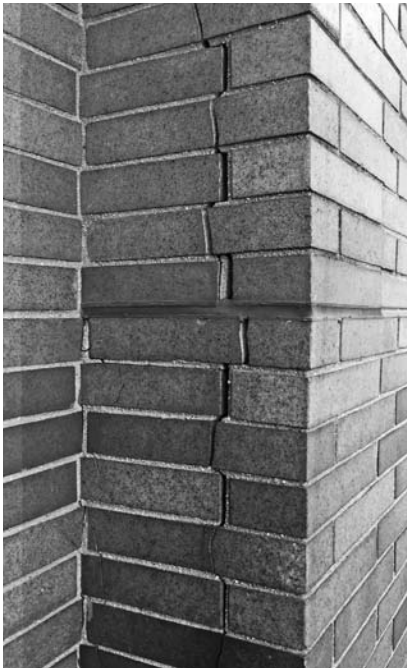
▲ Long, vertical cracks at building corners may indicate underlying structural distress.

When expansion joints are too narrow or spaced too far apart, there is insufficient accommodation for brick expansion, forcing sealant out of the joint and eventually leading to cracks and failure of the surrounding masonry. Failure to include expansion joints at building corners is a common cause of distress; as the masonry expands along the plane of the wall, the brick on each side of the corner comes together, leading to long vertical cracks and/or brick displacement at building corners.

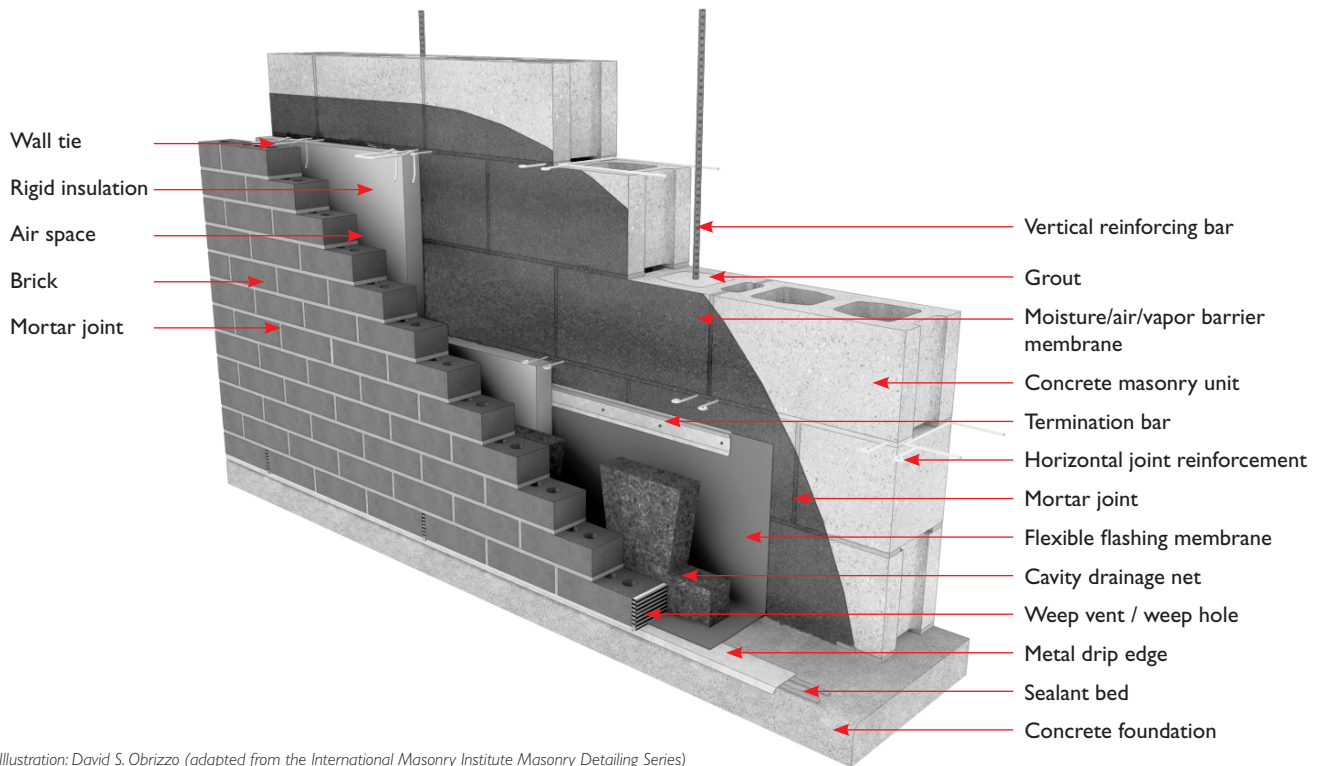
Typical Masonry Cavity Wall

In contrast, modern brick veneer cavity walls anchor a single wythe of face brick across an air space, typically two to four inches wide, to a back-up material. Part of a drainage system that includes flashings, drip edges, and weep holes, the air space creates a pathway for moisture to exit the wall assembly, while a steel, concrete, or masonry back-up provides structural support.

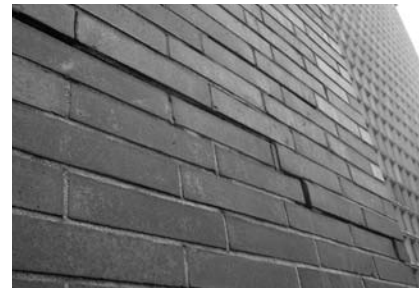
▲ Lateral displacement of brick veneer.

Insufficient or failed anchorage of the veneer to the back-up can lead to bowing and/or lateral displacement of the masonry.

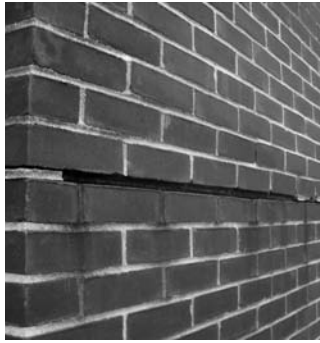
▲ Corrosion of steel shelf angle.

Causes of structural distress in brick masonry cavity walls are often related to the corrosion of embedded steel elements, which can lead to cracks and displacement. As water penetration causes steel lintels, reinforcement, anchors, ties, and accessories to corrode, they expand, exerting tremendous pressure on the surrounding facade, which can sometimes fail dramatically as a result.

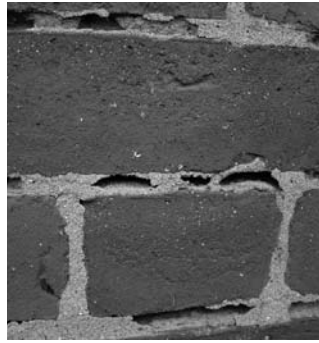
▲ Mortar joint failure.

Mortar Joint Repointing: Repointing is the process of removing damaged or deteriorated mortar to a uniform depth and replacing it with new mortar. When mortar is crumbling, cracked, or softened, repointing may be necessary to protect against water penetration.

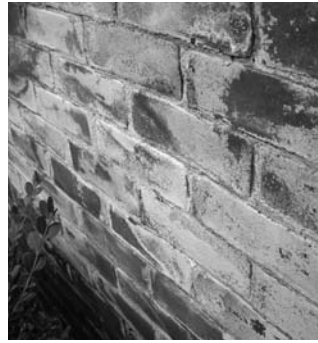
▲ Efflorescence.

Observable as white stains or salty streaks on the surface of masonry walls, efflorescence occurs when moisture within the wall assembly leaches water-soluble salts from the mortar or masonry. The main cause of efflorescence is water infiltration, whether from poor mortar joints, cracked brick, or other sources. Also, sloppy workmanship can clog the wall cavity with excess mortar and prevent water from reaching flashings and exiting the wall. Forced to find another means of escape, trapped moisture travels through the brick, resulting in efflorescence.

Once the problem has been identified and remediated, it may be difficult or even impossible to clean away salt deposits that have bonded to the masonry surface. If moisture has reached the building interior, water damage and mold may also need to be addressed.

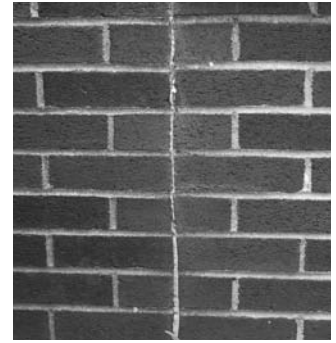
▲ Insufficient expansion joint width.

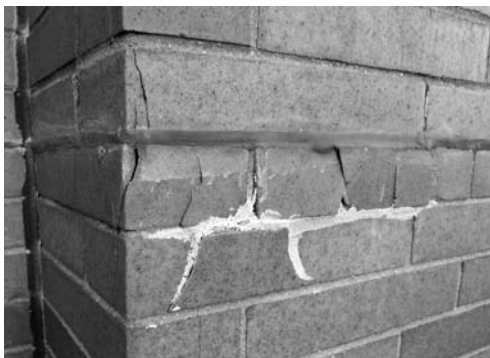
▲ Sealant alone cannot resolve masonry distress.
