Journal

Balcony and Roof Railings and the Code: Maintain, Repair, or Replace?

John P. Graz, AIA and Rachel C. Palisin, PE, LEED AP BD+C

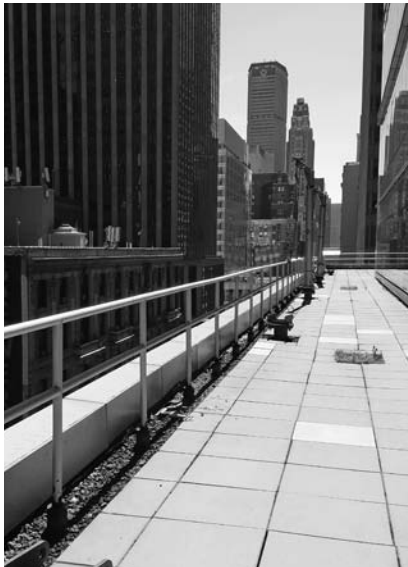
▲ As codes change, owners may find that existing railings must be updated or replaced.

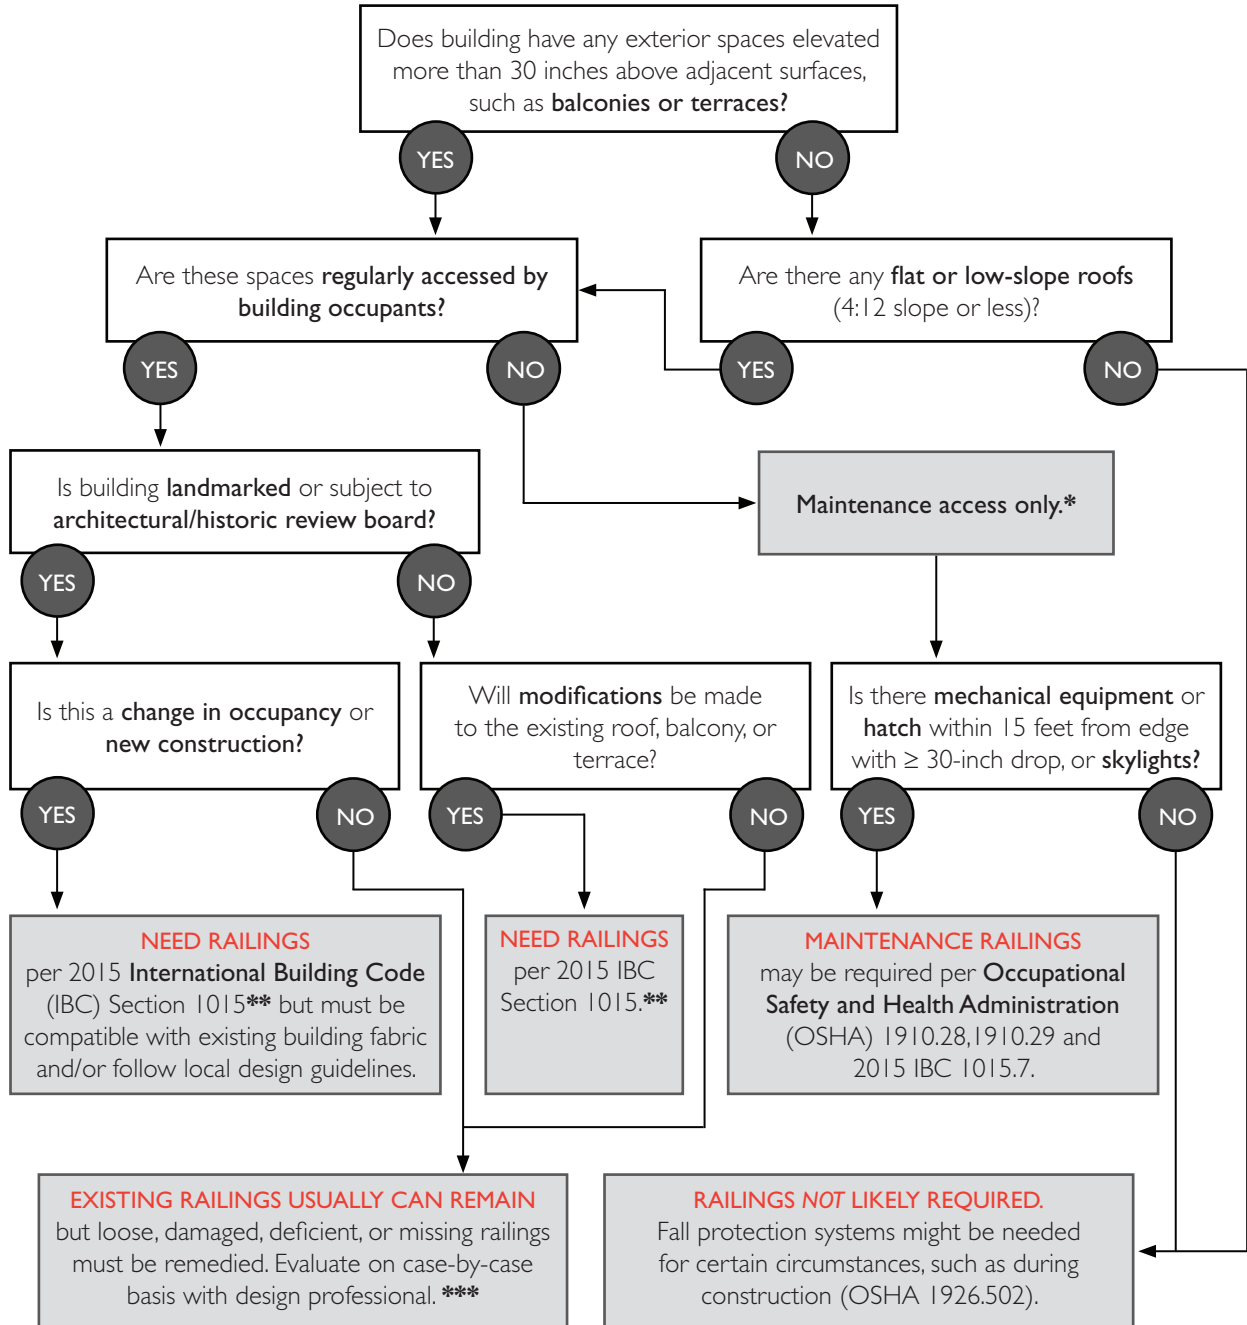
Do My Roofs, Balconies, or Terraces Need New or Updated Railings?

- * In New York City, roofs, balconies, or terraces with slope of 2.4:12 or less and height of 22 feet or greater require railings per 2014 NYC Building Code, Section 1509.8. Often, older buildings may comply with the code under which they were constructed.
- ** In NYC, railings must comply with 2014 NYC Building Code, Section 1013 and 1607. Often, older buildings may comply with earlier codes.
- *** The International Existing Building Code (IEBC) may also be applicable, depending upon building location.

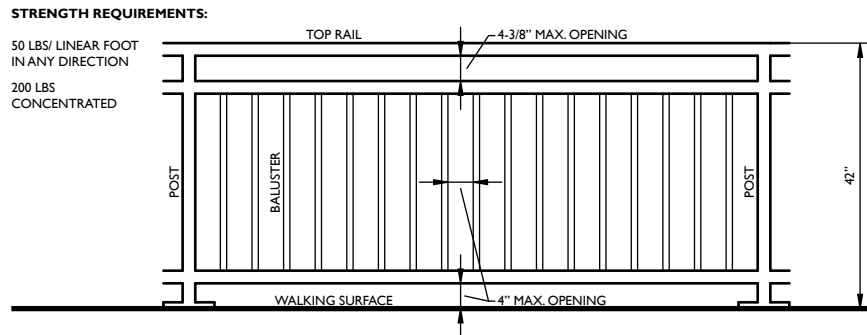
2015 International Building Code (IBC)

Typical Examples of Compliant Railing Configurations

The diagram at the top of this page illustrates the dimensional and structural requirements of the 2015 IBC, which demands higher performance than previous iterations. The 2015 IBC mandates that glass used in railing systems generally be laminated tempered glass, whereas the 2012 IBC accepted single tempered glass. Beyond the most recent revision, additional changes pile up when looking back just a few code cycles. For example, the 2015 IBC limits openings near the top of the railings to a maximum diameter of 4-3/8"; as recently as the 2006 edition, the IBC allowed top rail openings up to 8" diameter. As codes become more demanding, it is easy to see how a building constructed several years – or several decades – earlier could have railings which fall well short of meeting current regulations.

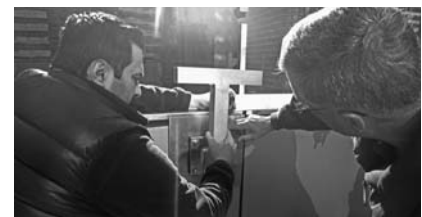
▲ Thicker insulation due to new energy code raises roof surface and demands taller railings.

Energy codes have indirectly impacted railing height by requiring increased insulation thickness for replacement roofing systems, resulting in an elevated roof surface relative to the top rail. With added insulation, railings that once were code-compliant may now be too low.
