Journal

Performance Considerations for Historic Window Replacement and Repair

Rachel C. Palisin, PE, LEED AP BD+C and Richard W. Off, AIA

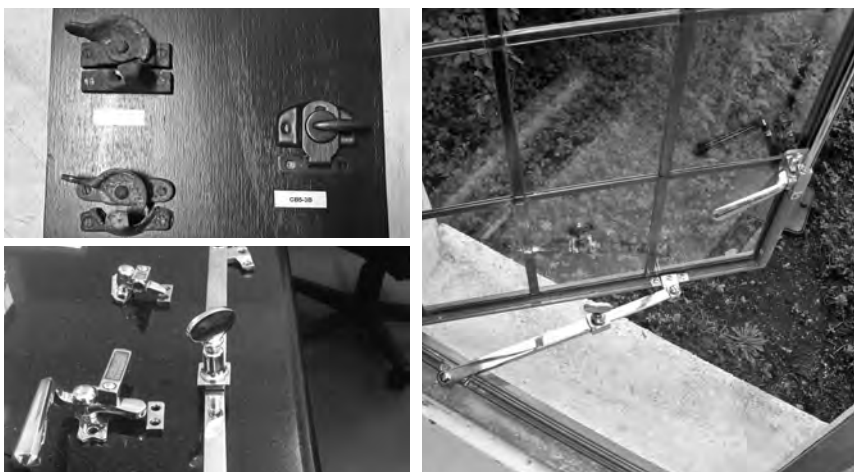
▲ Samples of original hardware (top left) facilitate restoration and, where necessary, replacement. Existing historic hardware may be removed and restored (bottom left), then re-installed (right).

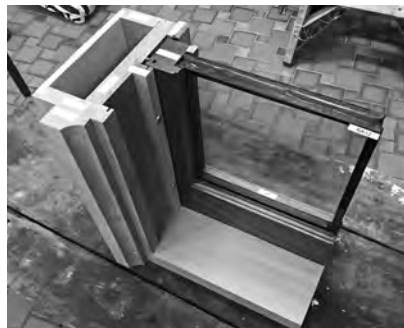
▲ Visual mock-ups are useful in historic window projects for verifying aesthetics.

Energy/thermal, structural and envelope standards can all be evaluated in some capacity through testing. First, a series of laboratory tests establishes the performance baseline, through both manufacturer/fabricator **qualification testing** and also **performance mock-ups**, or window units constructed solely for the purpose of laboratory testing, to ensure their ability to meet specified standards and requirements. Depending upon project specifications, samples and **visual mock-ups** might also be incorporated into the submittal process to better evaluate window appearance, including review of materials, finishes, profiles, and sight lines, before installation. This is especially critical with historic replacement projects, to verify that replacement windows match original or landmark conditions.

If one or more laboratory tests fail, or if appearances are not satisfactory, then mock-ups may be modified as required to achieve acceptable results. Then, such modifications are incorporated into the final design and manufactured windows. Once windows have been fully installed and sealed into their respective facade openings,

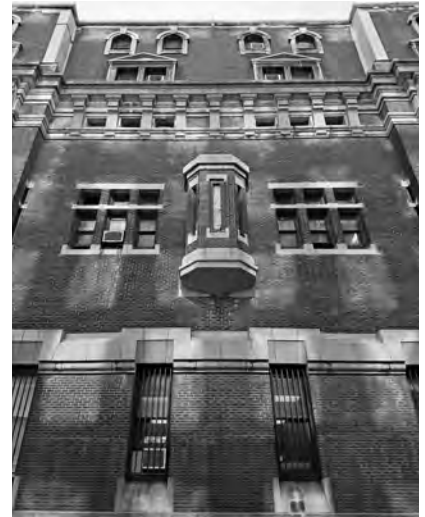
▲ For this landmark military building, window security was a top replacement consideration.

Even more challenging was the need to meet anti-terrorism blast-resistant standards. All the replacement windows and glazing needed to be able to resist a shock wave from explosions or other ballistic forces at the exterior of the building. To achieve the requisite blast resistance, the IGUs incorporated layers of poly-vinyl-butyl (PVB) plastic lamination, the same material used in car windshields. In this project, the lamination was applied to the inside surface of each glass pane of the IGU, creating what is known as a **double-laminated IGU**. For single-laminated assemblies, lamination can be applied to either the interior or the exterior lite. Double lamination maximized the glazing's resistance to lateral forces, as demonstrated by subjecting window performance mockups to laboratory-based shock tube testing, where the designed windows were evaluated for their ability to meet specified blast loads.

In addition to the glazing assembly, the anchorage also required special attention, as any lateral forces to which the IGUs are subject will be transferred through the frames to the surrounding masonry walls. A series of epoxy adhesive anchors were originally considered for use due to their high strength, but

given the position of the windows within the masonry walls, as well as the anticipated design pressures, epoxy anchorage was not employed because it could not achieve manufacturer-specified minimum edge distances, or the smallest allowable distance between anchors and the outer edge of the masonry. Instead, closely spaced mechanical anchors were ultimately specified, which are both suitable to the masonry substrate and able to achieve structural requirements.

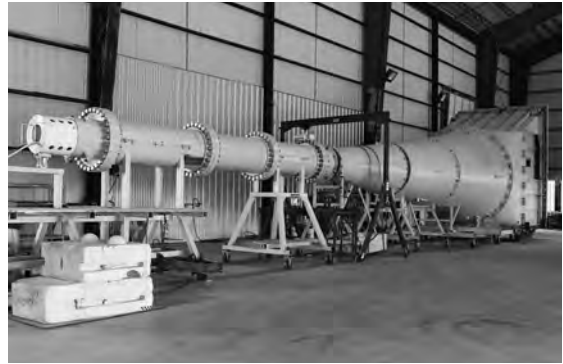
▲ Shock tube apparatus for blast resistance window testing.

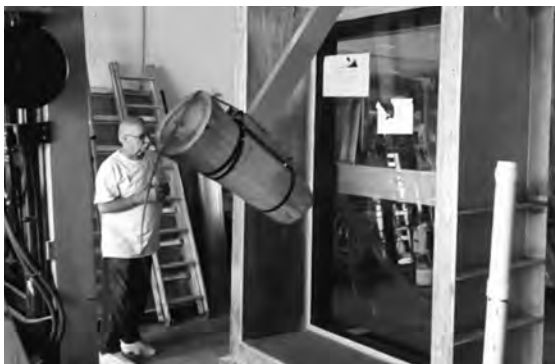
▲ Flood debris testing of a proposed window assembly.

To verify engineering calculations, **flood resistance laboratory testing** was performed, including **flood debris testing**, which evaluates the ability of windows to withstand large debris carried by fast-moving flood waters via impact loading, and also **hydrostatic pressure testing**, which measures the pressure of flood waters on glazing in a controlled chamber. To achieve passing results, it was again necessary to use laminated glazing in the storefront itself, as well as within the glass fin-wall system which was used to structurally support the glass. The fin-wall system consists of a series of vertical glass fins, which run perpendicular to the glass storefront, directly behind it at the interior side, attached only by a very thin vertical line of structural silicone sealant. Glass fins were used in lieu of vertical metal mullions to enhance the appearance of openness and minimize visual obstructions within the storefront system. Alternative and/or supplemental means of flood resistance measures were also considered, such as flood barriers or gates. This typically consists of metal posts and panels which would be securely anchored to facades or in the ground and requires a trained staff capable of rapidly deploying the system before an anticipated flood event.

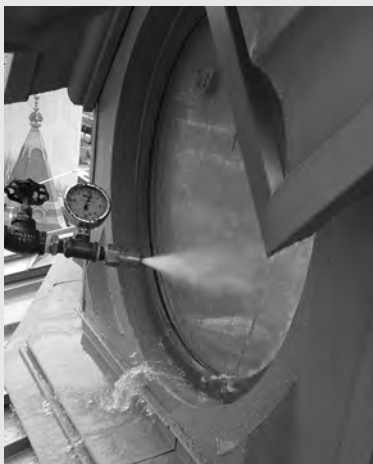
▲ Water test of newly installed window.

During construction, on-site tests provide quality assurance. The general procedure for construction testing should follow AAMA 502: *Voluntary Specification for Field Testing of Newly Installed Fenestration*. Testing consists of visual assessment of seals, alignment, and window operation, as well as air and water infiltration tests according to the standards of ASTM E 783 and E 1105, respectively. The project designer must determine the number and frequency of field tests, as well as passing thresholds for the specific metrics; it is not sufficient to only reference “test according to AAMA 502” in the specifications. ■

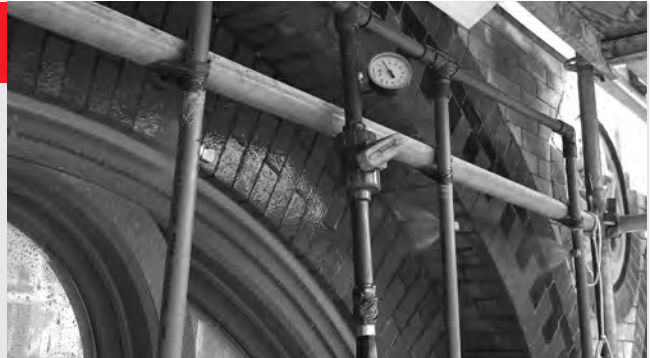
▲ In the field: Spray rack water test of a rehabilitated historic window.

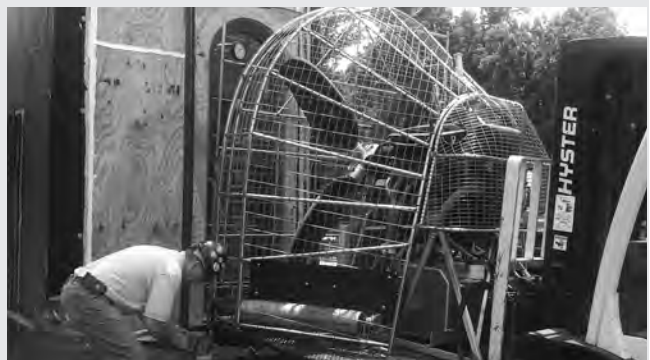
▲ In the lab: Wind and water test preparation for a window PMU.

Also referred to as a **performance mock-up (PMU)**, off-site testing is usually carried out at an architectural testing laboratory. The parameters of a PMU are set by the project specifications to follow the procedures of AAMA

101: *North American Fenestration Standard/ Specification*; the design professional may elect to test a single typical unit or multiple configurations. A general test program includes multiple tests for water penetration (ASTM E 547 and/

or E 331), air infiltration (ASTM E 283), and structural performance (ASTM E 330). Additional tests may be specified depending on project requirements, such as life-cycle testing or lateral force (earthquake resistance). Tests may be repeated after each other to determine if air infiltration, for example, increases after the window is loaded with the maximum structural pressure. The PMU generally represents testing the “best-case” scenario for any installation, since it is a controlled and easily accessible setup in a lab.

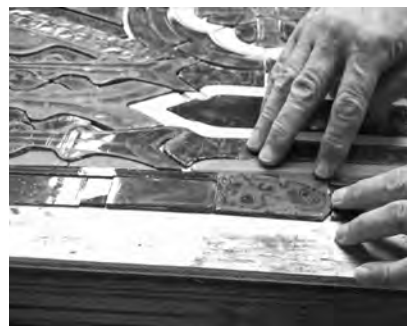
Documenting and reconstructing stained-glass mosaics is painstaking work.

confirmed that the window leaked and required extensive work. Given that much of the decorative glass and bronze frame components were in good condition, and that the window could be considered a priceless artwork, the project team decided to fully restore the window, rather than replace it. The window was carefully disassembled, salvaged, and brought to a studio certified by the Stained Glass Association of America. This allowed for the cleaning and archival documentation of each component, which would also facilitate replacement should pieces become damaged during restoration.

Historic stained glass is typically held in place by thin lead components

called **comes**, which are H-shapes for middle section pieces and C-shapes for edge pieces. All lead comes were replaced and resealed to the adjacent stained glass with a linseed oil-based waterproofing cement. Over time, as this cement deteriorates, windows are often temporarily repaired with elastomeric sealant, but when maintaining historic windows, it is essential to use a sealant which is compatible with the original materials. Following restoration, the window was reinstalled, and although the performance and operability do not conform to contemporary standards, they are much improved.

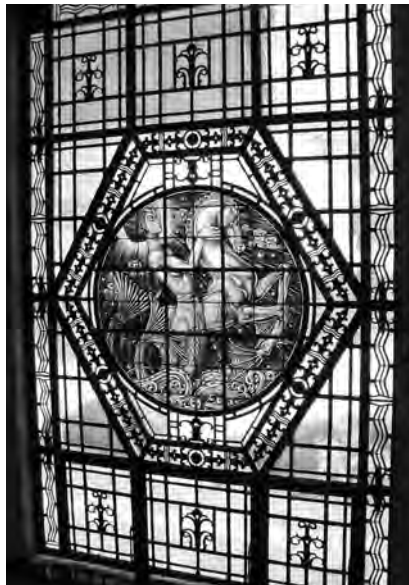
▲ This bronze-framed Art Deco window was removed, restored, and re-installed.
