# **Preventing Winter Damage**

By Steven J. Susca

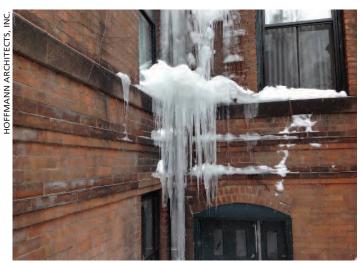
Icicles might seem like charming seasonal decorations, but they mean trouble—both for the building, and for those below.

In addition, water that melts and re-freezes at the gutter and drip edge begins to extend downward, forming icicles. With water continuing to flow down from the eaves, these pointed shards of ice can grow to many feet in length, posing a tremendous risk to pedestrians and vehicular traffic below.

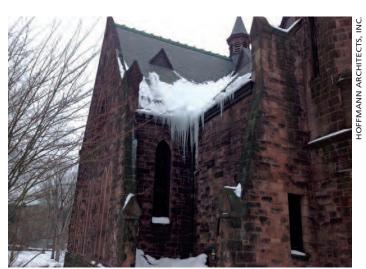
Snow and ice buildup at eaves.

When asked for examples of winter-weather problems, the first thing many facility managers and design professionals will bring up is *ice damming*: the frustrating—and potentially dangerous—accumulation of ice and snow at roof eaves. As snow on the roof starts to melt, water flows down to the roof edge, where it collects and re-freezes. Over time, this thawing and freezing creates a build-up of ice at the eave, and causes water to back up under the roofing material, eventually spilling over into the building interior.

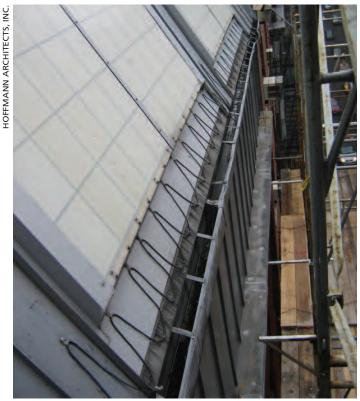
Prevention: Install heat tracing.

In some cases, building configuration makes preventing ice dams difficult, as configurations of roof and exterior wall interfaces may prove challenging to drain expeditiously. An electric ice-melt system using radiant heating cable may be installed as part of a roof rehabilitation or replacement project.

Typically, heat tracing is installed at eaves, extending down into gutters and, sometimes, down each leader to prevent ice from clogging drainage pathways. The icemelting coils should be used in conjunction with ice and water shield: a barrier sheet, typically composed of a rubberized bitumen membrane. Installed under the roof covering, iceand water-shield should extend from the edge of the roof to at least two feet (24 inches) inside the exterior wall line. Manufacturer requirements vary, but ice- and water-shield is typically applied at eaves, valleys, ridges, hips, rake edges, transitions, chimneys, and penetrations.

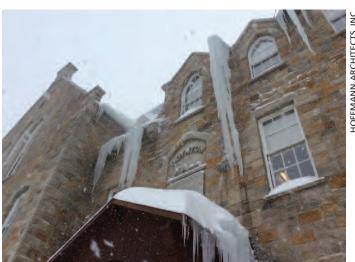
Hazardous ice formations.

Although snow guards were in place along the steep barrel-vaulted roof, many had bent under excess snow loads, and many of the fall-protection line brackets had been ripped out of their anchorage points by the tugging weight of accumulated snow. Dense traffic loomed below, immediately under the struggling snow-protection system, which, if compromised, would deliver a hefty payload of snow and ice to unwitting pedestrians and drivers below.

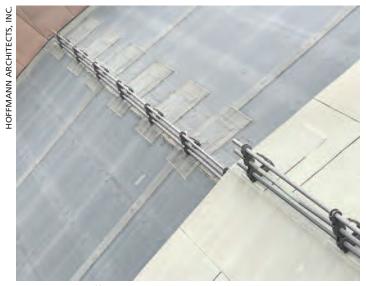
Prevention: Sufficient snow guards.

Evaluating the slope, frictional coefficient, and anticipated snow load of a roof is key to providing sufficient snow guards. In the example of the barrel-vaulted roof above a busy street, installing additional snow guards at an intermediate height between existing rows would reduce the amount of snow falling onto lower roof areas, alleviating pressure on the system. More snow guards to share the load means less frequent replacement of rails bent by excessive snow weight.

Accurately identifying the cause of loose snow guards is important to preventing recurrence. Adding fasteners can increase strength, but if the anchorage was incorrectly designed, or fastened to an unstable substrate, redesigning the system might be necessary. Routine inspection of snow guards after each winter season—and replacement of compromised pipe rails or guards—provides reassurance that, come cold weather, the system is ready to weather the storm.

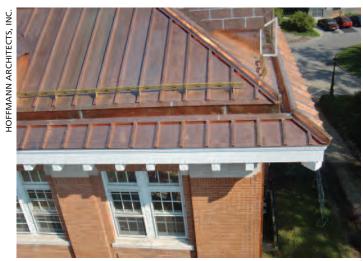
Prevention: Appropriate drainage.

Case in point: one well-meaning facility retained a contractor to replace aging gutters. When the façades began accumulating a great deal of ice in the winter, the contractor installed heat tracing and added screens over the gutters to collect debris. This only made matters worse. One action might have prevented the years-long effort to stem the overflowing drainage system and ice-covered façades: correctly sizing gutters.

Unfortunately, the replacement gutters were too small for the roof area, so they were overwhelmed with water and snow during storms. Keeping gutters free of debris is important, but the screens and heat-tracing only served to encourage ice-dam formation in the saturated gutters. Replacing the drainage system with an appropriately dimensioned one solved the problem.

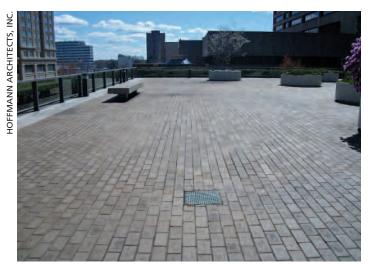
Prevention: Establish adequate slope.

Water runs downhill, which means that the lowest points of a plaza should be at drains. If water is collecting elsewhere, it may mean that the plaza does not have the correct slope. Sometimes, poor drainage can lead to heaving of plaza pavers, which in turn creates a low point on the walking surface that collects water and ice.

In that case, rehabilitation of the drainage system and re-setting or replacement of pavers may solve the problem. However, it may be that the plaza does not provide adequate slope to drains even with pavers set correctly, in which case rehabilitation and re-grading of the plaza may be the only long-term solution.

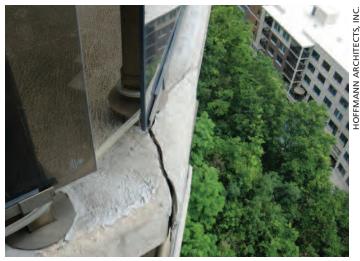
Cracks at slab edge.

In many instances, lightweight aluminum railing posts at concrete balconies are directly embedded into the concrete at the edge of the slab. If not properly finished and sealed, gaps between railing members will allow the railing stanchions to fill up with water. As the water freezes, it expands, which can cause expansion of the aluminum post where it enters the concrete. This, in turn, results in cracks at the edges of the slab.

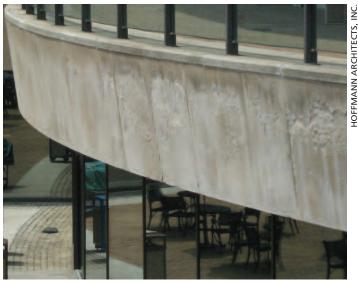
Freeze-thaw and salt damage.

Failed coatings and glazing compound can leave windows and doors exposed to deeper damage from the constant presence of moisture. Curtain-wall mullions may become displaced when subjected to freeze-thaw cycles, and masonry structures may show signs of efflorescence, or migration of salts to the surface. Where the façade meets plazas, sidewalks, or roads, deicing chemicals may accelerate damage from exposure and freeze-thaw cycling.

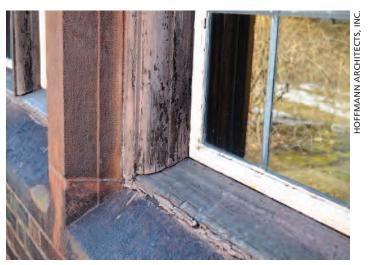
Prevention: Maintain coatings and seals.

When water can find a way into the façade, it can cause significant damage, especially as it expands when freezing, and contracts as it thaws. To protect sensitive façade elements, it's important to prepare well ahead of cold weather by replacing worn coatings, repointing open mortar joints, replacing failed sealant and gaskets, and replacing damaged materials.

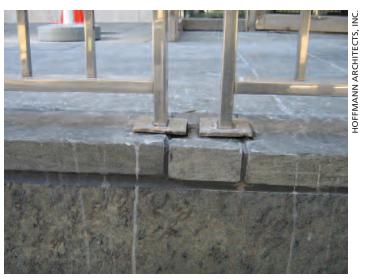
Prevention: Consider adjacent elements.

Where different materials intersect, there is potential for damage from differential movement. As each material responds to fluctuating temperatures, one is likely to expand or contract differently from another, which places strain along the plane where they meet.

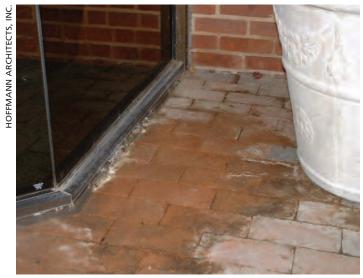
Corrosion and deterioration.

Façade elements adjacent to walking and driving surfaces need to be protected from caustic deicing chemicals, which can lead to corrosion, scaling, and disintegration. Opting for less damaging ice-management compounds not only protects vulnerable façade materials, it spares exterior stairs, plazas, and garages, too.

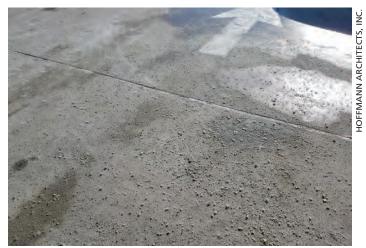
Prevention: Choose the right chemicals.

Rock salt (sodium chloride) may be the most common and least expensive deicing chemical, but that does not mean it is the best choice. When its corrosive and destructive properties are considered, it may prove the more expensive option, given the costs of rehabilitating the damage it does.

Calcium chloride is a better option, although it is still a corrosive compound. Better still is calcium magnesium acetate (CMA), an ice-loosening chemical that does not melt snow, but instead creates a slurry that prevents ice from bonding to the surface. Caveats are that CMA must be applied before snowfall, and that mechanical removal of the loosened ice and snow is required. Addition of grit or sand can improve traction, and reduces the amount of deicing chemical needed.

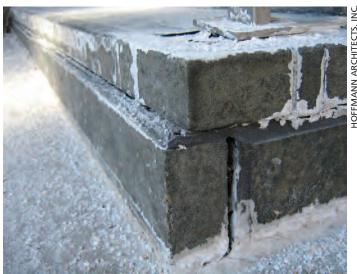
Prevention: Apply deicers judiciously.

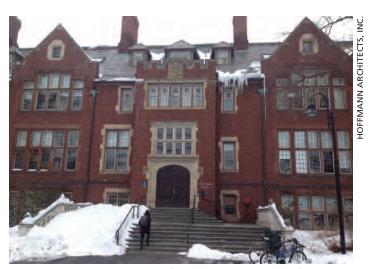
Exterior envelope assessment of the 20 buildings at this facility helped the institution prevent and treat the effects of harsh winter weather.

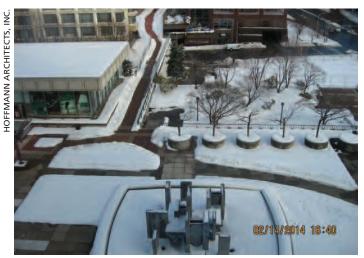
Winter weather and indiscriminate use of deicing chemicals led to widespread damage at this plaza, which was reconstructed to incorporate preventive measures, including heat tracing.
