Hoffmann Architects

Quarterly

Reconstruction Requires Ingenuity

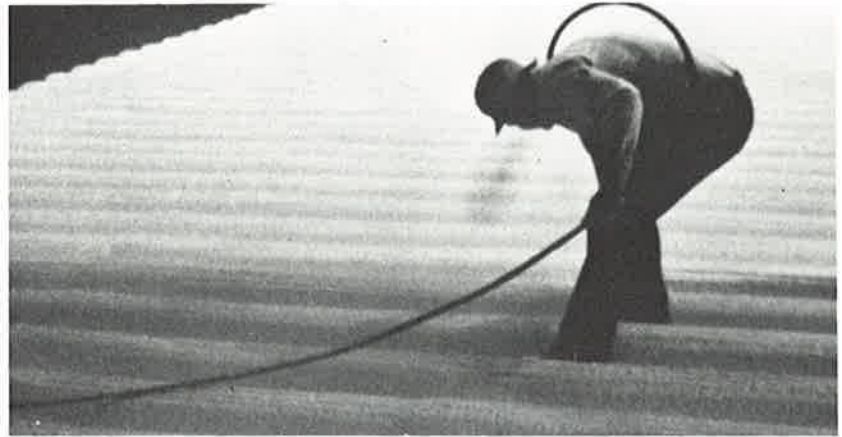
photo courtesy of the Urethane Foam Contractors Association

deck, treating rusted areas, tightening loose fasteners and adding new ones as necessary, spray apply a silicone coated polyurethane foam roofing system over the existing deck. The foam not only bridges small gaps, but also stiffens the roof

assembly while increasing the R-value of the roof. By thermally isolating the deck, movement due to differential temperatures is avoided. Leaks are stopped by the new system and use of the building is on-going during application.

Leaking Metal Roof

Leaking in an older standing seam metal roof. Have to avoid removing and replacing entire deck due to necessity of uninterrupted use of building.

Loosening of fasteners allowed movement in the joints. As they opened, they allowed water to enter the building and corrode the steel.
