Keeping It Together:

An Overview of Building Envelope Maintenance and Repair

Russell M. Sanders, AIA and Lawrence E. Keenan, PE

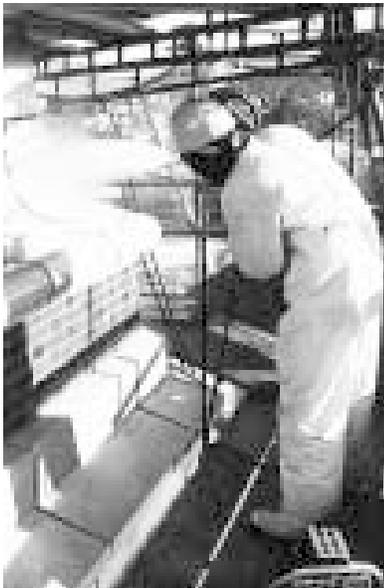
▲ Final cleaning of a reconstructed cast stone and brick facade.

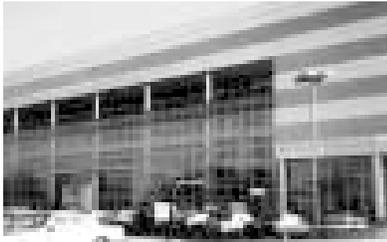
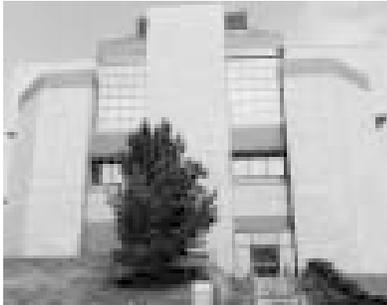
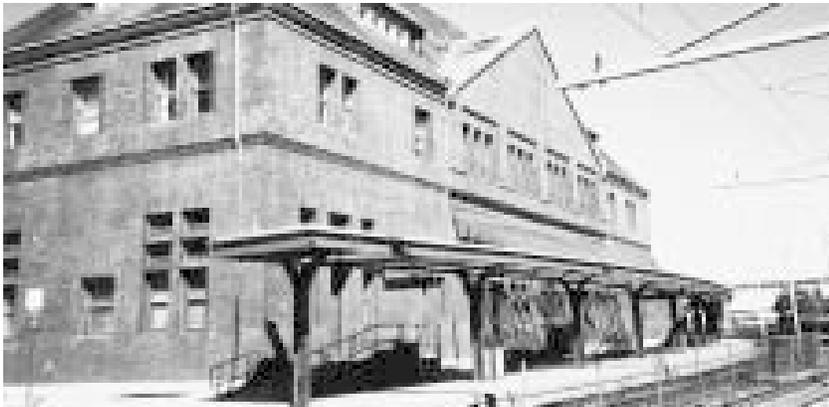
▲ Facade systems can differ widely in both materials and design principles. Pictured above are three examples (top to bottom): curtain wall, which supports only its own weight, of metal and glass; thin stone veneer curtain wall; and brick, load-bearing masonry, which supports weight beyond its own. The detail photo at right shows a thin stone panel removed from its concrete back-up.

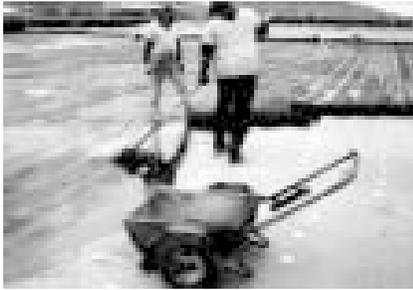
▲ Rather than keeping water out, a coating applied over this brick trapped moisture inside the wall, leading to heavy spalling.

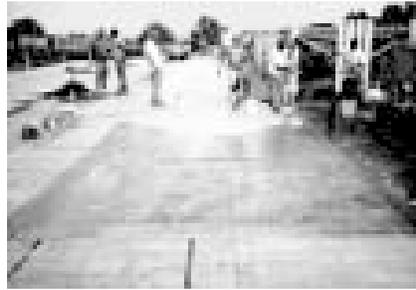
▲ Insufficient concrete coverage over reinforcement can lead to cracks and spalls as water begins to enter. Eventually, the steel will rust, growing many times its original size and blowing out everything around it.

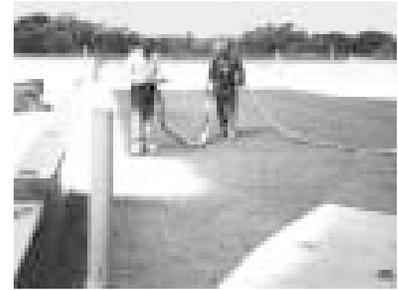
▲ Workers mop down the first layer of a modified bitumen roof (MBR) over mechanically attached insulation (top left). Single-ply EPDM membrane (a synthetic rubber) is applied (center). The photo above shows the nozzle through which foam roofing is applied. The light colored areas are exposed foam, and the darker sections have already been sprayed with a protective silicone coating.

accelerated material degradation or very short repair life. A common mistake made in the repair of sprayed polyurethane foam roofs (“foam”) is the use of asphaltic mastics. Foam roofs often have a coating of silicone applied for UV protection. Since the only product that adheres to silicone is more silicone, applying asphalt is little more than counterproductive.

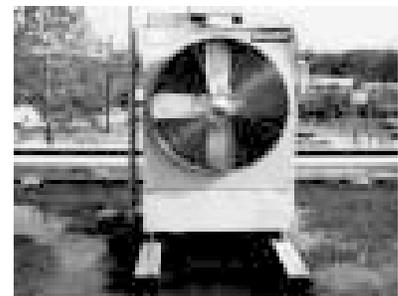
▲ A fan unit resting on wood sleepers which bear directly on the membrane can cause a puncture or tear, creating a site for water infiltration.

Most detailing errors occur at termination points. A great deal of effort is often expended to properly flash roofs onto walls and curbs only to find that the top edge, or termination, allows water behind the entire assembly. Another common error is improper anchorage of rooftop equipment. Take, for example, a fan resting on wood sleepers, which, rather than being anchored to the concrete deck, bear directly on the membrane. Without adequate movement control and weight distribution, such equipment can damage the membrane, leading to water entry and further deterioration. All too often, a simple oversight, like the minimum

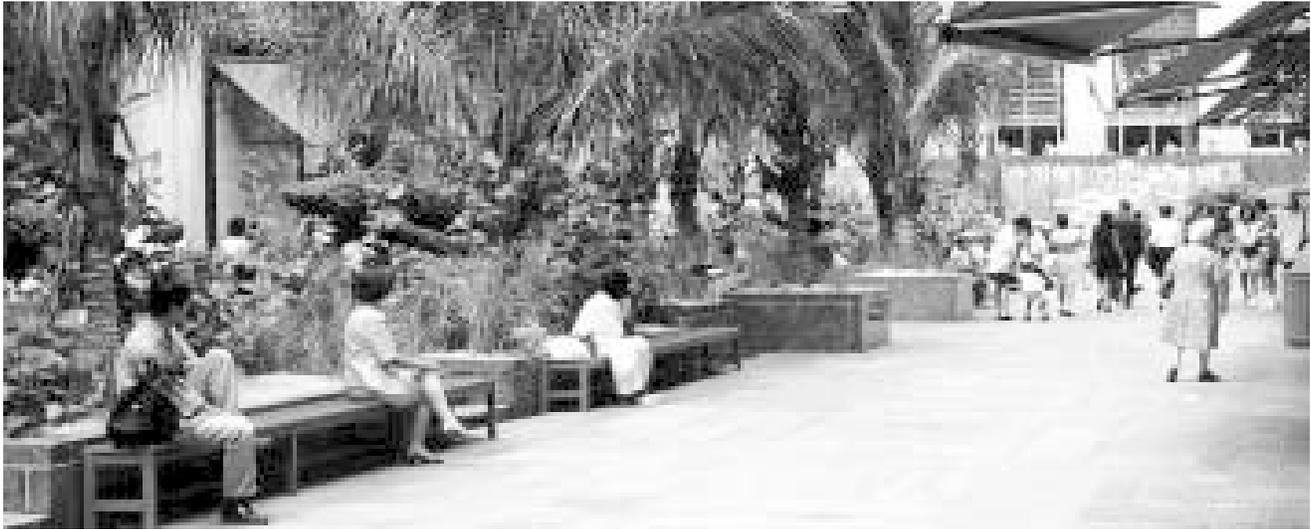
▲ The patchwork appearance of this plaza shows sites of repair work. Vegetative growth in the mortar joints indicates a constant source of moisture.

Most problems observed, such as leaks, stains and surface deterioration, usually stem from poor drainage. As an example, it is not uncommon to have the wearing (top) surface of the plaza sloped to drains, while the surface at the membrane is level. Water penetrating to the membrane then stays in place, causing the entire system to deteriorate prematurely.

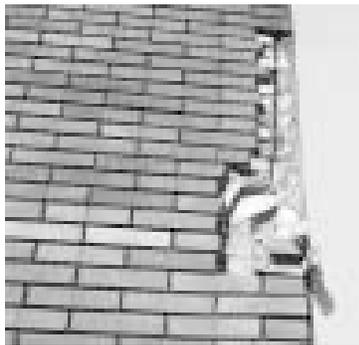
▲ Restricted movement at a joint prevented expansion of this masonry tile, which then broke under the pressure.

Materials will move according to their natural tendencies, whether the building is prepared or not. Where two or more materials meet, allowance must be made for their sometimes vastly different rates of expansion and contraction. The intersection of face brick with concrete anchors should include adequate compressible material between the two. Otherwise, as the brick expands and the concrete contracts, the wall will bow to allow for the movement. Within the face material, or between plaza elements, the same considerations must be made, such as a stone band in a brick facade.

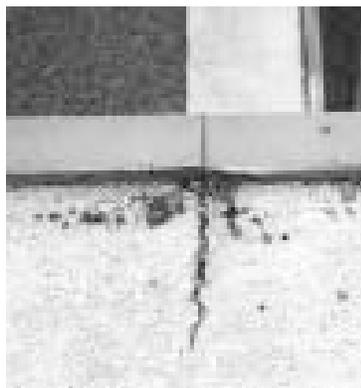
▲ Differential movement of the steel and foam on this roof has led to severe cracking. Like wood, foam also expands and contracts with moisture, further exacerbating the damage.

A dramatic example of differential movement is that of a foam roof meeting steel termination. Foam's rate of expansion/contraction is ten times that of steel, and it will pull away from the roof edge if meeting steel directly. Softer components are always sacrificial in cases of material incompatibility.

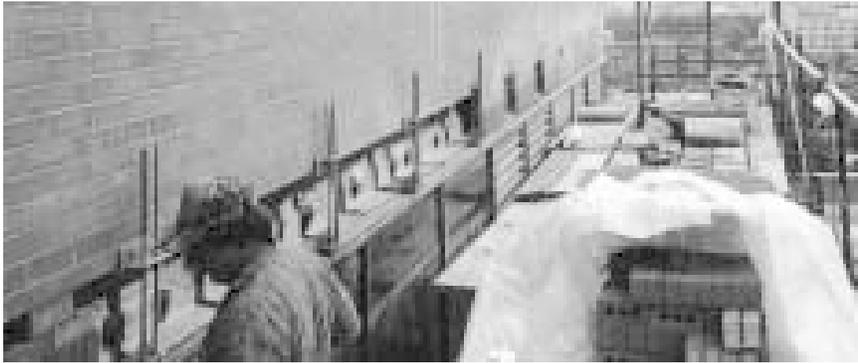
▲ When repairs become necessary, temporary shoring and protection of surrounding areas may be required. The cost of such additional measures should be calculated into the overall budget for the project.
