Journal

Troubleshooting the Building Envelope: Addressing CAUSES, Not Symptoms

John J. Hoffmann, FAIA and Russell M. Sanders, AIA

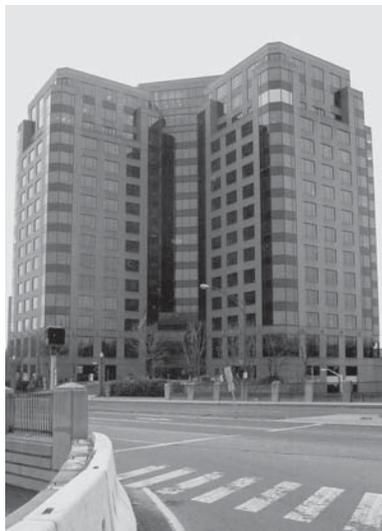
▲ Water infiltration, thermal expansion/contraction, improper construction or substandard materials, structural movement or stress, and age contribute to the inevitable deterioration of building materials over time.

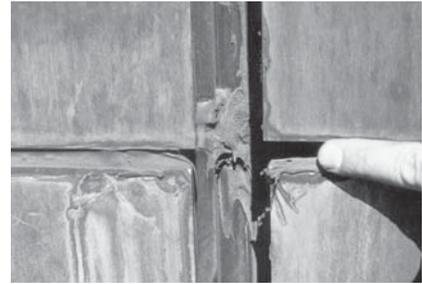
A Sealant failure between aluminum panels.

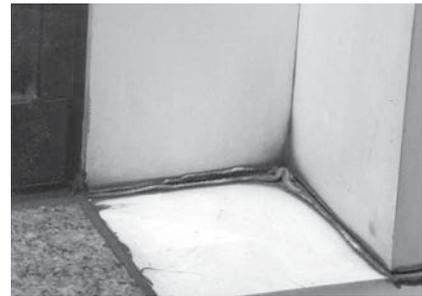
A Cohesive joint failure.

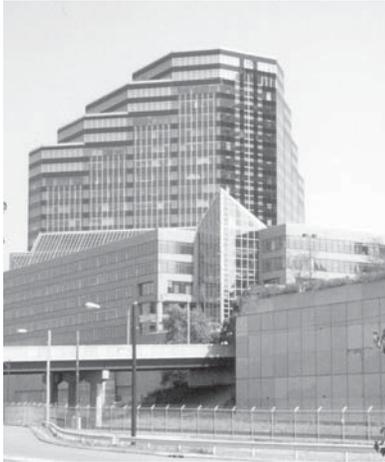
▲ Glass curtain wall and window systems at a suburban corporate office park.

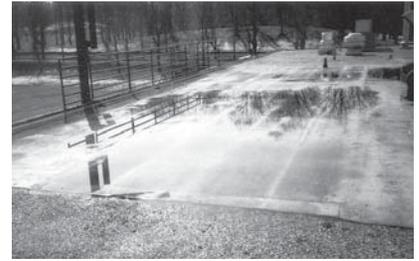
▲ Ponding (water retention on the roof membrane) can occur in low slope roofing systems.

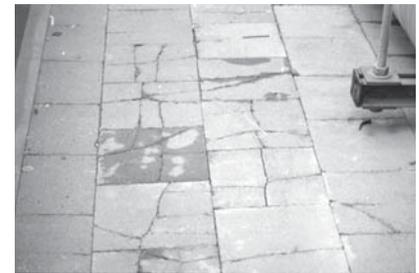
▲ Note cracks in these damaged ballast pavers (in a low slope system).

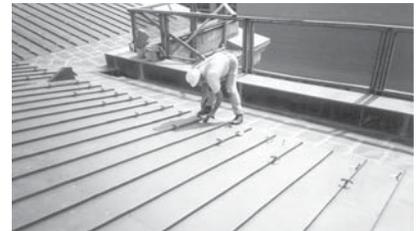
▲ Open seams/solder joint failure are indicators of deterioration in metal systems. Proper care during application of roofing materials is critical to preserving a roof’s useful life.

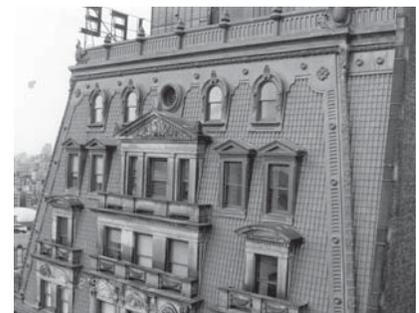
▲ An historic mansard roof (having on each side a steeper lower part and a shallower upper part) with terra cotta tiles.

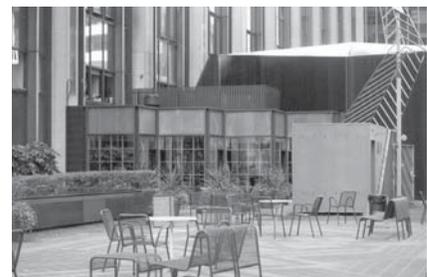
▲ Plazas/terraces often incorporate seating, planters, and lighting design, all of which must be considered when planning maintenance and repairs.

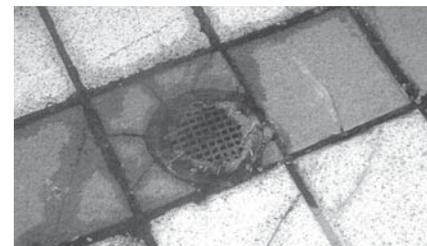
▲ Debris should be cleared of drains to ensure their effectiveness. Note cracks which permit water entry.

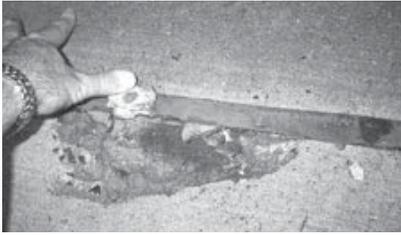
▲ Spalls, laminations that break off due to corrosion of reinforcement/embedded items, are among the indicators of failure in parking structures.

Case in point: when cracks (which can develop on the top surface for any number of reasons) permit water to enter the concrete, the steel reinforcing bars that are embedded within the concrete for strength begin to rust. As the steel rusts, it pushes the concrete away, causing it to chip and spall—risking damage to vehicles and injuries to people.

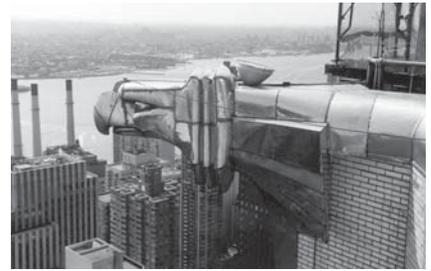
▲ Large, stainless steel replicas of automobile hood ornaments adorn the landmarked Chrysler Building. Over the years, roofing mastic, sealant and other incompatible materials were used to make repairs, all of which exacerbated negative conditions.

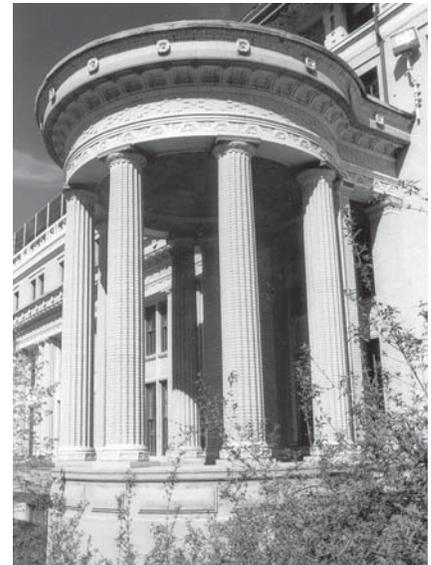
▲ Intricate patterns and decorative elements can present challenges when rehabilitating historic structures.
