# Journal

## Curtain Walls: Not Just Another Pretty Façade

Russell M. Sanders, AIA

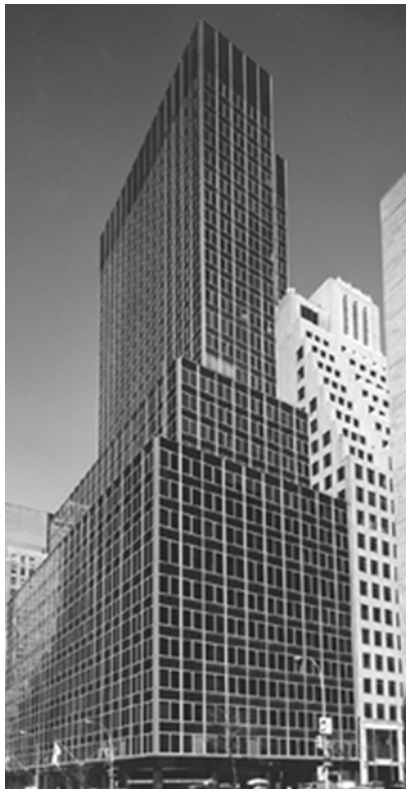
**A** Curtain walls may be rehabilitated for aesthetic reasons or to improve energy efficiency, in addition to the need to resolve deterioration associated with weathering, age and materials or installation failures.

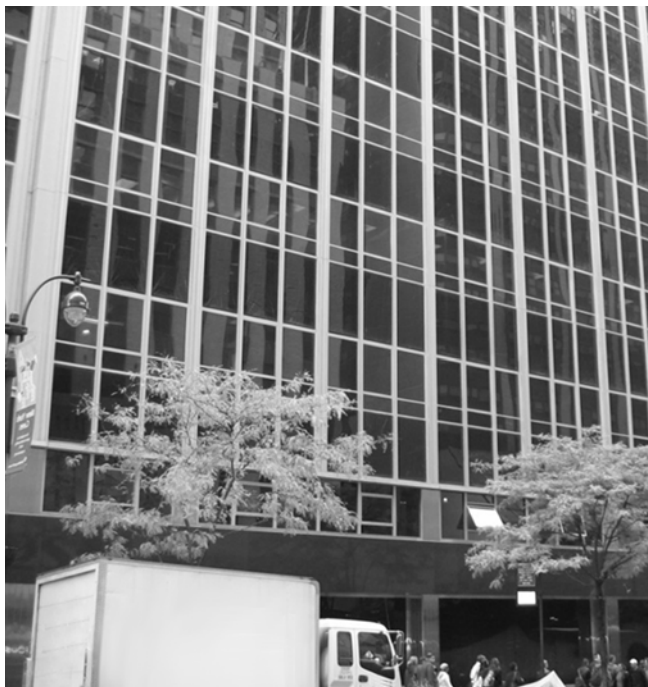
Figure 1a.

Figure 1b. Illustration demonstrates the characteristics in a typical stick curtain wall system, shown in Figure 1a to the left.

The oldest type of curtain wall is the stick system. (Figures 1a and 1b below) It features a cladding and exterior wall structure from floor to floor. The stick system is assembled in the field using various components, including anchors, mullions, rails, vision glass, spandrel glass, insulation and metal back pans. In addition, there are various hardware components, including connectors, setting blocks, corner blocks, pressure plates, caps, gaskets and sealants. Not only is the stick system airtight and resistant to water penetration, it's cheap, and quick

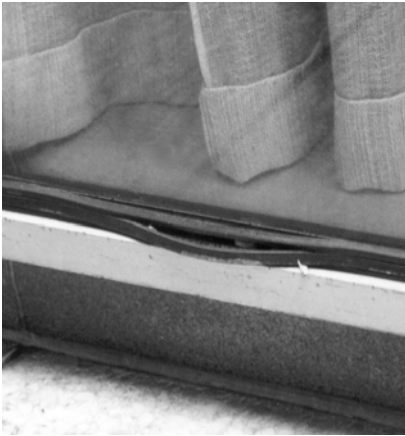
**A** Figure 3. Failed gasket at the base of the glazed curtain wall will permit water and air penetration.

A curtain wall is a combination of many elements with two common interfaces between the parts: gaskets and seals. Gaskets and seals provide watertight, flexible connections between the panels and framework. Generally, curtain wall framework and panel materials rarely deteriorate; failure of those components is a result of damage. But gaskets and seals are made of compounded elastic materials that can dry, shrink and crack and lose adhesion (Figure 3).

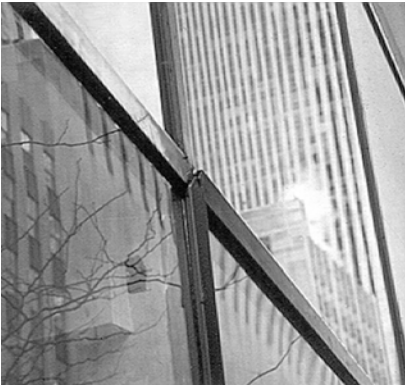
**A** Figure 4. The metal support system behind the mullion cover has rusted, causing it to extrude.

Dripping water at window heads or wet flooring are the most obvious indications of moisture problems. If the existing curtain wall is a thermal pane system, condensation can form between the panes of glass. Insulated panels that no longer provide insulating qualities can mean that moisture is entering the system. Deformation of the framework can occur if water that has intruded the system collects and expands during freeze-thaw cycling (Figure 4).

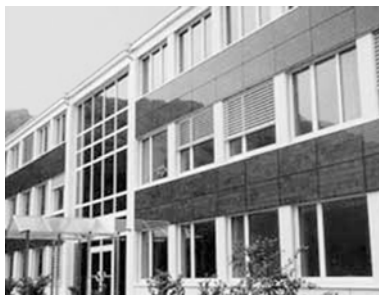
▲ Figure 6

▼ Below, Figure 6 shows a factory built with spandrel glass incorporating photovoltaic cells.

Solar cells, or *photovoltaics*, convert sunlight directly into electricity (Figure 6). Solar cells are made of semi-conducting materials similar to those used in computer chips. When these materials absorb sunlight, the solar energy knocks electrons loose from their atoms, allowing the electrons to flow through the material to produce electricity.

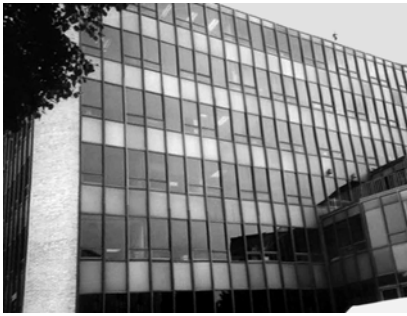
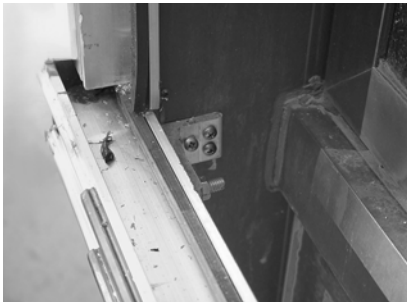
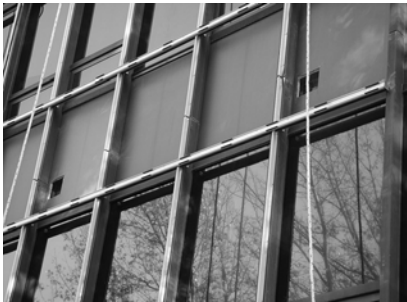
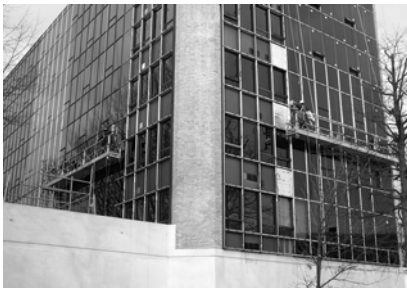
◀ From top to bottom, figures illustrate how a curtain wall is reclad. Figure 8 shows the curtain wall prior to replacement. Figure 9 shows the horizontal rail attached to the structural mullion. Figure 10 shows new veneer rails attached to existing curtain wall mullions. Figure 11 shows the installation of new vision, spandrel and insulation panels. Figure 12 shows the completely reclad curtain wall.
