Journal

Care and Preservation of Slate Roofs

Deborah J. Costantini, AIA and Benjamin J. Robinson, Assoc. AIA

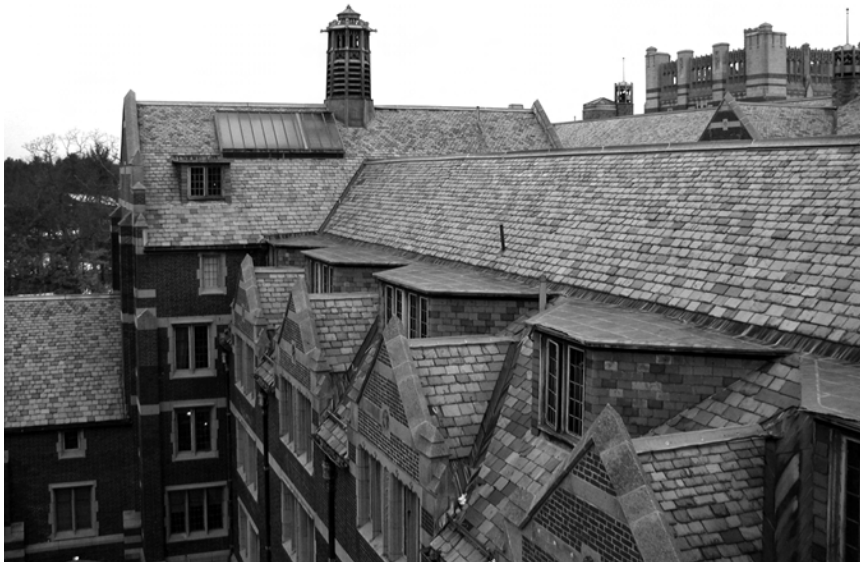
▲ With regular maintenance and appropriate, periodic repairs, a well-designed slate roof can last upwards of a century.

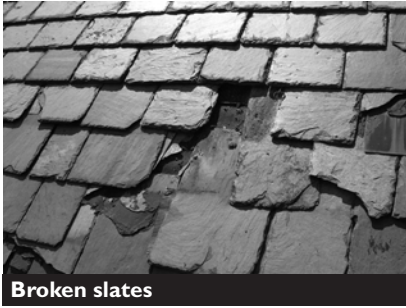
Broken slates

- **Slate.** Document cracked, broken, misaligned, delaminated, or missing slates. "Sounding" a slate by tapping it with knuckles or a slating hammer can help determine its integrity; a dull thud can indicate poor condition, whereas a full, deep sound generally means the slate is intact.
- **Flashing.** A slate roof is only as good as the weakest flashing detail.

Replace deteriorated or missing slates. To remove a broken or damaged slate, a slate ripper can be used to extract the existing nails. The slate then slides out, and a new one can be inserted using either the nail-and-bib or slate hook techniques described above.

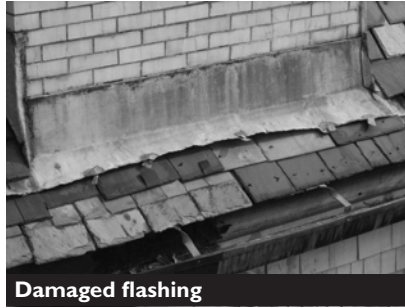
Damaged flashing

Slates may last centuries, but flashing must be maintained and replaced periodically. Look for loose and missing fasteners, and flashing that exhibits deformation, wearing, corrosion, or pin holes. Open seams and missing flashing members are also common sources of water entry. Areas to investigate include: ridge, hip, valley, roof-to-wall, drip edge, and step flashing.

Repair/replace flashings. Open seams and missing or inappropriate securement can be repaired, while deteriorated flashings will need to be replaced. Copper flashings can be replaced in kind, with a minimum of 16-ounce copper; although a heavier, 24-ounce weight is preferred for erosion-prone areas like valleys and gutters. Lead-coated copper is also commonly used for historic restoration, because of its durability in repair applications.

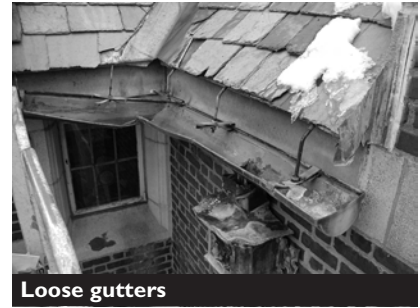
Loose gutters

- **Drainage system.** Deterioration of copper gutters and drainage attachments manifests similarly to flashing damage. Check for the signs of distress listed above at gutters, conductor heads, leaders, attachments, and related flashings.

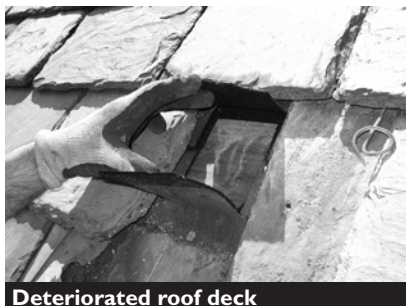
Deteriorated roof deck

- **Substrate/roof deck.** Inspect the rafters and sheathing for moisture staining. Test probes, involving removal of selected slates to expose the substrate, can be used to determine if wood rot is present when attic space is inaccessible.

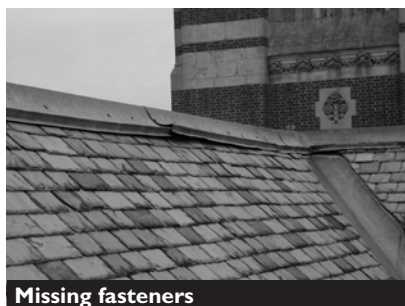
Missing fasteners

- **Fasteners.** Confirm the condition and material of nails and other fasteners. Copper or steel nails are generally found on most slate roofs, but replacement slates or flashings may have been secured with inappropriate fasteners, which may deteriorate prematurely.

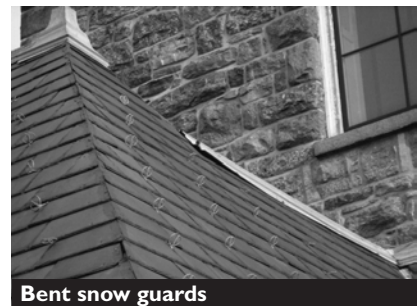
Bent snow guards

- **Accessories.** Check the stability, proper functionality, and correct installation of snow guards, lightning protection systems, and other safety devices.

Replace damaged safety accessories. Snow guards that are bent or broken should be replaced promptly, as large drifts of snow are potentially dangerous, both in themselves and in their tendency to loosen and dislodge slates, which can then fall from the roof.

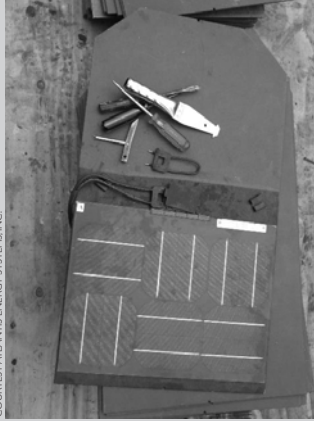
Integrating Solar Power with Traditional Stone

One way to integrate a PV system with a slate roof is with a product called “Sunslates.” Sunslates are dimensionally the same as a slate shingle and are installed the exact same way by a roofer. They clip together in series to create a low voltage electrical circuit, and an electrician connects the system to the building’s electrical panel.

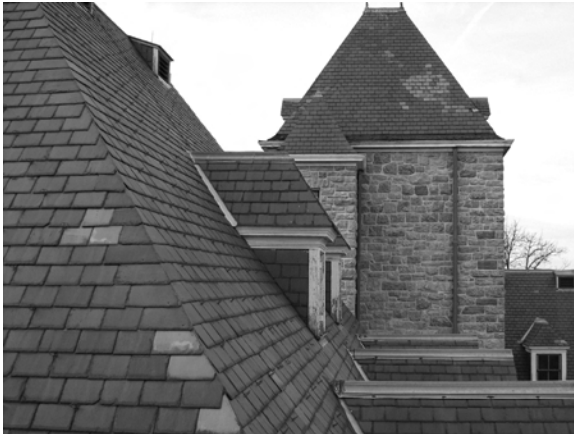
A Failure to match the color, profile, and texture of existing slates when selecting replacements can lead to an unattractive patchwork appearance.

To avoid a patchwork of obvious replacement slates, matching by color, size, and texture is an essential part of any slate replacement effort. When available, attic stock can be used, or extra materials can be ordered during a replacement project to maintain stock for future repairs. A knowledgeable roofing design professional should be able to identify the slate type on your roof and its origin, and should be able to locate matching slate, either salvaged or newly quarried.
