# Journal

## The Greenest Building Is the One that Doesn't Need Rebuilding

John J. Hoffmann, FAIA

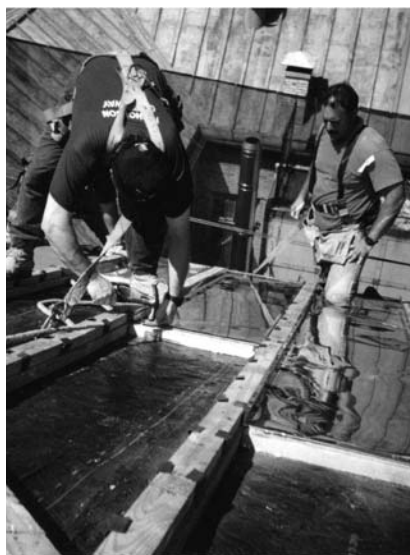
**Embodied energy** encompasses all of the materials, transportation, and labor required to construct a building. Attention to detail conserves this energy by promoting longevity.

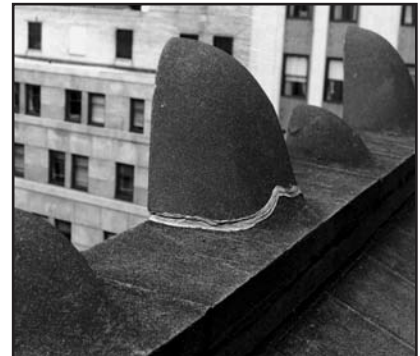
**▲ Inappropriate “band-aid” repairs** are not only unsightly, they create additional impact on the environment when they fail or, worse, damage surrounding building elements, which in turn require repair.

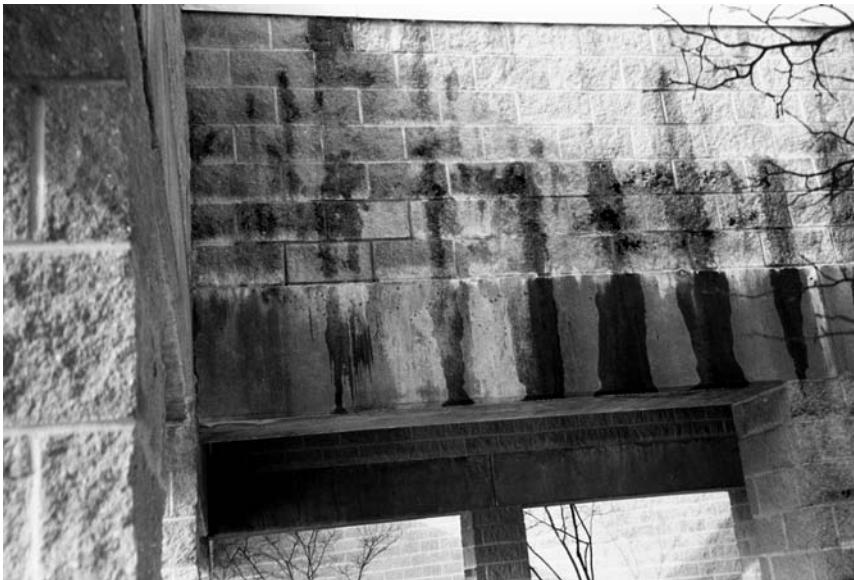
**▲ Failure to properly detail and build** this concrete block wall left it open to water entry, which led to toxic mold growth. Exterior wythes must be demolished and rebuilt, wasting materials and energy.

In a recent project, Hoffmann Architects was asked to evaluate and rehabilitate the concrete block walls of a prison facility. The structure had been built a scant five years earlier, and would have scored a number of points on the LEED rating system: the walls contained an energy-efficient six inches of insulation, well above the standard. Because a prison’s requirements differ from those of other structures, the design needed to be especially sturdy and resistant

What the design overlooked were the details. Poor design and construction methods permitted extensive water entry into the wall cavity. Due to the constant presence of moisture, mold spores developed and proliferated, creating a health hazard for staff and inmates. Ultimately, the decision was made to completely rebuild all of the exterior walls; the mold, an environmental toxin, would then require expert remediation. Meanwhile, additional energy (and taxpayer dollars) would need to be expended on specialized construction methods and added security for the duration of the project.

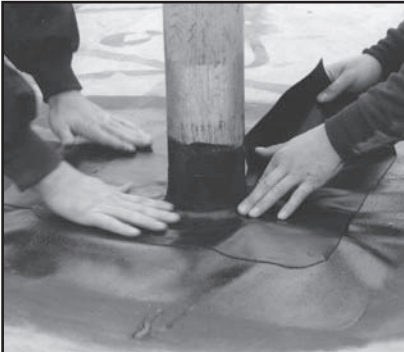
**A Correct detailing** of roof penetrations and building intersections can make the difference between a roof that must be thrown out and replaced in a few years, and one that's still going strong at twenty.

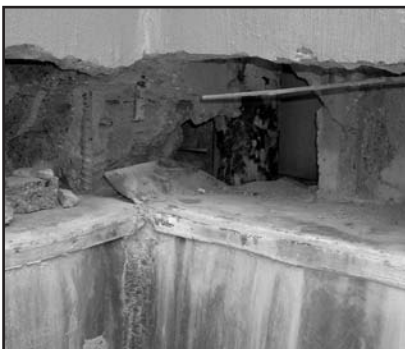
**▲ What's wrong with this picture?**

Through-wall flashing is not turned up inside the wall, corner laps are insufficient, and reinforcing bars penetrate flashings. The result: multiple points for water entry.

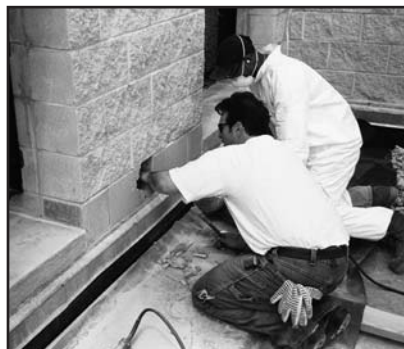
**▲ Appropriate, timely maintenance and repairs** are critical to sustaining building materials. Investigation into a problem's cause prevents the additional financial and environmental burden of duplicate repairs.

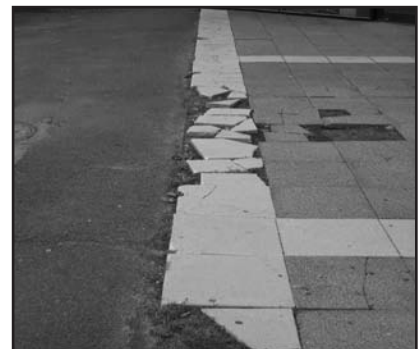
**▲ Design flaws** permit water entry and lead to premature breakdown of components. After only a few years of use, this plaza must be ripped up and replaced, wasting energy and resources.

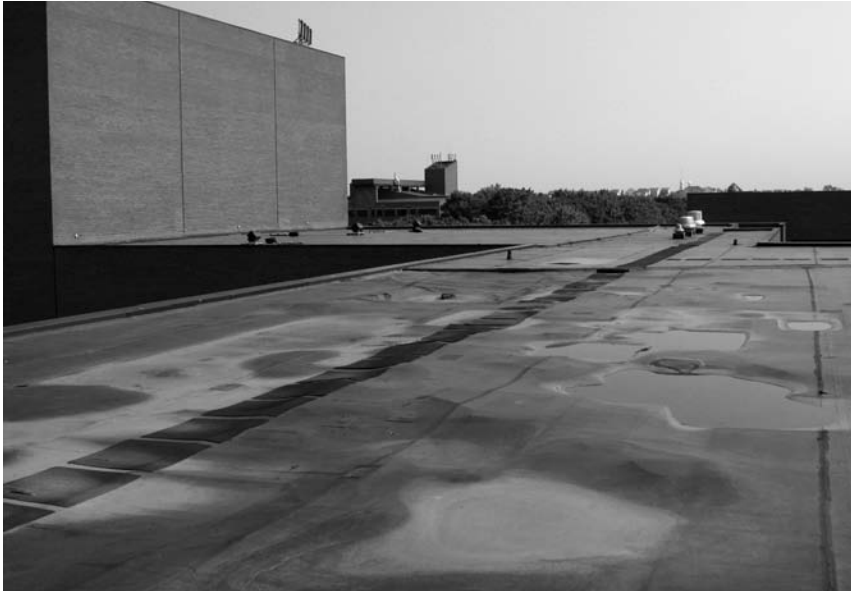
**▲ Inappropriate materials selection** can mean early replacement—and wasted resources. When wind pressures proved too great for the self-adhered insulation on this roof, the material pulled apart and shifted under the membrane.
