Journal of architectural technology published by Hoffmann Architects, Inc., specialists in the rehabilitation of building exteriors.

## Waterproofing Challenges

Richard P. Kadlubowski, AIA and Dean W. Yates, AIA

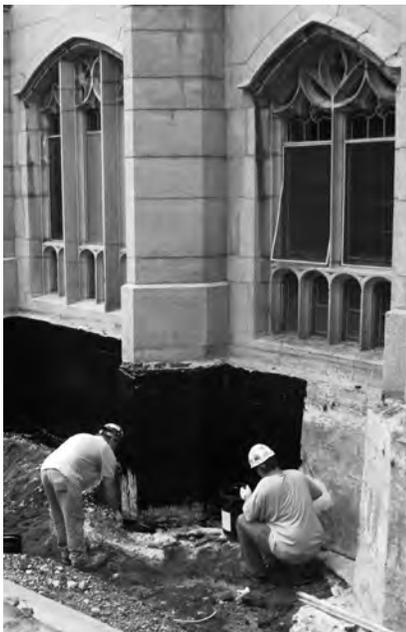
▲ Once below-grade waterproofing is buried, leaks due to faulty application can be difficult to resolve.

**Cons.** The shortcoming to positive side systems lies in leak detection and remediation. Blind side waterproofing cannot be inspected once the concrete is poured. Even for membranes installed after concrete is cast, it's too late to correct for sloppy installation once the waterproofing is buried. If the system fails, rehabilitation can involve major excavation and reconstruction of paving, landscaping, and wall systems.

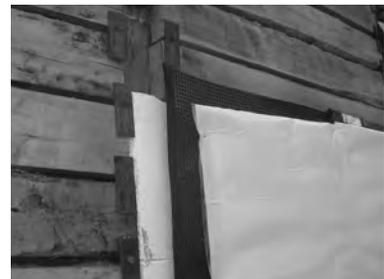
**▲ Blind side waterproofing** sheet with drainage composite, installed prior to concrete.

For below-grade applications, the earth can be banked back such that a positive side membrane is installed after the foundation is set. In urban areas where every square inch comes at a premium, this may not be an option. Blind side waterproofing incorporates the waterproof membrane on the face of the shoring before the foundation is cast. Concrete is then poured, and the waterproofing fuses to the foundation wall as it cures.

**Blind side waterproofing:** Installation of waterproofing membranes and drainage before the concrete foundation is poured.

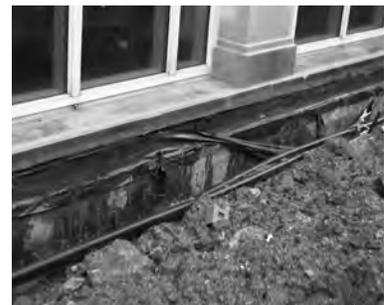
**▲ Positive side waterproofing** defects, viewed during repair excavation.

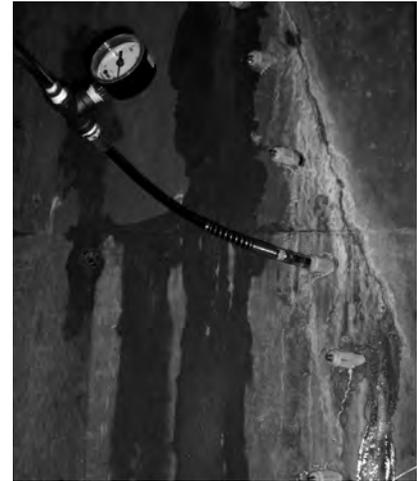
**A Negative side waterproofing** injection via ports along a foundation wall crack. Gauge monitors pressure of injected resin.

**Injections at interior surfaces.** Resolving cracks through injection with epoxy, hydrophobic or hydrophilic resins can be an economical way to solve minor waterproofing problems without excavation and reconstruction. The danger, though, is that this approach can be a shot in the dark, as it is nearly impossible to know what conditions are on the other side of the wall without seeing firsthand.

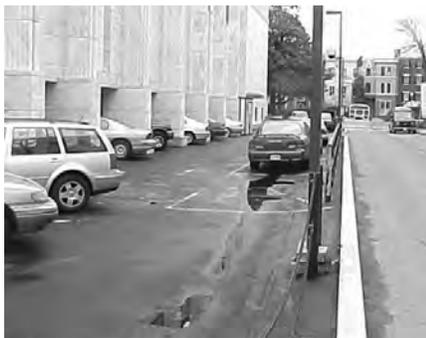
▲ Below-grade vault is under parking deck.

For sensitive spaces below-grade, more sophisticated systems have been used. As an example, a rare book vault built below the water table employed a wall-within-a-wall arrangement, with a pump system in the channel between the inner and outer walls to augment the positive side membrane.

## BELOW-GRADE VAULT WATERPROOFING: FOLGER SHAKESPEARE LIBRARY

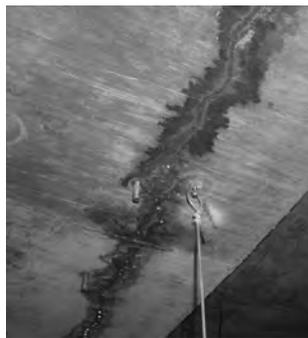
▲ Leaks at underside of deck.

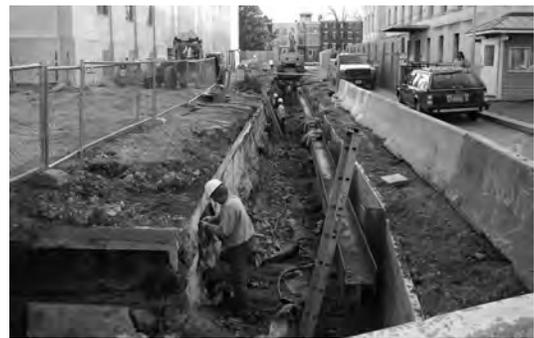
▲ Excavation to expose vault and deficient waterproofing.

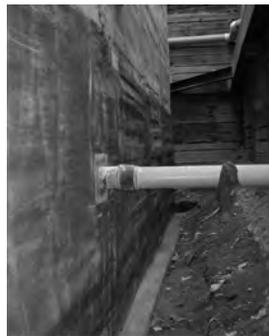
▲ Spray-applied liquid waterproofing.

- *Fluid applied membranes*, similar to those used in roofing applications, roll or brush on as a liquid and cure to form a monolithic, seamless membrane.
- *Sheet systems* are also similar to those used on roofs, including single-ply thermoplastics and rubberized asphalts.
- *Hybrid systems* combine a fluid-applied membrane with embedded fabric reinforcing to create a

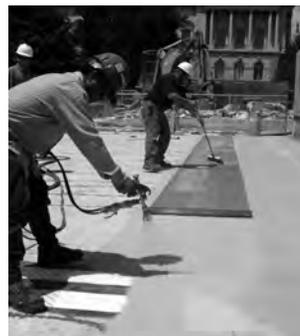
▲ Application of deck waterproofing with reinforcing fabric.

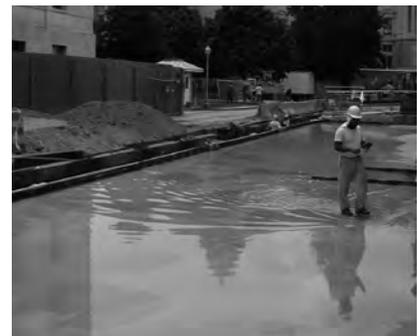
▲ Flood test of waterproofing on rehabilitated deck.

**Non-destructive testing.** Flood tests saturate an area, such as the backfill at a foundation wall, to generate conditions conducive to moisture penetration. Waterproofing failures can then be noted and addressed. Additives,

such as dyes or scents, incorporated into the flood test water can help identify leaks that are otherwise difficult to detect.

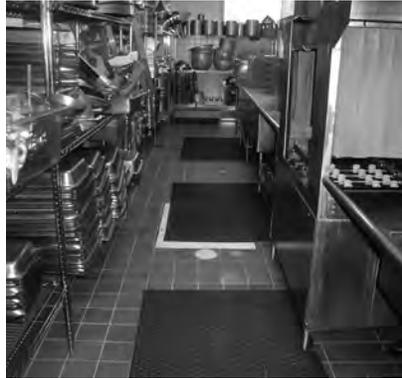
▲ Dishwashers and other kitchen equipment introduce a high-volume water source with a high potential for leaks.

Where numerous penetrations, complex plumbing systems, liquid storage units, and heavy traffic combine, waterproofing distress is hard to avoid. Pumps, dishwashers, and tanks add a high-volume water source to a space—and a high potential for leaks. From the brewing room at an entertainment complex to the lobby of an urban hotel, water infiltration at essential operational facilities is as logistically difficult to resolve as it is challenging to diagnose. Such functional spaces cannot be closed down for weeks at a time while waterproofing remediation proceeds. Thoughtful phasing is needed to take advantage of usage downtimes and to permit continuous operation during critical periods.

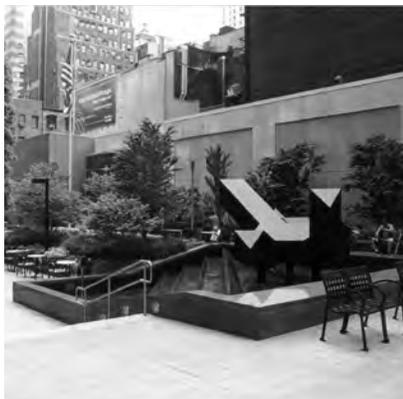
▲ Fountains demand extra attention to waterproofing detail, especially when over occupied space.

If a fountain sits above occupied space, even a small leak may be immediately noticeable as damage to interior fittings or finishes. For water features on grade, however, the only sign of trouble may be an uptick in the volume of make-up water added to keep the water level consistent. Pools and fountains are closed systems, so water loss should be minimal. If you're

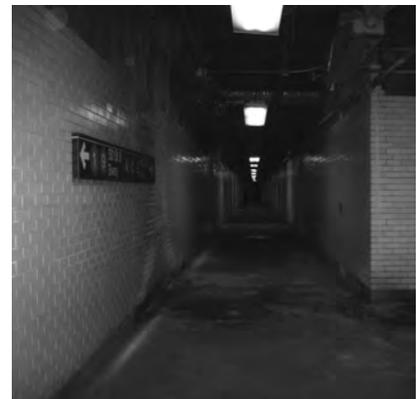
▲ Pedestrian tunnels offer convenient access, but their location under busy areas makes waterproofing particularly challenging.

Where high basements or tunnels penetrate foundation walls, water entry is a common problem. If the floor of a tunnel is a slab-on-grade, where the concrete rests directly on the ground, and the foundation wall extends below this slab at the intersection, water will follow its natural

tendency and run downhill, into the deeper below-grade space. Transitions such as these demand extra attention to detailing and construction sequencing to prevent failures.

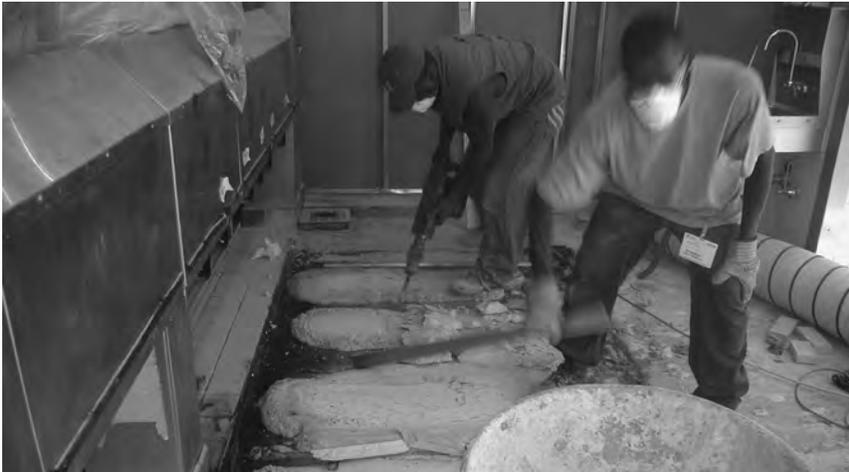
▲ Suspending kitchen operation for waterproofing rehabilitation is hardly desirable. But if leaks are ignored, water damage to structural systems and finishes will only make things worse.
