Journal

Preventing Winter Damage

Steven J. Susca, PE

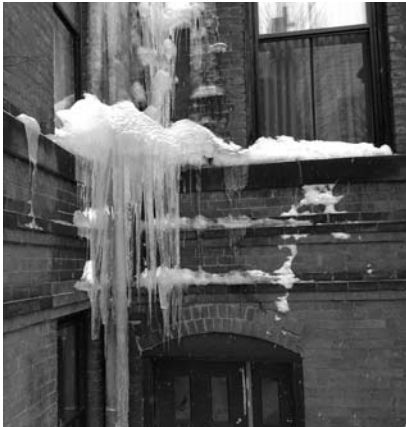
▲ Icicles might seem like charming seasonal decorations, but they mean trouble – both for the building and for those below.

When asked for examples of winter weather problems, the first thing many facility managers and design professionals will bring up is *ice damming*, the frustrating – and potentially dangerous – accumulation of ice and snow at roof eaves. As snow on the roof starts to melt, water flows down to the roof edge, where it collects and re-freezes. Over time, this thawing and freezing creates a build-up of ice at the eave and causes water to back up under the roofing material, eventually spilling over into the building interior.

water at the gutter and drip edge begins to extend downward, forming icicles. With water continuing to flow down from the eaves, these pointed shards of ice can grow to many feet in length, posing a tremendous risk to pedestrians and vehicular traffic below.

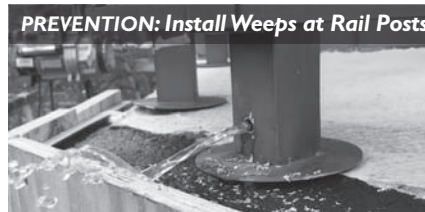
Cracks at Slab Edge

aluminum railing posts at concrete balconies are directly embedded into the concrete at the edge of the slab. If not properly finished and sealed, gaps between railing members will allow the railing stanchions to fill up with water. As the water freezes, it expands, which can cause expansion of the aluminum post where it enters the concrete. This, in turn, results in cracks at the edges of the slab.
