## Repair and Maintenance of Historic Limestone and Marble Structures

**Theodore F. Babbitt, AIA**

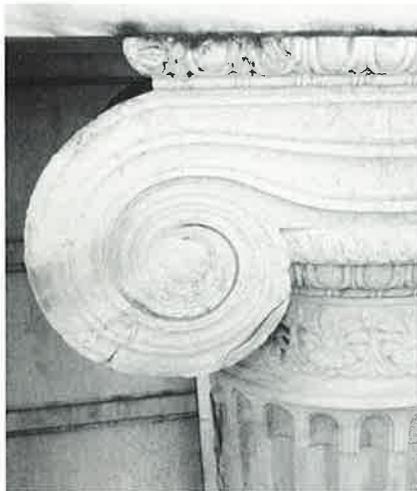
Detail of marble column showing deterioration of the capital. Note severe cracking in the volute.

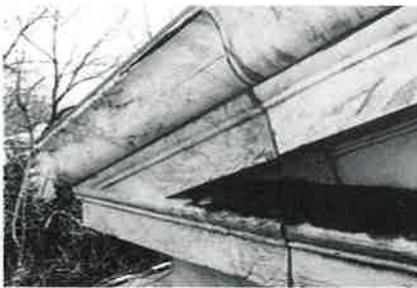
Pediment detail shows effects of stone displacement.

**Resetting** returns displaced stone to its original position.

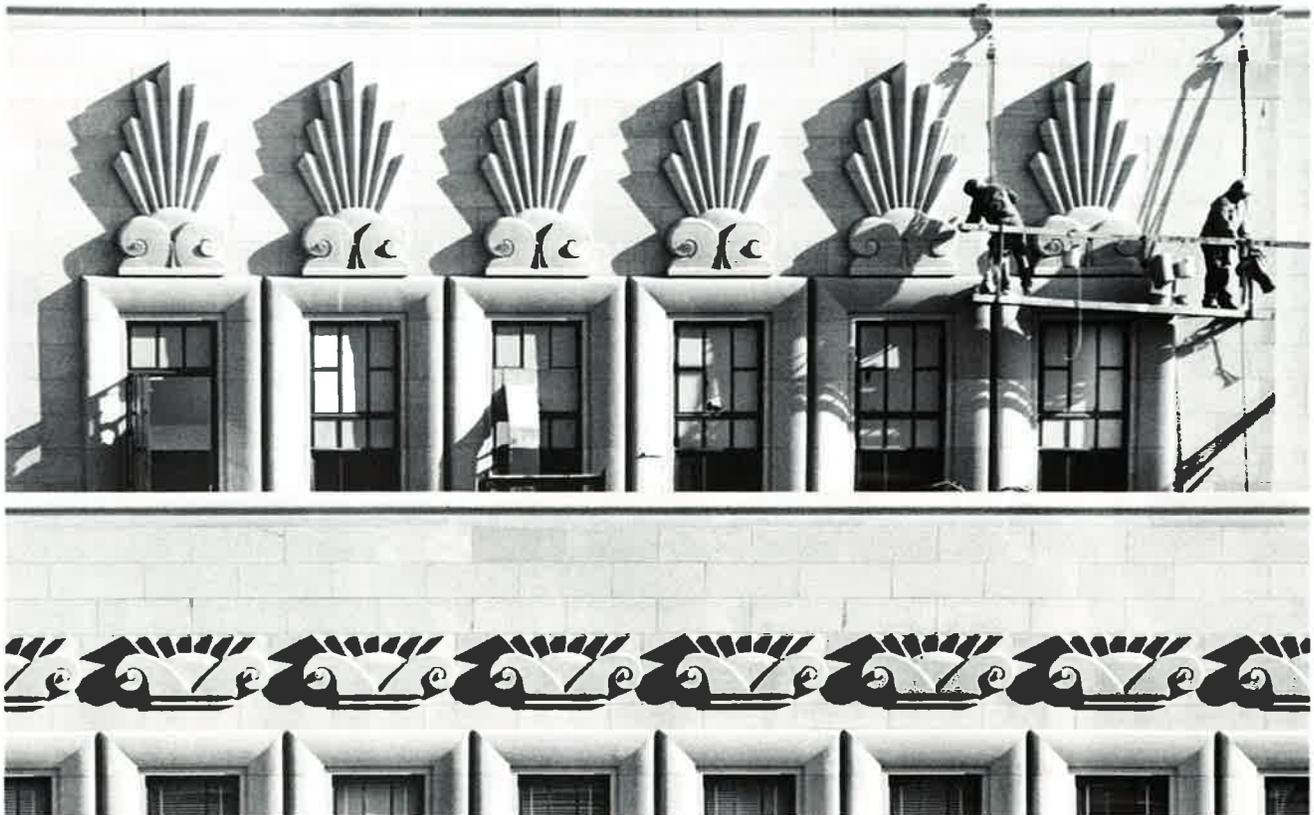
Restoration of limestone facade at Art Deco-style headquarters building.

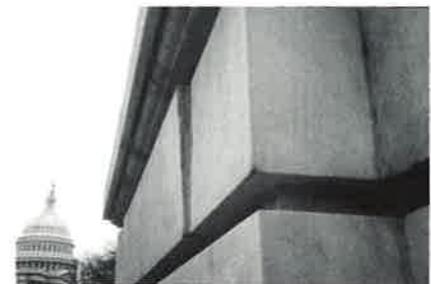
Water infiltration has caused stone section to shift from original position.

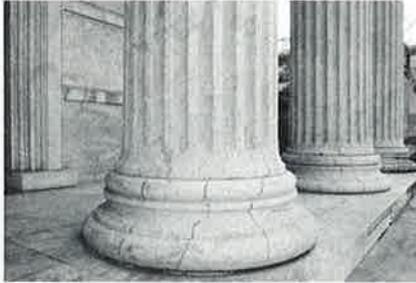
Severe cracking at base of marble column.

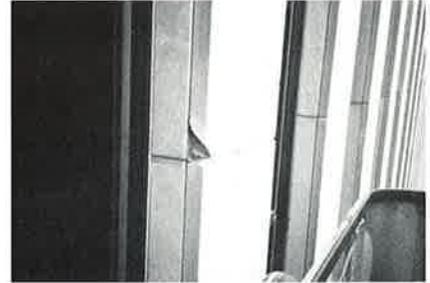
Spalling at joint between limestone panels.

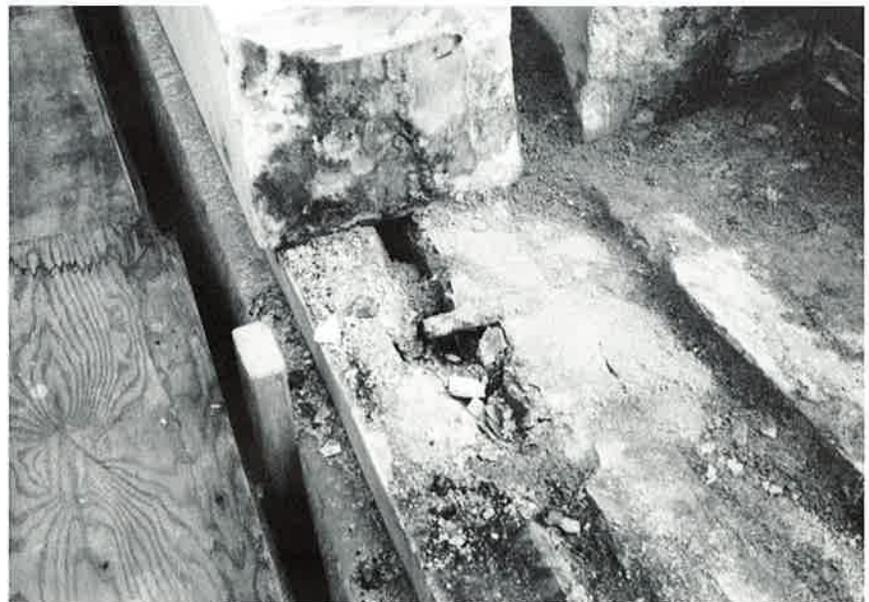
Stone has been removed to examine metal anchor, which has corroded and broken.
