JOURNAL

First Issue 1993 Volume 11 Number 1

Solving Glazed Brick Deterioration Problems

Arthur L. Sanders

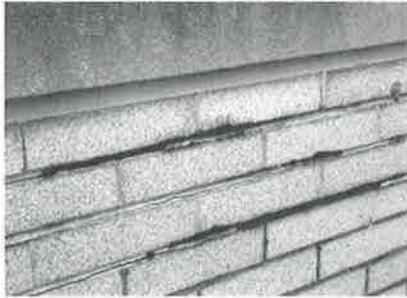
Organic growth.

To do so, you must look at the clues — the symptoms of decay in glazed brick. Often, the type of damage can help pinpoint the source. The chart and photos on page 2 show some common indicators of deteriorating conditions in glazed brick.

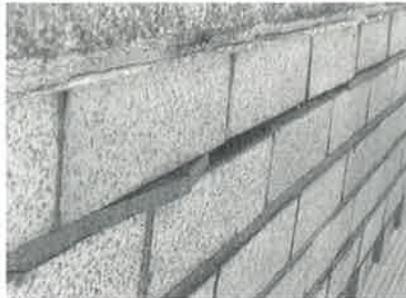
Deterioration and missing mortar at joints.

- Mortar has eroded to expose the brick behind the glazed face.
- Mortar has crumbled from the joint.
- Hairline cracks have appeared in the mortar.
- The bond between the mortar and the glazed brick is broken.

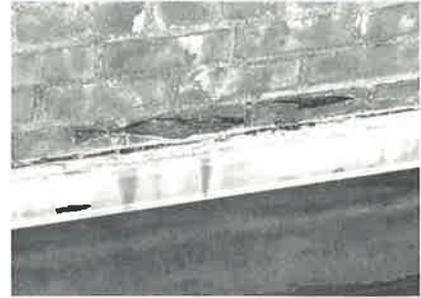
Missing weep holes.

Another common location for problems in glazed brick is at flashing locations, such as lintels, relieving angles, and the base of walls. These areas usually have a membrane installed to collect water that has penetrated the interior face. Frequently, however, no weep holes or other venting mechanisms are installed at these flashings to allow relief of this moisture buildup. In these cases, the moisture-laden brick expands, leading to spalling, cracking, bowing, and deterioration of joints.

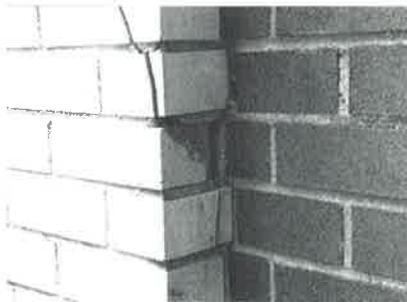
Cracked brick.

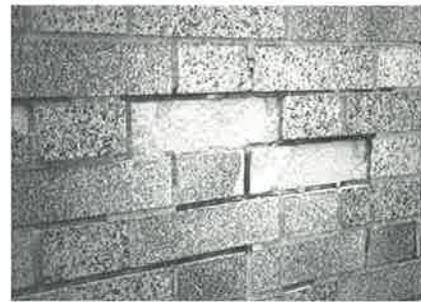
Spalling of glazed brick.
