JOURNAL

First Issue 1996 Volume 14 Number 1

Concrete Repair: A Case of Weighing the Options

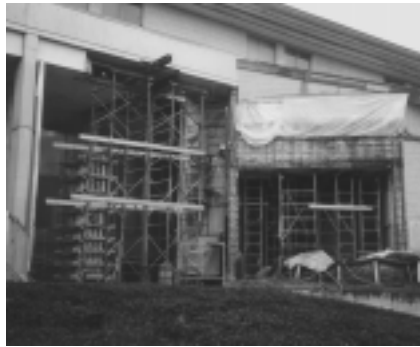
Extensive shoring and demolition is required for the "full removal and replacement" method.

For the test treatment, the firm specified hydro-demolition to remove the concrete skin from two columns and a spandrel face. This required extensive shoring down to grade level through adjacent guest rooms. That meant gutting the guest rooms, removing built-in furnishings, walls, ceilings — and then restoring all areas to their original condition once the repair was completed. The net result was all new concrete from one monolithic pour, which provided a well-controlled chemistry, a good passivating film, and an aesthetically acceptable match with the original concrete facade. (Concrete passivity is discussed in more detail in "Causes and Symptoms of Concrete Deterioration" on page 5.) Although full removal and replacement offered an excellent technical solution for the long-term use of the facility, it was expensive and highly disruptive to daily usage. Hoffmann Architects and the client agreed that this was not a viable solution.

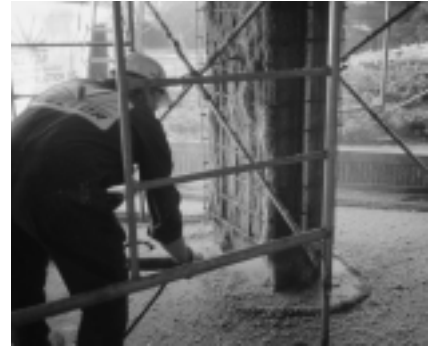
Applying sodium carbonate in preparation for re-alkalization.

The goal of re-alkalization is to set up a passivating film around the embedded steel. To do so, titanium mesh is attached to the concrete surface. A wood pulp mâché is applied to the concrete surface and the mesh, which is then sprayed with special chemicals designed to set up the passivating film. An electrical current is impressed through the mâché and mesh to force the chemicals into the concrete. One week is usually needed to force the

chemicals to the depth of the reinforcing steel. The mesh is removed afterwards.

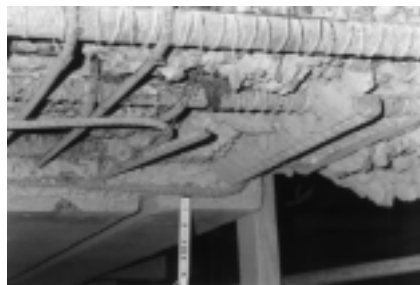
Deteriorated concrete is removed with hydro-demolition.

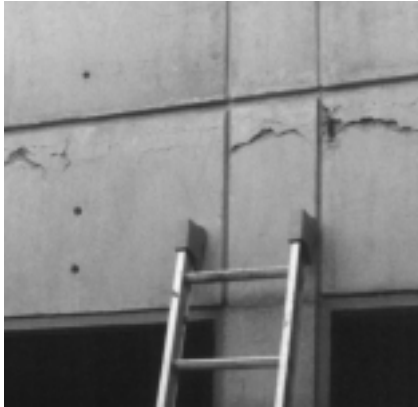
Severe spandrel spall over east entrance of Xerox Document University.
