Thin-Stone Veneers Offer Unique Design and Performance Demands

Theodore F. Babbitt, AIA

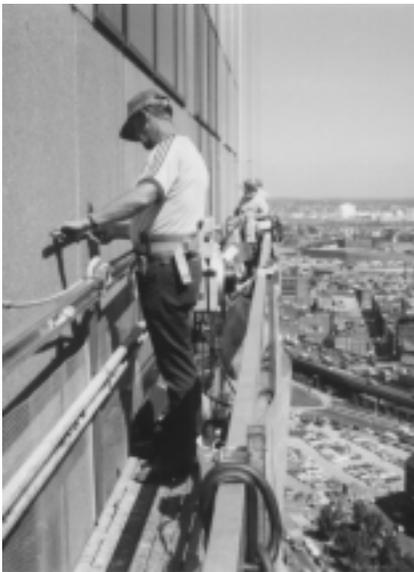
Thin-stone veneer being prepared for face-pinning.

Face-pinning can be used to re-secure a cracked piece of stone which is in danger of breaking loose or an entire piece of stone which has suffered anchorage failure. While this repair technique may mar the appearance of the stone, it is often undertaken as an essential safety measure. More extensive repair projects may involve removing and re-setting the stone or installing a replacement stone. Re-setting stone is often impractical, (continued on page 8)

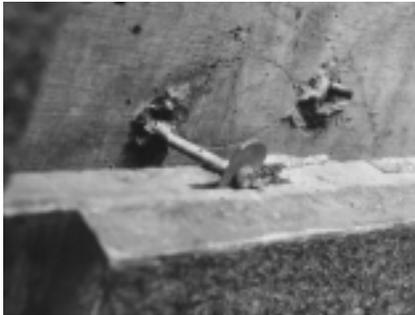
An anchor set in a slot in the top of a thin-stone panel.

There are two types of anchors used with thin-stone veneers: anchors which are inserted into *kerfs* and anchors which are inserted into holes drilled into the sides or rear of the stone panel. (A kerf is a narrow slot cut longitudinally into the edge of the stone panel, and is used to hold an anchor which secures the stone slab to its supporting backing. Illustration A on

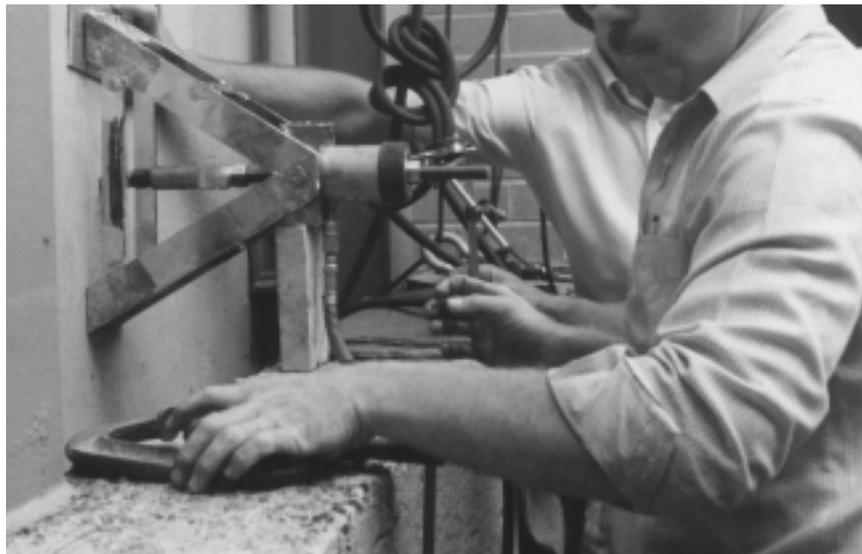
A pull-test in the back-up wall is used to evaluate anchorage performance.

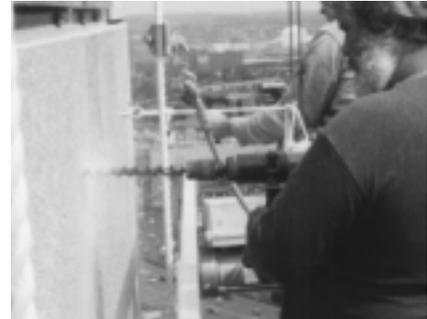
Step 1: Drilling the stone and back-up wall in preparation for the anchor.

A counterbore hole approximately 1" in diameter by 3/4" deep should be drilled in the stone to accommodate the nut and washers. A 3/8"-diameter corresponding hole should be drilled in the concrete or masonry back-up to hold the anchor rod. A depth gauge used during drilling will ensure the proper depth of both openings. If the stone is less than 2" thick, however, counter-boring may not be possible, and the nut will remain exposed, a definite aesthetic disadvantage.

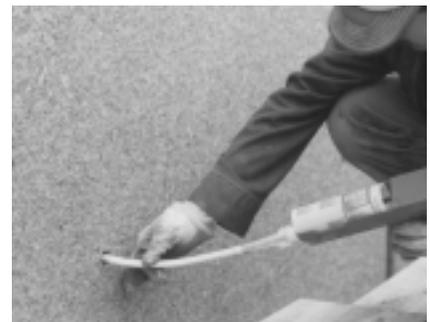
Step 2: Injecting the epoxy adhesive into the anchorage hole.

When using an *adhesive anchoring system*, the holes in the back-up structure are cleaned first of dust and stone fragments (using a brush and compressed air) before the adhesive is injected or inserted. This will help achieve a solid bond between the adhesive and the anchor rod. The anchor rod should be left undisturbed during the setting time specified by the adhesive manufacturer. Once the adhesive has set, a stainless steel washer and nut should be installed over a neoprene pad.

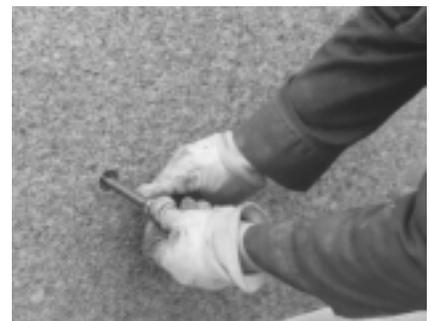
Step 3: Inserting the anchor rod with nut.

drilling dust from the hole. The anchor should be pre-assembled, using two neoprene pads and a stainless steel washer, with the nut engaging two or three threads of the anchor

rod. The anchor should be set to its full depth with light hammer blows. The anchor is then tightened to the specified torque, using a calibrated torque wrench, causing the expansion shield to grip.

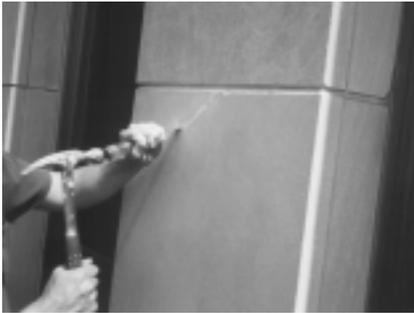
A worker removes failed patching material from a crack in the limestone facade.

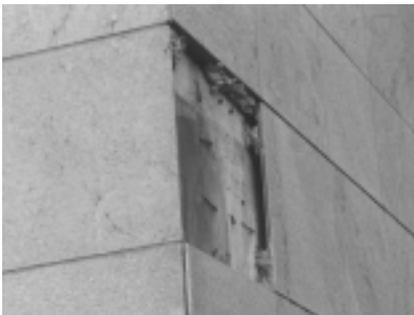
Damaged stone has been removed, exposing the concrete back-up wall.
