Concrete Deterioration

technical notes

Concrete Maintenance

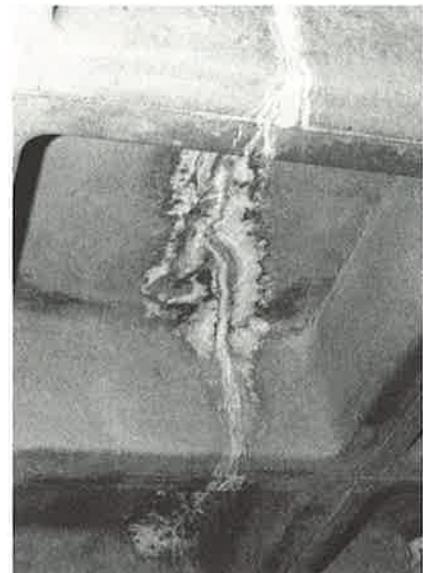
Leaching is caused by frequent water migration through the floor slab or cracks. As water migrates through, it takes along part of the cementing constituents, depositing them as a white film, stain, or a stalactite on the ceiling below. This process will weaken the concrete over a period of years and is accelerated by porous or perpetually moist concrete. Leaching frequently occurs from cracks beneath gutterlines.

leaching

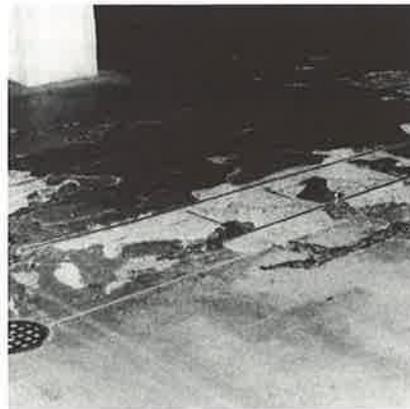
exposed reinforcement

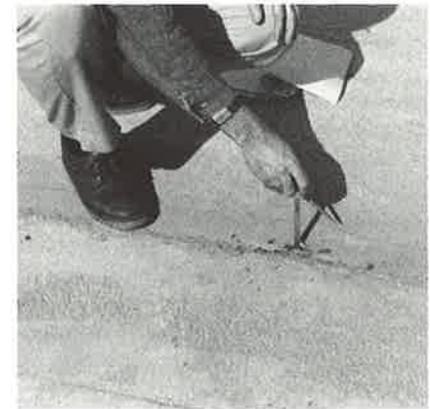
deterioration of joint sealant

Construction joints deteriorate for several reasons, usually associated with failure of the sealant or failure of the adjacent concrete. Joint sealants may not have the required degree of flexibility, bond, strength, or durability for a particular application. If concrete adjacent to the joint is not sufficiently durable, then local scaling will cause joint sealant failure.

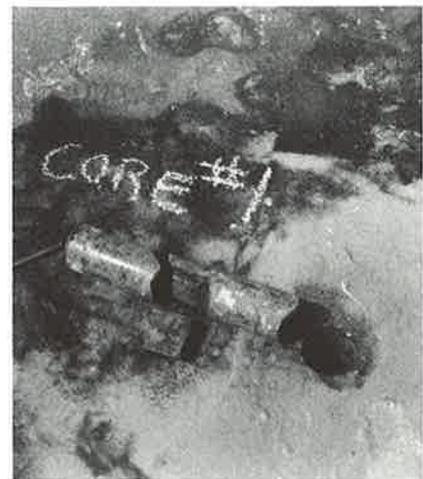
core showing subsurface cracking

Next, determine the nature and extent of the problem. The walk-through survey is a start, but it must be understood that a visual survey reveals only visible deterioration. A review of the survey results may indicate the need for a more comprehensive survey which would include testing for subsurface fractures and delaminations and/or deicing salt contamination. Despite the most thorough investigation, some hidden deterioration may be revealed only after the start of repair work.

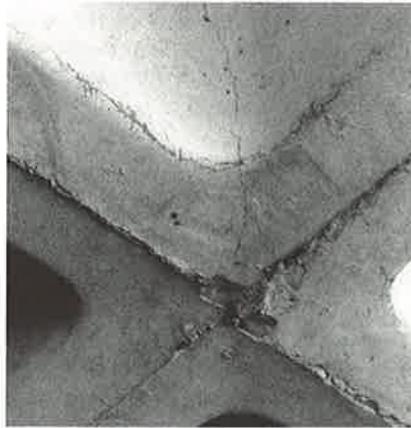
cracking in a waffle slab

Some cracking occurs normally during the curing of the concrete due to settlement of the new concrete and shrinkage during drying. Additional cracking can be caused by any of the following construction practices: insufficient vibration of the concrete during placement, use of poorly designed formwork, placement of high slump concrete or stripping of the formwork before the concrete is strong enough to support itself and any applied loading. One result of early removal of the forms is a tendency for radical cracking to appear at columns as the columns attempt to punch through the newly placed slab.
