**Hoffmann
Architects**

Sealant Joint Rehabilitation: More Than a Quick Fix

Paul C. Lanteri, AIA

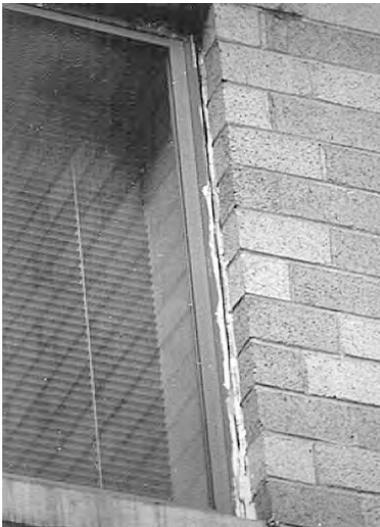
▲ Sealant failure at an aluminum-framed window. Aluminum expands and contracts nearly four times as much as brick masonry due to temperature changes. A sealant must be selected that will accommodate that movement.

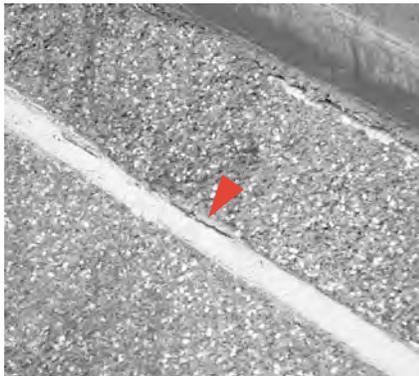
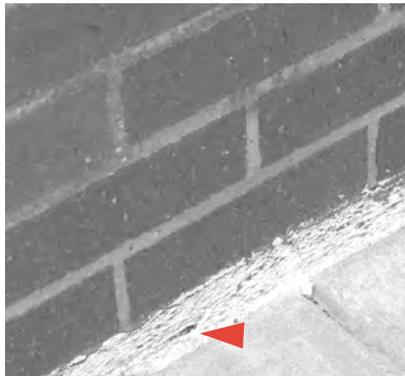
❑ Sealant failures: Below left, adhesive failure at this joint on a horizontal surface. Below center, this large sealant joint where a concrete sidewalk meets a masonry wall is crazed and nearing the end of its useful life. Below right, adhesive failure at this joint on a vertical surface.

During adhesive failure, the sealant separates cleanly from its substrate. This type of failure will result if the sealant is applied to a dirty or wet surface, or if the substrate is contaminated by a material—such as paint or a waterproofing coating—that will discourage a strong bond. Other causes

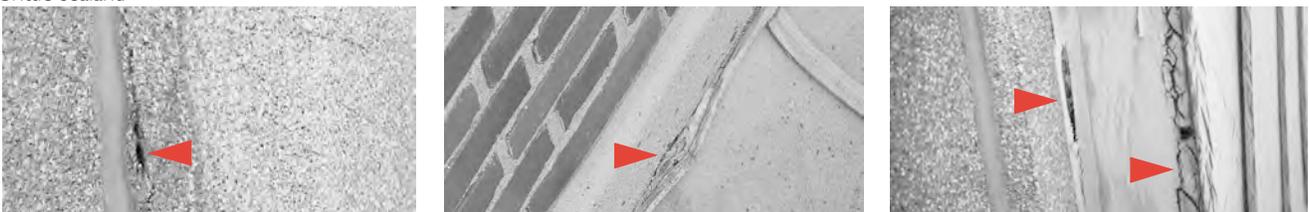
▼ Below left, substrate failure . Below center; bulging caused by excess compression of joint. Below right, cohesive failure and aging, cracked and brittle sealant.

Substrate failure occurs when the sealant remains tight to the substrate, but the substrate separates from itself. This type of failure takes place when the adhesive and cohesive strength of the sealant is greater than the cohesive strength of the substrate.

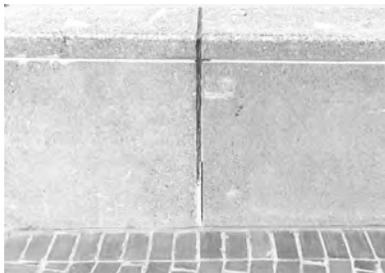
▲ At this plaza, sealant failures at perimeter walls and inadequately terminated base flashing could be allowing water to enter open joints.

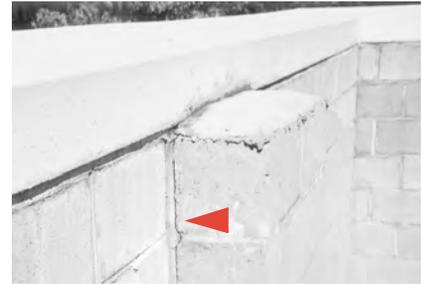
▲ Above left: When is sealant at the end of its useful life? When adhesive failure allows water to enter the wall through the coping. Above right: Adhesive failure along sealant joint of pilaster.

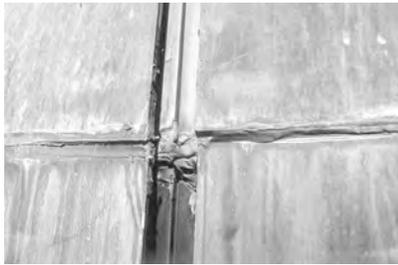
▲ More is not better: The use of too much sealant, especially one that is inappropriate for a particular joint application, will result in not only an unpleasant appearance but also premature sealant failure.

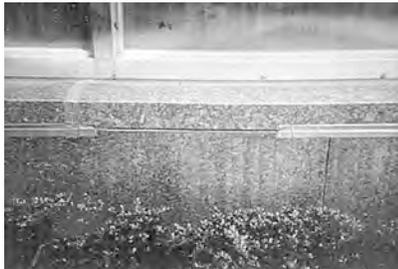
▼ Here, a building owner used duct tape to seal open joints. This is *NOT* the answer: Only properly selected and applied sealant should be used in joint rehabilitation projects.

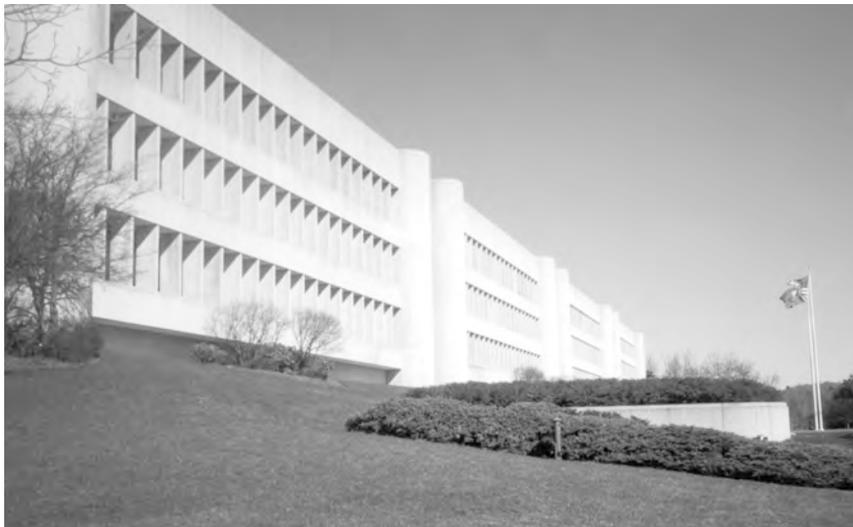
■ **Xerox Corporation Headquarters** Stamford, Connecticut. Hoffmann Architects provided design and construction administration services to restore the limestone and glazed curtain wall facade, including replacement of all joint sealant, at this corporate headquarters.

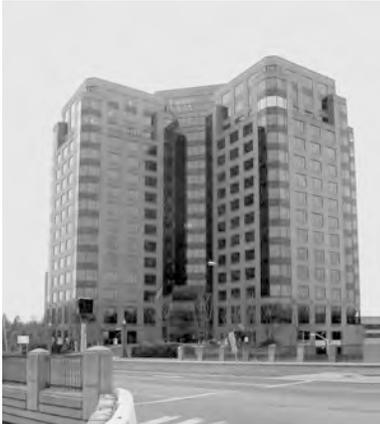
▲ Sealant replacement was integral to the rehabilitation of this modern office building. The exterior walls are brick with "punched" windows and glazed curtain walls.
