**Hoffmann
Architects**

Journal

Exterior Brick Masonry Walls: Causes of and Solutions to Inevitable Deterioration

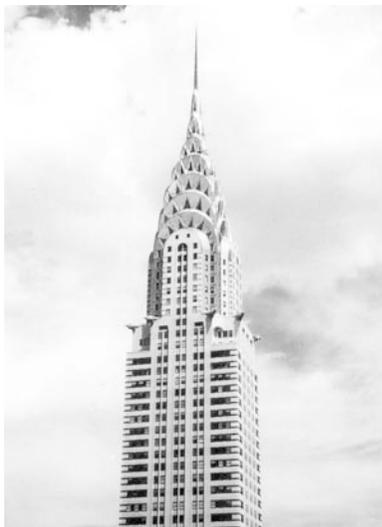
▲ The landmarked Chrysler Building in New York City is clad in glazed brick. Though the towering structure is perhaps best known for its shining spire, its facade features intricate, automobile-inspired brick patterns.

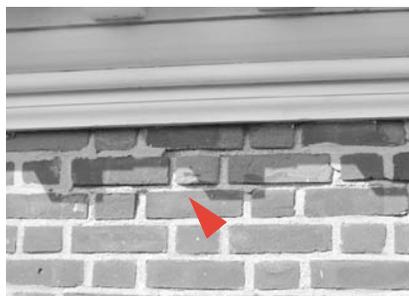
V Below left, cracking through brick masonry wall. Below middle, eroded mortar joints below this cornice. Below right, inadequate partial repointing has left many mortar joints vulnerable to water intrusion.

Loss of mortar leaves an exterior wall vulnerable to water infiltration. Repointing is required when the bond between the mortar and the brick is broken, when mortar has crumbled from the joint, when hairline cracks appear in the mortar; and when mortar has eroded to expose the back-up wall material.

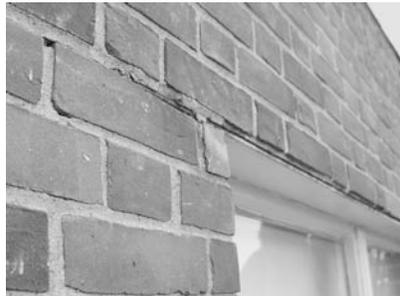
Counter-clockwise from left:
 ■ Leaks in the flashing at this window lead not only to water infiltration into the building, but also to corrosion of steel lintels and deterioration of the anchorage system that supports the brick face.

In a drainage or barrier wall system, flashings are typically located where intersecting elements have interrupted the cavity or collar joint within a wall. These locations include continuous relieving angles; wall openings such as windows or louvers; and continuous horizontal elements like stone or concrete cornices, belt courses, and water tables. Leaks in the flashings at these locations can lead not only to water penetration into the building, but also to corrosion of the steel lintels and deterioration of the anchorage systems that support the brick façade or masonry appurtenances. Corrosion of steel lintels is often indicated by spalling of brick at the jamb of the opening just below the lintel, loss of mortar around the embedded steel, or rust staining on the face of the brick.

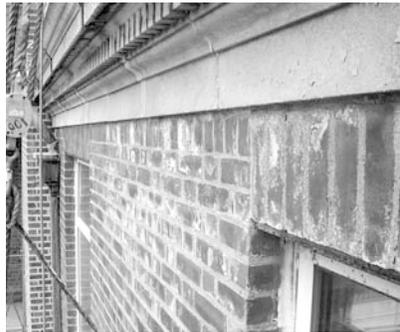
■ Efflorescence at brick masonry under cornices and belt courses is a sure sign of water infiltration through leaking flashing or open butt joints in the stones above.

Efflorescence at brick masonry under cornices and belt courses is a sure sign of water infiltration through leaking flashing or open butt joints in the stones above. Water washes the soluble salts out of the mortar onto the surface of the brick where it crystallizes through evaporation of the water, forming what appears to be white fuzz on the surface of the brick. The loss of soluble salts eventually affects the permeability of the mortar allowing water to permeate the joints, which can cause further deterioration of the mortar and brick.

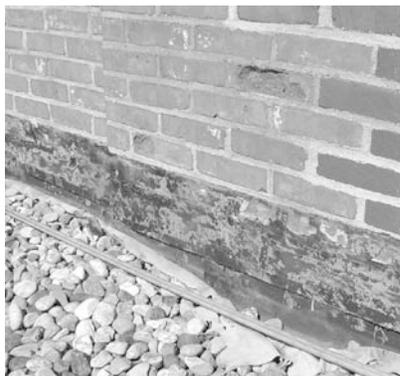
■ The bed joints above the through-wall flashing at the base of this wall have been sealed over; trapping moisture within the wall, causing spalling of brick.

reglet-mounted counterflashings, the sole purpose of which is to provide protection for the roof flashings. Bed joints above properly installed through-wall flashings normally consist of mortar, with or without weeps, and allow water to filter out of the wall. Bed joints that also serve as sealant joints require a weep system to allow water to exit the wall. Frequently, these joints are mistakenly viewed as a source of water infiltration and are sealed over, trapping moisture within a wall and

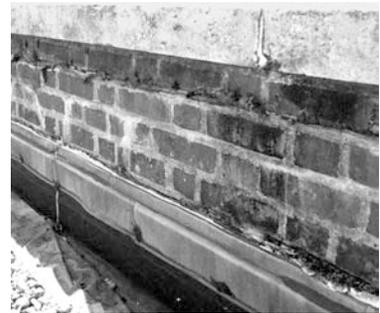
■ The bed joints above the through-wall flashing have been sealed over at this roof parapet, causing water retention. Note moss growth and efflorescence.

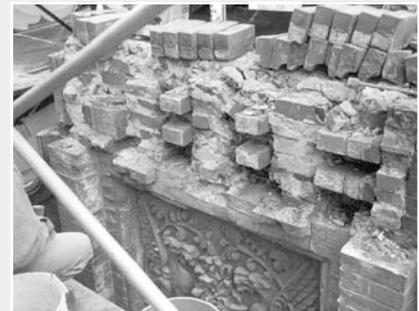
▲ Severely deteriorated brick at the hotel necessitated complete reconstruction of the upper exterior walls and replacement of face brick at lower areas.

reconstruction of the upper exterior walls and roof of the structure. These repairs included the replacement and/or restoration of damaged brick and ornamental terra cotta, complete repointing of all mortar joints and the application of a water-repellant coating.
