Journal of architectural technology published by Hoffmann Architects, Inc., specialists in the rehabilitation of building exteriors.

Preventing and Treating Failure in Glazed Curtain Wall Systems

Russell M. Sanders, AIA and Craig A. Hargrove, AIA LEED AP

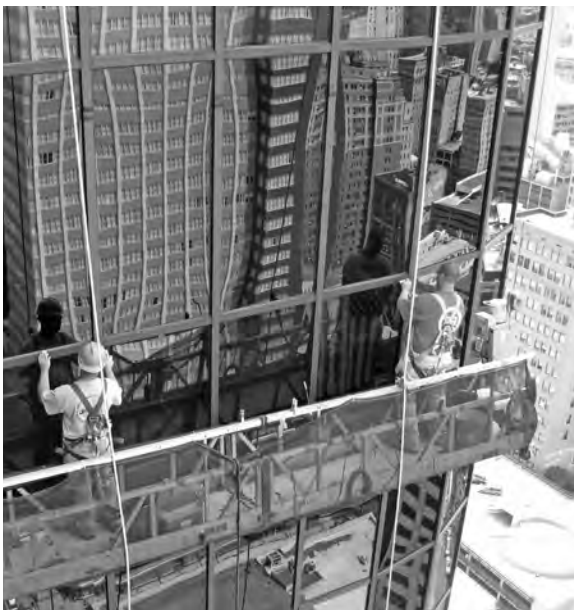
▲ Workers repair failed gaskets at a glass curtain wall high-rise.

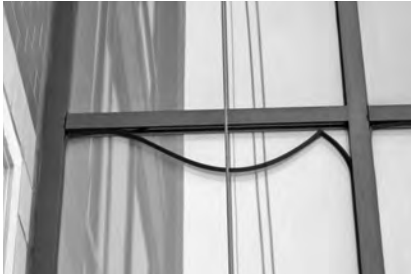
▲ Loose gaskets or seals.

As they age, gaskets begin to dry out, shrink, and crack. Subjected to ultraviolet radiation and freeze-thaw cycles, the elastic material degrades, much like an old rubber band. At first, air spaces created by the shrinking,

dried gaskets admit air and moisture into the system, leading to condensation, drafts, and leaks. As the gaskets further disintegrate, they may loosen and pull away from the frame. Without the support of flexible gaskets, the glass loses stability and may shatter or blow out. For this reason, it is important to maintain and routinely replace gaskets to keep the curtain wall system operational and safe.

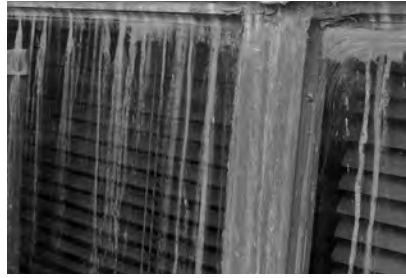
▲ Streaked glazing.

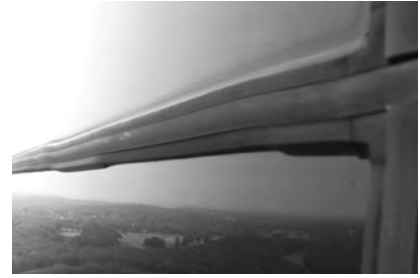
▲ Gaskets disengaged from glazing.

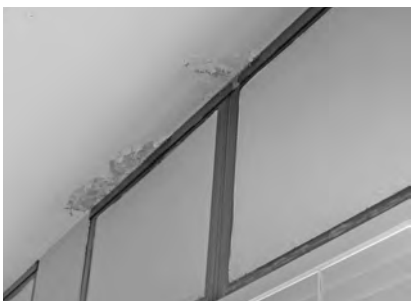
▲ Leaks and drafts.

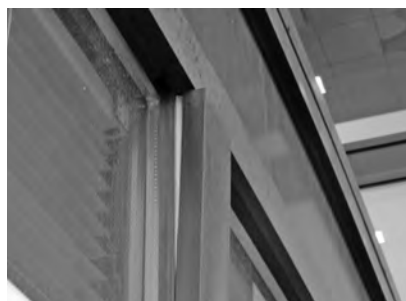
▲ Displaced mullion covers.

Poorly installed trim covers and accessories can pose a danger to people and property below, particularly when adhered using structural glazing tape alone, without mechanical attachments. Construction sequencing is of particular importance, as swing staging and scaffolding can damage or displace mullion covers. Maintenance activities may also be responsible for loose trim elements.

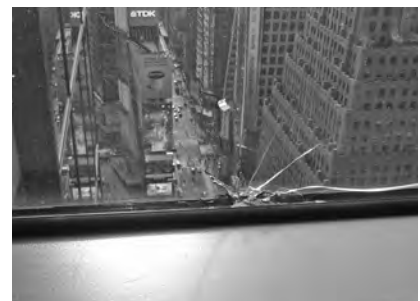
▲ Broken glass.

Nickel sulfide (NiS) inclusions can cause glass to shatter suddenly, sometimes years after installation. All glass has microscopic imperfections, or inclusions, that result from the manufacturing process. Generally speaking, these are of little concern. The exception is NiS inclusions in tempered glass, which have led to a number of dramatic glass failures. As glass is heated during the tempering process, NiS converts to a compressed (alpha) phase. When the glass is cooled rapidly to temper it, the NiS lacks sufficient time to return to a stable low-temperature (beta) phase. Over months or years, the trapped NiS transitions to the beta phase, expanding as it does so. The resultant pressure leads to micro-cracks in the glass, which can propagate until the glass structure is thoroughly compromised, and the glass shatters in what seems to be a spontaneous breakage.

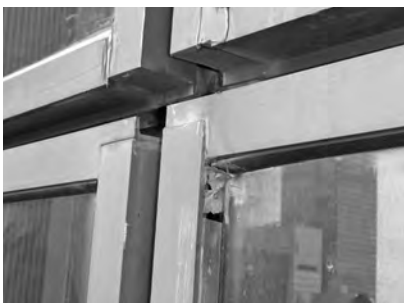
A Gaps at frame corners.

Missing, incorrectly applied, or otherwise deficient sealants at frame corners and other intersections can lead to serious water infiltration issues. Failure on the part of the contractor to follow manufacturers' guidelines, and on the part of the design professional to provide sufficient oversight, can result in water damage that is both difficult to access and expensive to repair.

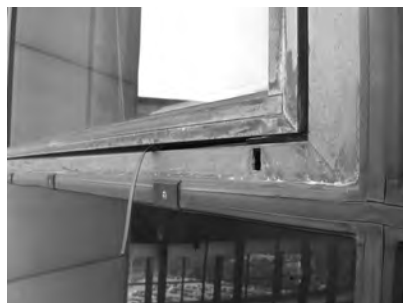
A Loose or missing weather stripping.

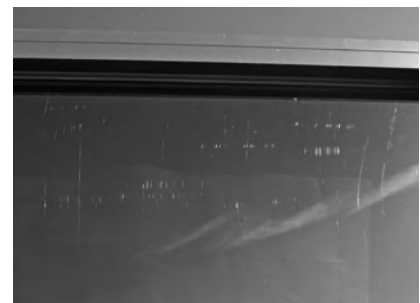
A Scratches and hairline cracks.

Hairline cracks in glass may indicate excessive thermal loading, particularly if the glass has a coating, such as a low-e film or tint. When the sun strikes the glass, it heats the exposed portion of the pane, causing it to expand. The unexposed edges remain cool, creating tensile stress that can lead to cracking, particularly in glass that has not been heat-strengthened or tempered.

Glazing that displays systematic scratches or other defects after installation may need to be evaluated for structural integrity. In such cases, a representative sample of glass units may be removed and tested under laboratory conditions. ASTM E997 is one test method for determining the probability of breakage for a given design load.

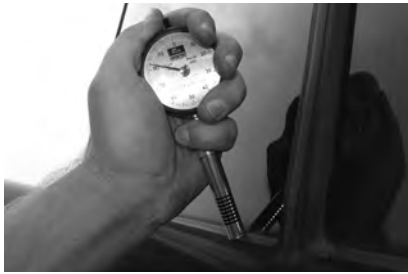
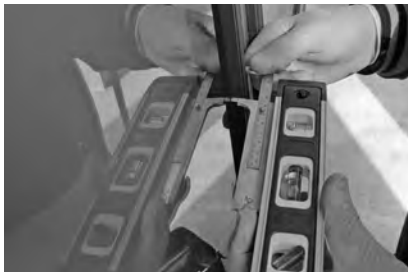
▲ Evaluation may include measurements of gasket hardness (top) and of glazing alignment (bottom).

If leaks, deflection, etched glass, or other issues have become a concern, an architect or engineer should conduct a systematic evaluation of the curtain wall system, beginning with close visual inspection. ASTM International provides test standards for the evaluation of air and water penetration, as well as structural performance of glass in curtain wall applications. Tests for water penetration, such as ASTM E1105, use a calibrated spray rack system with a positive air pressure differential to simulate wind-driven rain. ASTM E783 specifies test procedures for determining field air leakage at specific pressures.
