JOURNAL

Second Issue 1990 Volume 8 Number 2

Have You Checked Your Mortar Joints Lately?

Theodore F. Babbitt, AIA

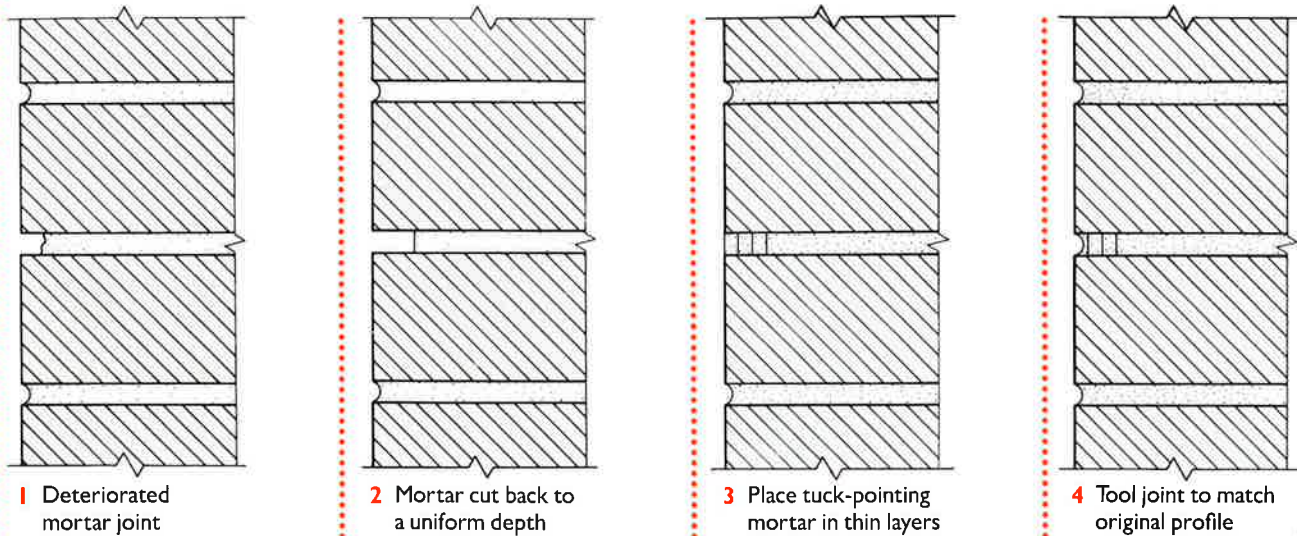
Tuck-Pointing Mortar Joints

To open the joint, we recommend cutting out the old mortar to a depth of $\frac{5}{8}$ of an inch. If the mortar is still unsound at that depth, the cut should be made deeper. Old mortar can be removed with a small mason's chisel or a hand-held grinder. All loose mortar must be brushed or flushed from the joint. It is essential to avoid damaging the masonry when "raking" horizontal and vertical joints.

When undertaking a repointing project, the main concern is that all of the old, loose mortar has been cut out to the required depth and the joint is free of debris and dust. This is critical. Before new mortar is applied, the joint needs to be blown out with an air hose and the brick or stone needs to be wet so that it does not suck moisture out of the newly applied mortar.

Where existing mortar has been removed to a depth of greater than an inch, these deeper areas should be filled first, compacting the new mortar in several layers. The back of the entire

joint should be filled successively by applying approximately 1/4 inch of mortar, packing it well into the back corners. As soon as the mortar has reached thumb-print hardness, another 1/4 inch layer of mortar—approximately the same thickness—may be applied. Several layers will be needed to fill the joint flush with the outer surface of the brick. It is important to allow each layer time to harden before the next layer is applied; most of the mortar shrinkage occurs during the hardening process, and layering thus minimizes overall shrinkage.
