# JOURNAL

First Issue 1990 Volume 8 Number 1

## Waterproofing / A Roundtable Discussion

## Positive Side vs. Negative Side Waterproofing

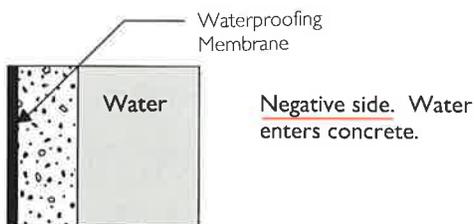
Adapted from materials courtesy of *U.S. Waterproofing*

Negative side waterproofing involves placement of a waterproof barrier on the side *opposite to applied hydrostatic pressure*.

Positive side waterproofing involves placement of a waterproof barrier *on the side of applied hydrostatic pressure*.
