## Hoffmann Architects + Engineers receives Lucy G. Moses Preservation Award from New York Landmarks Conservancy

*Facade restoration of Masonic Hall NYC awarded the Conservancy’s highest honor*

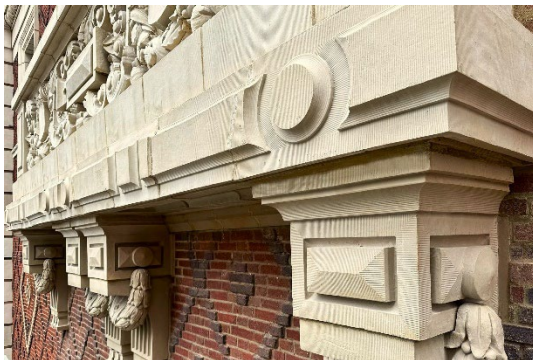
As part of New York City's Facade Inspection and Safety Program (FISP), Hoffmann Architects + Engineers conducted an investigation of the exterior walls at Masonic Hall NYC. The design team traced observed cracks, spalls, displacement, and open joints not only to age and exposure, but also to the construction style of the facade assemblies. With transitional architecture somewhere between the load-bearing mass walls of early masonry buildings and the freestanding metal skeletons of later high-rises, Masonic Hall NYC has a steel-framed structure with heavy, thick walls that reinforce and fireproof the frame. Corrosion of concealed steel caused the metal to expand, jack, and crack adjacent masonry, with integrity of the steel itself also a concern.

Moreover, the facades contained no provision for expansion and movement beyond mortar joints. Pressure from years of moisture-driven expansion caused masonry cracking and drove fine networks of cracks ("crazing") to develop in the terra cotta glazing. As more cracks formed, more moisture found its way into the enclosure, accelerating the cycle of deterioration. Unsightly and damaging biological growth was another result of the perpetual presence of moisture.

Terra cotta distress poses a particular concern to safety. Unlike brick and ashlar limestone, terra cotta units are hollow shells with internal ribbing, so, when a crack forms, it often penetrates through the entire thickness of the shell. The danger of falling terra cotta merits special mention in the FISP guidelines and requires immediate stabilization.

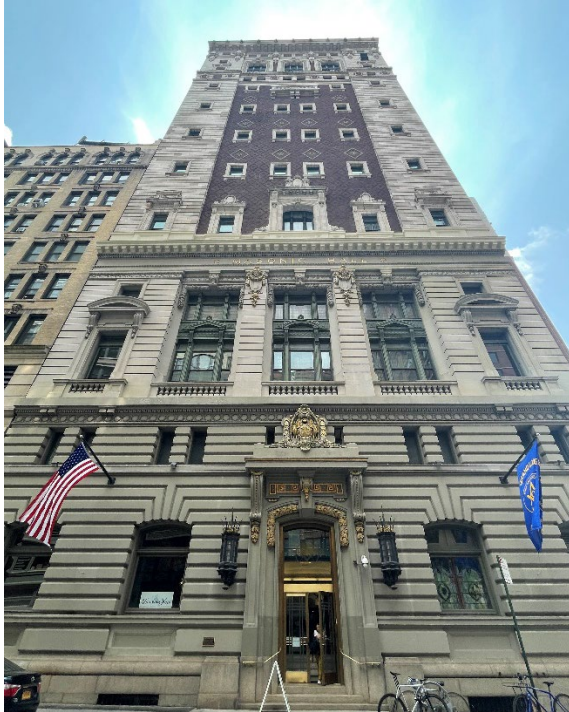
of the historic fabric as possible was paramount. A two-part strategy provided structural stability while restoring original features: replace where required by surface or substrate conditions, and repair where masonry was salvageable and service life could be extended.

The work included repair of corroded structural steel, as well as replacing and augmenting steel components as necessary. To reduce moisture intrusion, the project sought to close breaches in the building enclosure, especially at the roof level. Where existing damaged masonry and decorative units could be salvaged, they were patched, pinned, cleaned, and recoated.

The most significant portion of the project was replacement of severely damaged and insecure ornamental terra cotta. These pieces were removed, then painstakingly surveyed and cataloged for fabrication, using meticulous color, texture, and profile matching, along with mockups, to verify exacting

reproduction. Select areas of highly damaged brick and limestone were also replaced, using similarly rigorous matching strategies. While most terra cotta was replaced in-kind, concerns about the ability of the aging framing to support replacement terra cotta, plus new steel anchorage and substructure, drove the decision to make isolated replacements with more lightweight substitute materials.
