Journal of architectural  
technology published by  
Hoffmann Architects, Inc.,  
specialists in the rehabilitation  
of building exteriors.

## Restoring and Maintaining Archaic Concrete Floor Systems

J. Christopher Clements, AIA

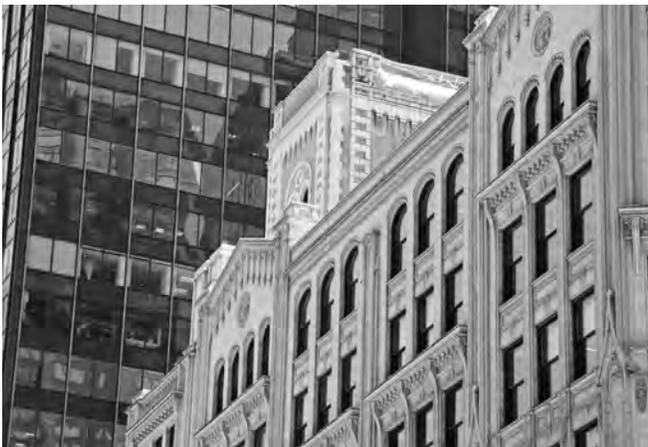
▲ Hidden in plain sight, archaic floor systems predominated in the late 19th and early 20th centuries, and many are still in service today. This 1910 building, nestled between glass towers, has a cinder concrete roof.

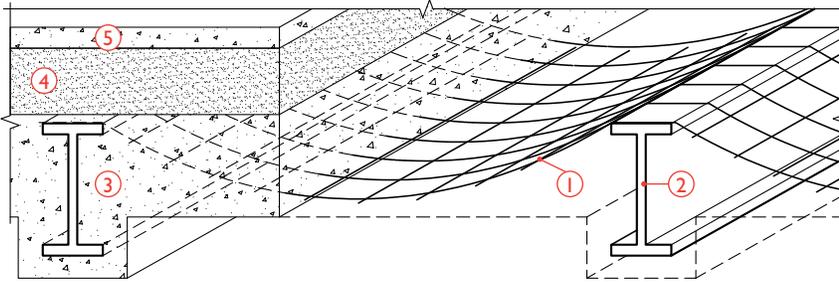
### Cinder Concrete

| 1 | Wire mesh | 3 | Cinder concrete slab | 5 | Cinder concrete topping slab |
| 2 | Support beam | 4 | Cinder fill | | |

As indicated by its name, a cinder concrete system is comprised of a cinder fill layer encased on either side by low-strength concrete. This cinder fill was made from the cinder and clinker left over from the burning of coal, an abundant waste product at the turn of the century. Anywhere from four to eight inches thick, this loose cinder layer provided lightweight fire protection.

Tensile strength in this system was provided by wire mesh draped between light gauge steel beams. Laid in this way, this arrangement provides tensile support by means of a catenary system, the strength of which is the basis of many of the various alternative floor systems.

Taken together, the cinder fill provides fire resistance and helps distribute the load, the draped wire mesh provides tensile strength, and the concrete topping provides the walking surface, transfers loads to the mesh, and protects the system from water intrusion. In typical installations, the floor would be covered over with wood sleepers and hardwood floors or, in the case of

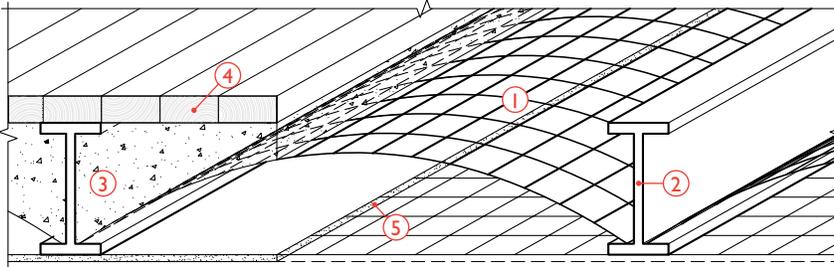
### Roebeling System A

| 1 | Stiffened wire mesh | 3 | Cinder concrete slab | 5 | Plaster ceiling on wire mesh |
| 2 | Support beam | 4 | Wooden sleepers | | |

System A was comprised of the company's stiffened wire cloth arched between I-beams, providing a formwork onto which lightweight concrete was poured. Oftentimes this would be a cinder concrete of the same type used in the floor systems discussed previously. Above this, wood sleepers and fill material provided the base for wooden flooring. Depending on the situation, the arches could be covered by another layer of stiffened wire cloth stretched between the I-beams

and covered with an applied plaster coating or left open with the beams themselves coated in concrete. While this might appear to be a reinforced concrete system, it is not and was not intended to be so, as the wire mesh is positioned distinctly outside of the concrete.

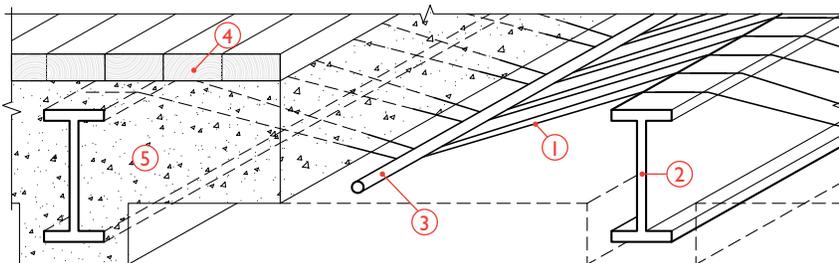
### Metropolitan

| 1 | Twisted wire pairs | 3 | Hold-down bar | 5 | Plaster of Paris and wood chip slab |
| 2 | Support beam | 4 | Wooden sleepers | | |

The metropolitan system was patented in 1899 by Conrad Freitag. What distinguishes it from other alternative concrete systems is that the binder is gypsum rather than Portland cement. In the metropolitan system, gypsum plaster is mixed with treated wood chips and sawdust as aggregate, then poured between steel beams. As with

cinder concrete, tensile strength is provided by wire reinforcement in a catenary arch, though in this case the structural support is provided not by wire mesh but by twisted pairs of wires individually secured and strung between the beams. These wires carry almost all of the load; the thick but lightweight plaster slab predominantly serves as a base for the walking surface and provides fire resistance.

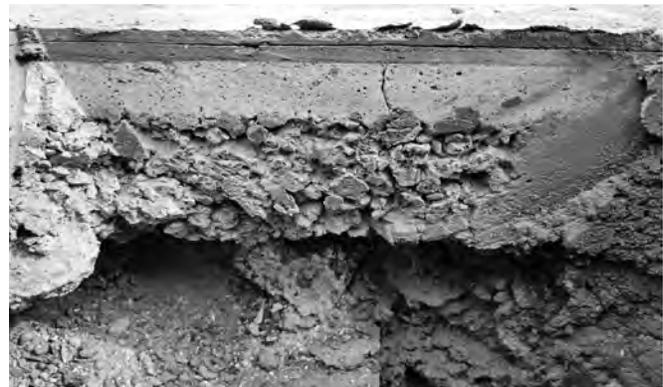
▲ Typically 1 part cement, 2 parts sand, and 5 parts cinders, cinder concrete slabs are structurally unstressed, relying on wires to carry loads.

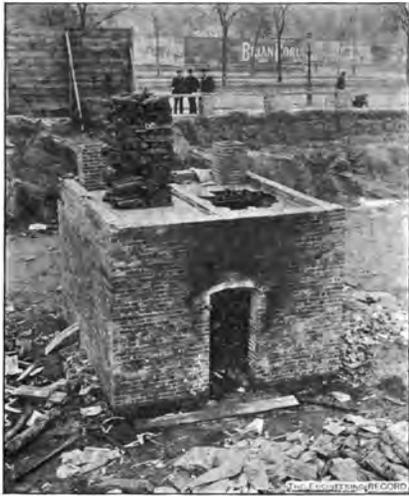
▲ Under intense heat and load for an 1897 empirical test, the Roebling floor, at left, remained intact, while the tile arch collapsed.

The test protocol was designed to judge fire resistance and was as direct as it was thorough. First, a sample of the floor system was built across four brick walls. The floor was loaded to 150 PSF and, with that load in place, the assembly was subjected to increasing temperatures over a period of five hours, with more than three hours spent at over 2,000°F. After this, the underside of the floor was hosed down with cool water to simulate the action of extinguishing a fire, and additional load was placed on the floor to bring it up to a total loading of 600 PSF. The floors were monitored during testing, and measurements of deflection made at the final stage. The results of these tests proved these new systems superior to established brick and terra cotta floors and spurred their acceptance. ■

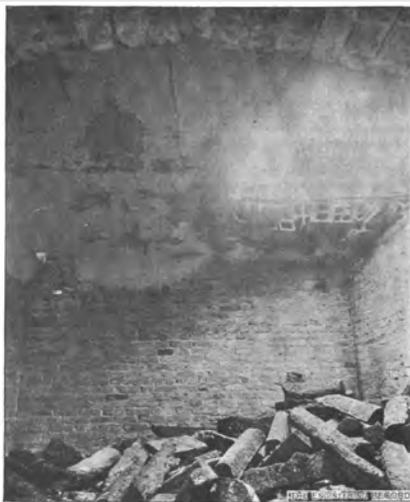
▲ Interior of test chamber shows the concrete arch intact and the tile arch after rupture.

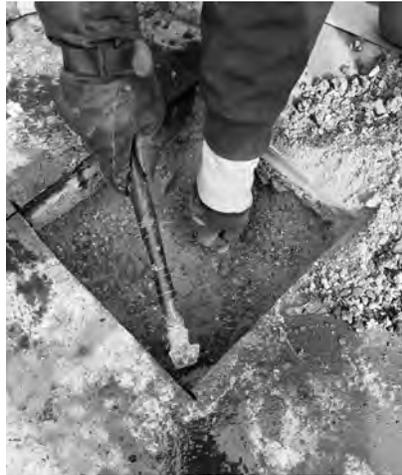
▲ Since damage to wire-reinforced floors may compromise load capacity, invasive probes require experience and planning.

It is important for an owner or building professional to know about the presence of an alternative concrete system, preferably prior to any construction work or even design. While cutting into a slab is the surest way to verify the presence of an alternative concrete system, it is probably the least convenient – or desirable. Severing the wires in these systems can seriously compromise their structural capacity.

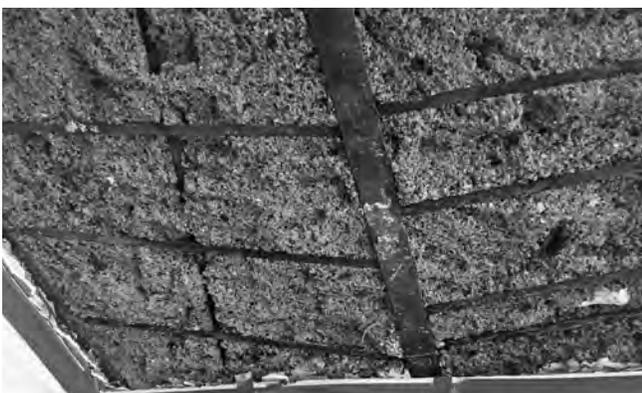
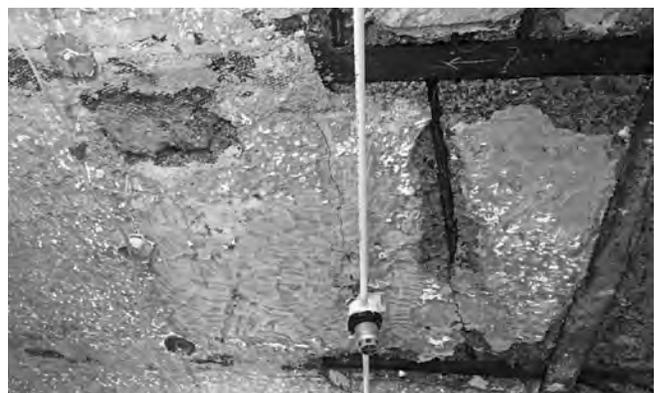
▲ With a pumice-like texture that is rough and porous, cinder concrete uses byproducts of coal as economical, lightweight, fire-resistant aggregate (left). Often, a surface of wire lath was suspended below the beams and coated with plaster to provide a finished ceiling (right).

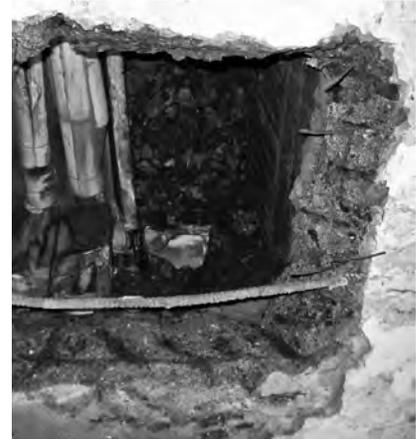
▲ A test cut into this concrete ceiling reveals wire mesh compromised by corrosion.

Due to their thin gauge, wire- and wire-mesh-based systems are especially susceptible to corrosion damage, which can quickly impact their strength. To make matters worse, chemicals present in cinder fill or aggregate can produce corrosive compounds, such as sulfuric acid, when mixed with water, accelerating deterioration. It is not uncommon to find wires in compromised slabs that have completely disintegrated, leaving only rust. Even in the absence of corrosive failure, cracking can cause the embedding concrete to lose enough integrity that the individual wires are subject to

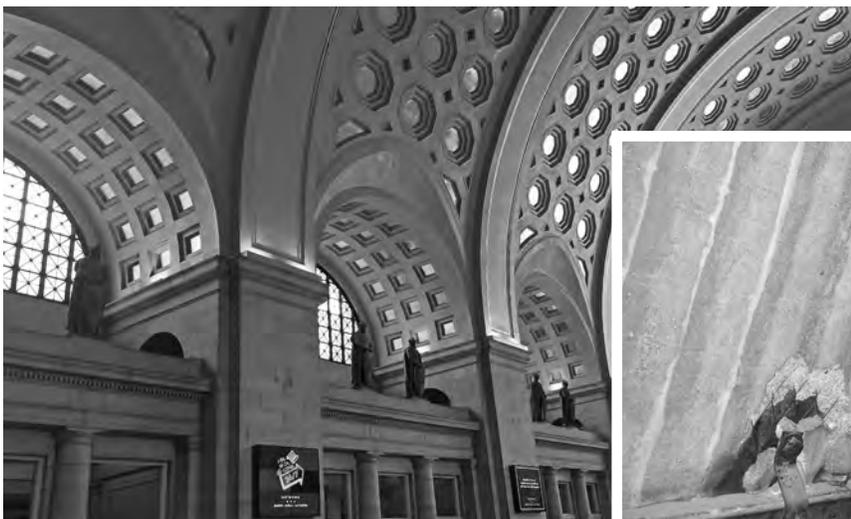
▲ Within this soaring vaulted ceiling lurks an archaic concrete system that has been covered over, making it challenging to access and repair. Note the exposed structural wire mesh where fasteners for the roof were added in the 1980s.

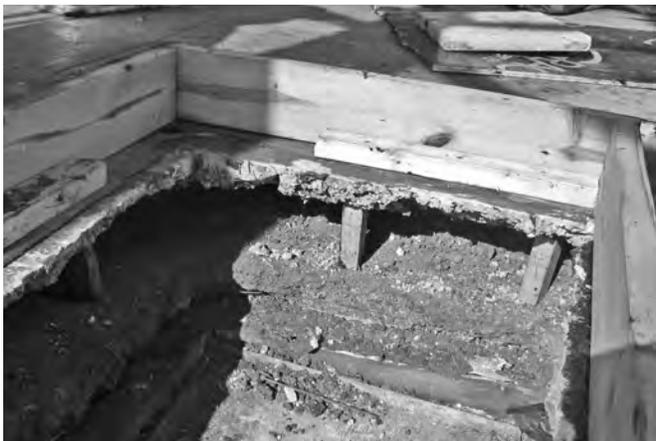
▲ Cinder concrete decks were favored in the 1920s-40s for their load capacity, fire protection, light weight, low cost, and ease of construction.
