Hoffmann  
Architects

# Journal

## Thin Stone Marble Facade Systems

Juan Kuriyama, AIA and Stephanie L. Dillon, Assoc. AIA

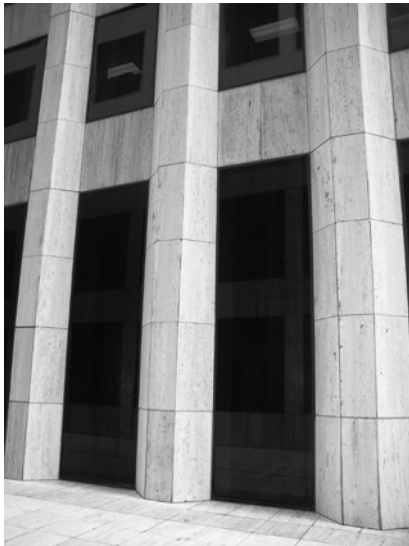
▲ New stone-cutting technology permits thinner marble panels—and brings new design challenges.

ally cut to a thickness of three or four inches. Developments in stone cutting allowed for ever-thinner panels, with the 1970s seeing marble as thin as a half inch. Lighter weight panels saved money in materials and installation, but brought with them new problems.

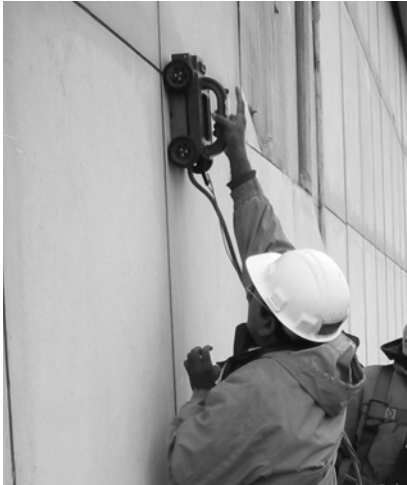
▲ Ground-Penetrating Radar (GPR) identifies anchor locations without removing panels.

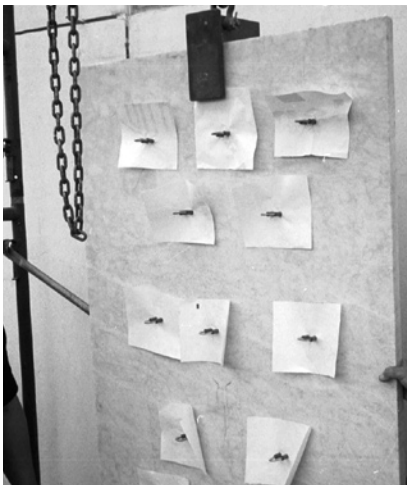
▲ Replacement panel mock-up to assess anchor geometry and installation protocol.

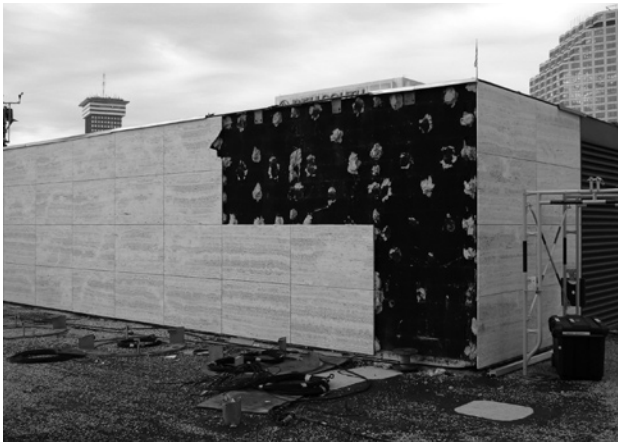
▲ Penthouse marble panel replacement in process.

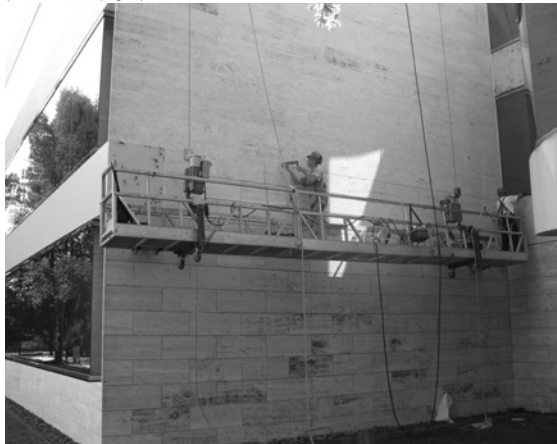
▲ Periodic sealant replacement should be part of a comprehensive maintenance program.
