New Rule Mandates Annual Parapet Inspections for New York City Buildings

Beginning January 1, 2024, New York City building owners must undertake a yearly inspection of parapet walls, then remedy any hazardous conditions.

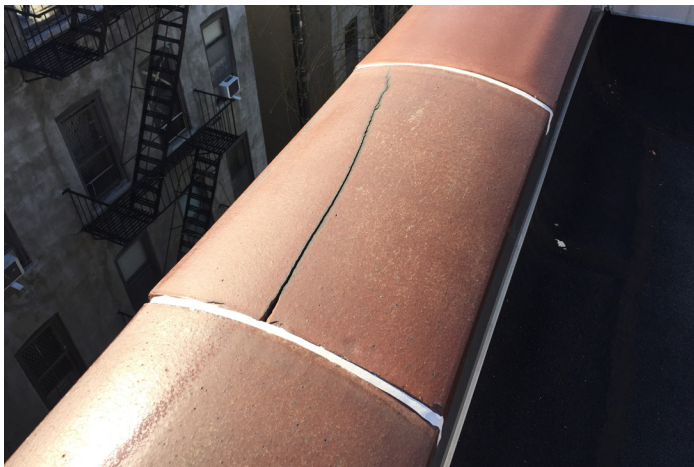
Cracked terra cotta coping stone poses a potential hazard.

- Whether the parapet is plumb (within a horizontal distance of 1/8 its cross-sectional thickness);
- Evidence of excessive deterioration, such as displacement, cracks, spalls, deteriorated joints, or loose / missing masonry and coping stones; and
- Stability and proper attachment of appurtenances, including railings, ladders, fire escapes, signs, and telecom equipment.

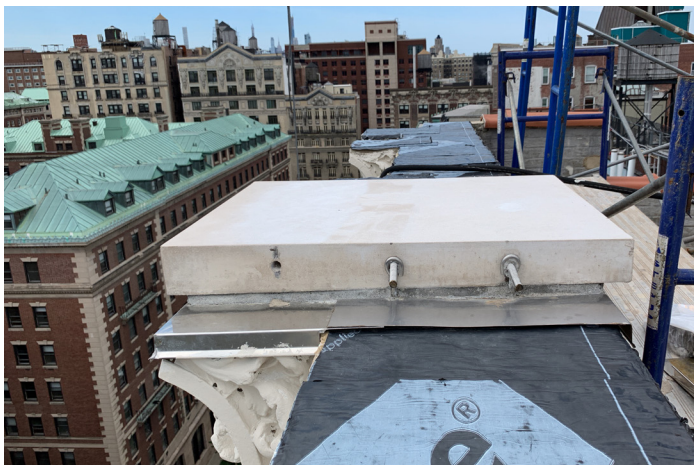
Parapet reconstruction incorporating waterproofing membrane, flashings, precast coping stones, and steel anchors.
