Journal

Substitute Materials in Historic Restoration: When to Consider Alternatives

Richard W. Off, AIA

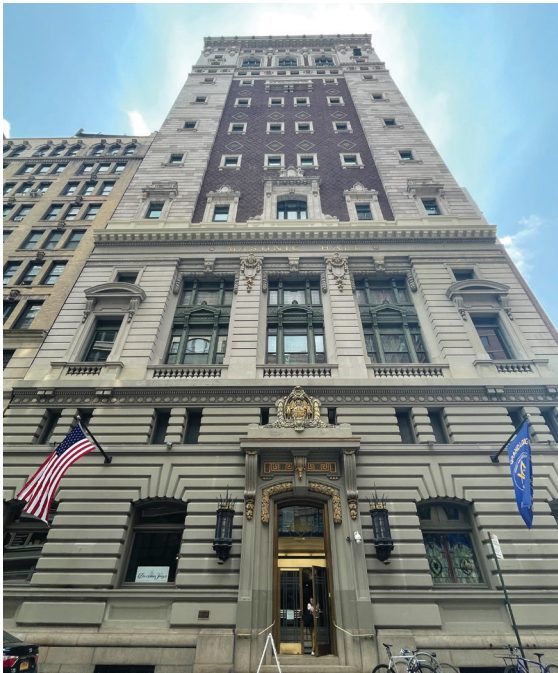
▲ Historic restoration of this Beaux-Arts tower incorporated both traditional materials and, where necessary, substitutes.

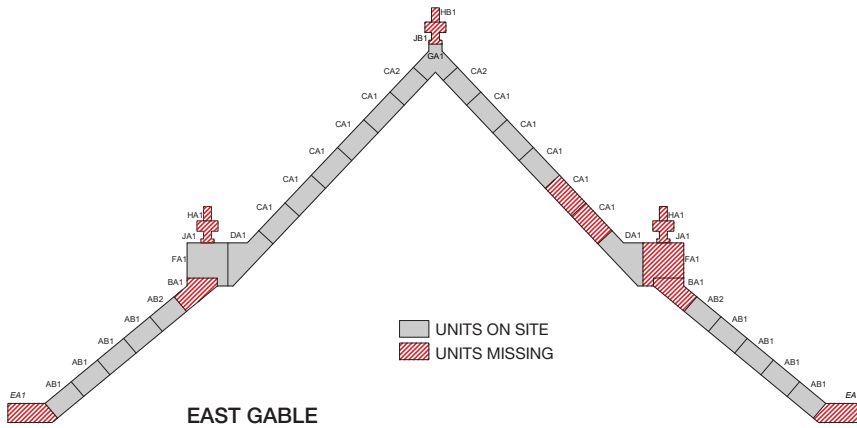
▲ Despite the owner’s proactive order of replacement terra cotta for deteriorated gables, when units were unpacked and inventoried, some were missing (left & top). Lead times for terra cotta were too long, so polymer-resin composite, carefully matched (center), filled in the gaps (right).

Availability can be an issue even for historic materials which were once mass-produced, such as terra cotta. A popular material in the late 19th and early 20th century that once had many sources throughout the United States, architectural terra cotta now has just two major manufacturers in the country. Limited availability not only affects lead time, as it can take longer

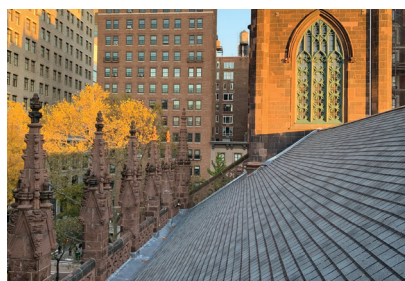
▲ Asphalt shingles mimicking slate roofing.

There can also be performance reasons for selecting a substitute material. A design professional may determine that the original or existing materials have fundamental deficiencies, or they were inappropriately implemented in an assembly, climate, or exposure that makes them prone to deterioration. For example, concealed anchorage and structural systems may need to be replaced with substitutes not only because they lack corrosion-resistance, but also because they may have fatigued or were not engineered to contemporary standards. Sometimes, supporting metal has deteriorated but cannot be replaced. Instead, the design team might replace exterior claddings that rely on these metal components with substitutes that are lighter weight, such as cast composite resin in lieu of stone masonry, or asphalt shingles in place of slate roofing.

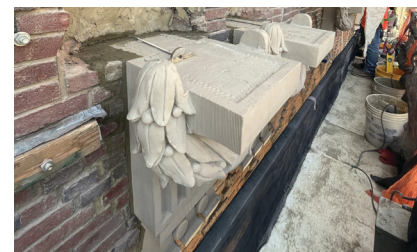
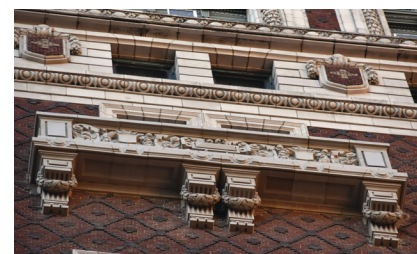
Project documents for structural rehabilitation involving substitute materials must be detailed and exacting to yield long-lasting repairs (left). At this Juliet balcony, concerns about the aging framing prompted isolated replacement of terra cotta with lightweight substitutes (right).

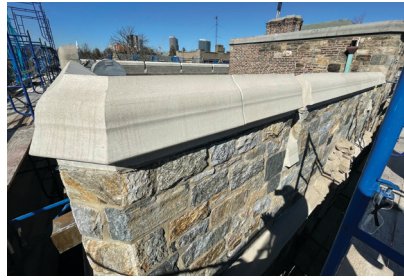
▲ Cast stone replaces limestone at a parapet.

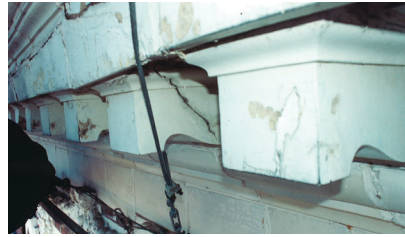
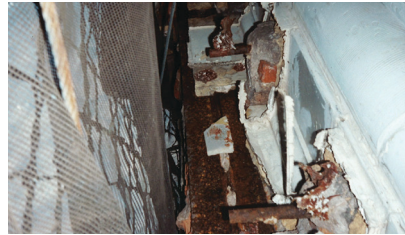
▲ Substitute materials addressed severe deterioration and weight concerns at this terra cotta cornice.

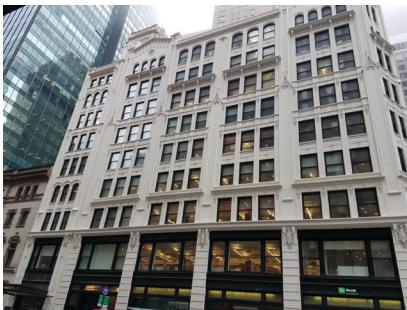
▲ Open Society Foundations Headquarters, New York, NY, *Facade Repairs, Including Replacement of Terra Cotta with Cast Stone.*

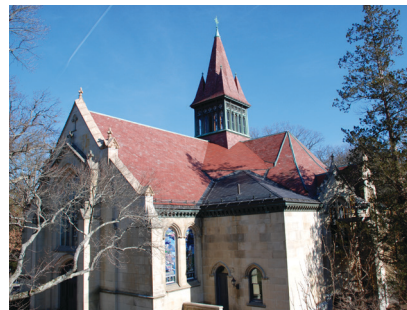
▲ Wellesley College, Houghton Chapel, Wellesley, MA, *Roof Coping Replacement Using Cast Composite Resin for Missing Terra Cotta.*

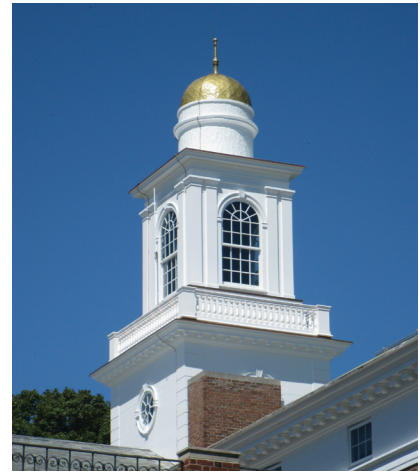
▲ Choate Rosemary Hall, Mellon Library, Wallingford, CT, *Cupola Renovation, with Custom-Milled Cellular PVC in Place of Wood.*

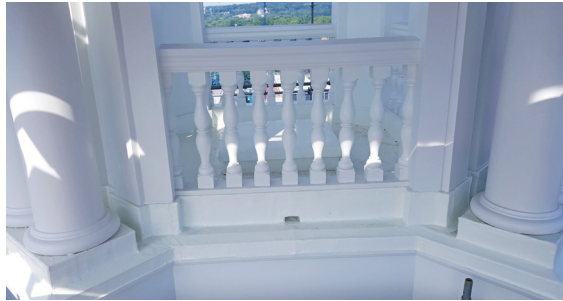
▲ Custom-milled cellular PVC in this restored cupola base resolved persistent wood rot issues.
