JOURNAL

First Issue 1999 Volume 17 Number 1

Historic or Landmark Structure Rehabilitation

Understanding Your Options

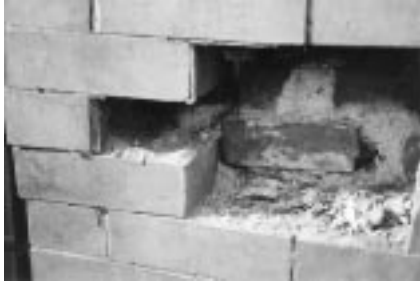
Behind the brick face of this historic structure, a probe reveals interior masonry that has disintegrated to powder. Note also the dramatic brick displacement and lack of a proper seal at the mortar joints, which can lead to moisture infiltration and further damage.

Failure to identify and treat the underlying causes of deterioration often results in their recurrence in the near future. For instance, re-anchored face brick will break down prematurely unless the material (steel, concrete, clay, brick, etc.) and condition of its back-up are taken into consideration. Moisture infiltration caused by improper

anchorage will necessitate early replacement of the new facade. To guard against such duplicate repairs, a thorough investigation of the building materials is essential before any work can begin.

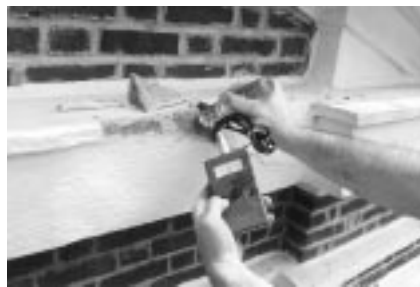
Determining the moisture content of subsurface masonry is a frequently used investigative method that can help identify the integrity of back-up materials.

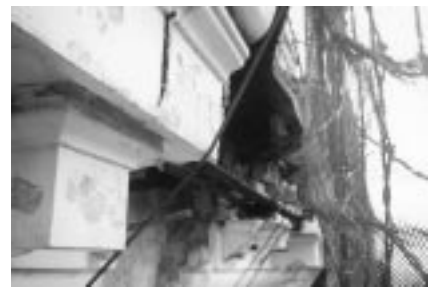
As an emergency measure, netting was installed on this severely deteriorated, 80-year-old cornice to prevent loose materials from falling.

increase costs of subsequent work or cause more damage to the structure, these measures ought either to enhance or lay the groundwork for future rehabilitative efforts. To illustrate, the common practice of installing netting to secure dangerously loose facade materials may be a good temporary fix until a more permanent solution can be identified and implemented. If improper anchorage is used, however, the netting can fail. At the other extreme, removal may be sufficiently difficult that further envelope damage is induced.

During a recent rehabilitation project, Hoffmann Architects' design team was faced with a badly deteriorated, eighty-year-old terra cotta cornice, cantilevering three feet off the 14-story Taft Apartments, formerly the renowned Taft Hotel, in New Haven, Connecticut. Deterioration included open joints and severe corrosion of the embedded support steel. The entire cornice had been netted, and numerous large pieces had fallen into this protective barrier.

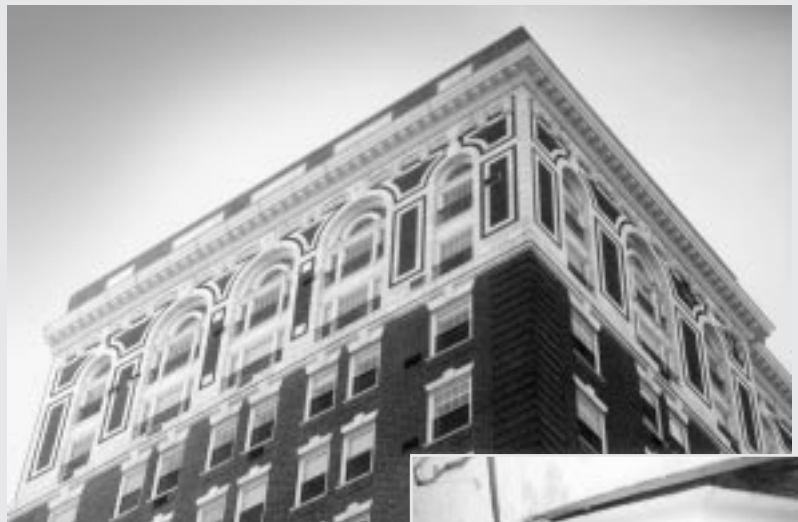
As the cost of repairing the ailing terra cotta cornice (inset) of this landmark building was well beyond the project's budget, the design team called for a replacement with more contemporary materials.

As a historic landmark, the building was subject to restrictions from the city commission on any rehabilitative work. But here, the cost of reconstructing the cornice as originally designed was prohibitive. Instead, the design team came up with a solution which satisfied both the commission and the owner's budget: recreate the cornice, down to the last detail, using FRP (fiber reinforced plastic). The required variances were obtained by the project team on the owner's behalf.

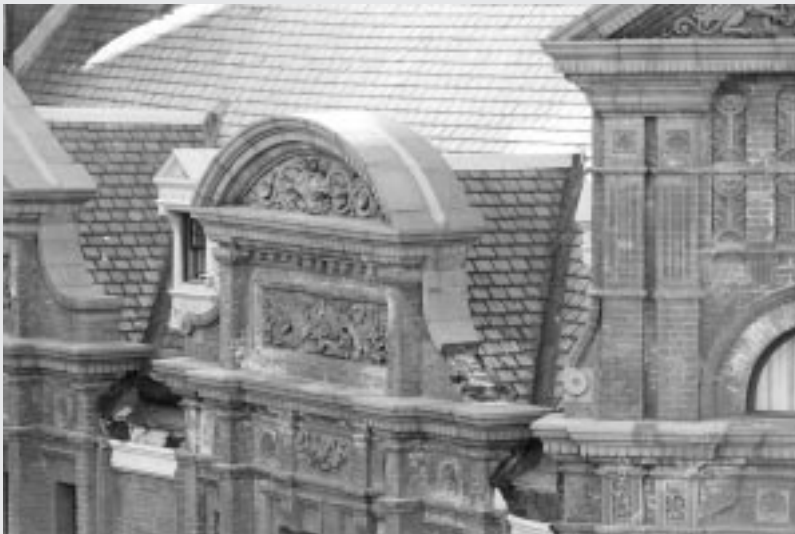
Intricate brick work and thin mortar joints necessitate clear construction documents and innovative methods to achieve rehabilitation.

Detailed, lucid construction documents are imperative, as Hoffmann Architects' rehabilitation of one National Historic Register building illustrates. On the turn-of-the-century, Queen Anne-style Goodwin Hotel, in Hartford, Connecticut, an intricate brick facade pattern and thin mortar joints are among the distinctive details.

While these delicate features are characteristic of 1800s architecture, they are also problematic. The joint size and brick pattern prevent an adequate bond between the face brick and interior wythes (layers) of masonry. They also present difficulties in repointing the mortar joints to create a watertight facade.

To resolve the problem, Hoffmann Architects specified replication of the brick pattern at the areas of reconstruction, while bonding the face brick to the interior masonry with a series of stainless steel strap anchors custom-fabricated for this project. To meet the re-pointing challenge, the firm specified a custom mortar mix, which improved upon the strength of the original mortar while still maintaining its flexibility. The specifications also called for the combined use of hand and power tools to remove the existing mortar; to fill the joints, both injection and traditional jointing tools and trowels were indicated. ■

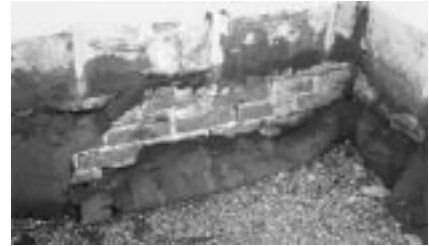
This repair effort used roofing cement to seal over a leaking brick parapet wall — a solution that instead trapped moisture within and caused further deterioration.

A case in point: Once sites of water infiltration have been identified in a report, "quick-fixes" such as water repellent or waterproof coatings may seem like tempting solutions. But these coatings can instead trap moisture within the wall, leading to breakdown within the masonry, while the sealer masks evidence of the ongoing deterioration.

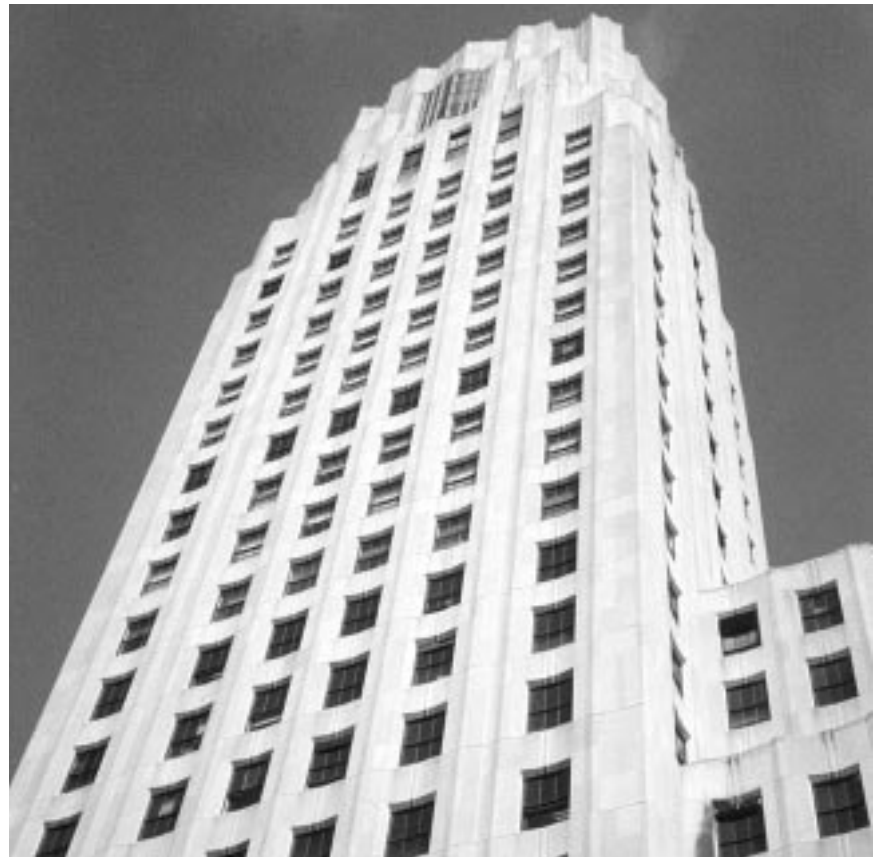
The master plan for this Art Deco landmark included masonry and roofing restoration, and rehabilitation of the 1,500 deteriorated steel windows.

When the owners came to Hoffmann Architects, they complained of heat loss from the 1,500 original steel-frame windows but were unsure how to proceed. Other issues throughout the building were also troublesome and in need of work. Hoffmann Architects devised a four-year master plan to rehabilitate the exterior envelope, including masonry, roofing, and windows. Collaborating with historic and design organizations, window manufacturers, and the New York City Landmarks Preservation Commission, Hoffmann Architects helped the Bank of New York to identify and understand their options for the deteriorating windows.

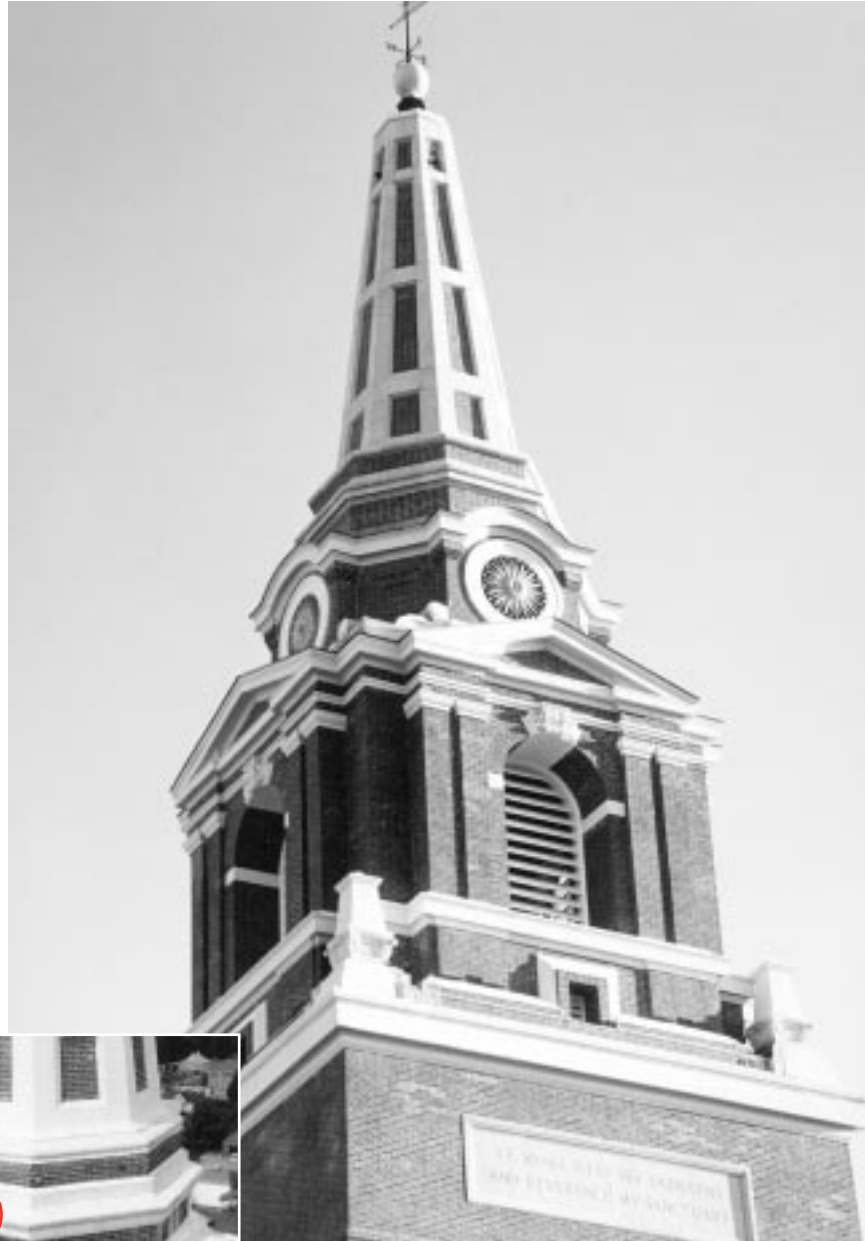
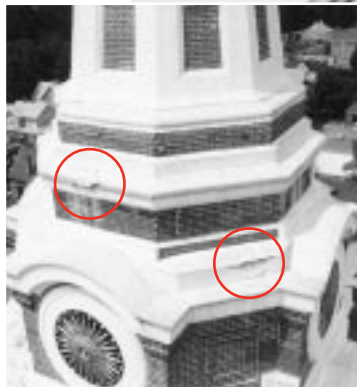
The steeple of this Stanford White-designed church was rebuilt and then lowered intact by crane atop the existing structure. The new replacement adds durability and strength through a steel frame and brick/concrete construction.

After previous repair methods failed, Hoffmann Architects was retained to investigate the cause of the problem. Based on the report from this study, the Church then asked the firm to find a lasting solution. The design team created plans for complete reconstruction of the spire using a new steel frame. This design ensured a

sturdier construction, adding many years to the life span of the structure. The team also replaced the brick/terra cotta of the original design with a brick/

precast construction to add further durability. The result: a steeple which looks like the original, but which will withstand many years more weathering. ■

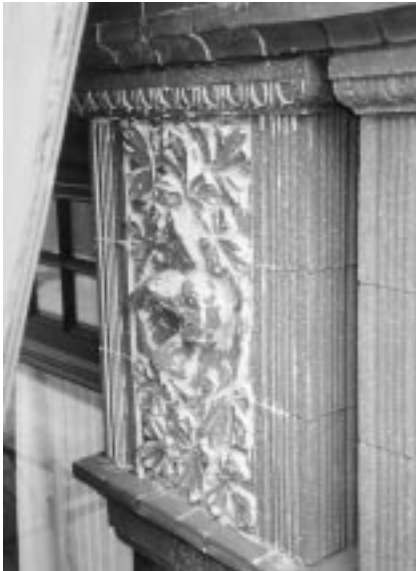
Part of the load-bearing wall, this intricate terra cotta element was handcrafted in the late 1800s. It was painted shortly after the turn of the century and then sandblasted some years later to remove the paint. The marred and pitted surface left by the sandblasting allowed moisture entry, leading to subsequent deterioration.
