Second Issue 1991 Volume 9 Number 2

Rx for Parking Garage Maintenance and Repair:

Treating the Causes Rather Than the Symptoms

John J. Hoffmann, AIA

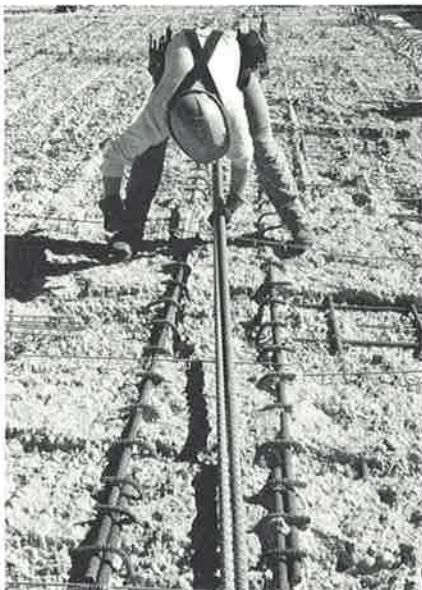
Installation of new rebar became necessary after concrete deterioration led to exposure and corrosion of reinforcing steel in this concrete structure.

Most parking structure problems result from steel reinforcement in the concrete being exposed to the chlorides in salts. As a result of this exposure, the steel rusts and swells, causing the concrete to deteriorate.
