Hoffmann
Architects

What Went Wrong?

Diagnosing Building Envelope Distress

John J. Hoffmann, FAIA and Deborah J. Costantini, AIA

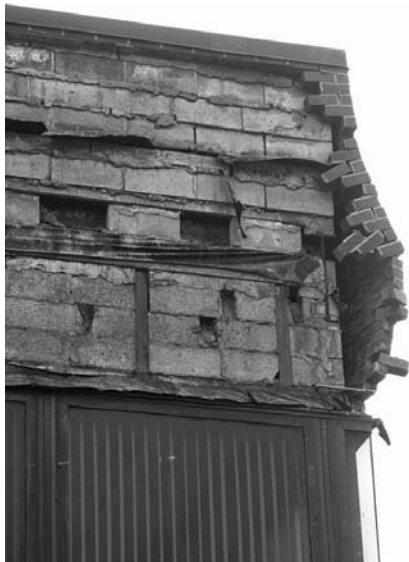
When our design professionals first visited the building pictured in Figure 1, they found loose brick and mortar below the windows, failed sealant at

jamb, aluminum sills bent upward at the front edge (Figure 1a), and, most notably, significant gaps between the head of the window frame and the opening (Figure 1b). Concerned that the windows may have fallen in their openings, the project team conducted a follow-up window investigation to find out what had gone wrong.

What we found is that rather than the windows falling into the wall, the opposite was true – the wall was moving upward around the windows.

Building materials expand and contract at different rates. Brick, for example, expands over time, whereas concrete shrinks. In this fairly typical cavity wall construction, the brick masonry is only a one-brick-thick veneer. Behind it is an open cavity space to allow for drainage, along with insulation and an air/vapor barrier. On the other side of this cavity is concrete masonry back-up, which provides the structure of the wall; unlike solid brick masonry
