Hoffmann
Architects

Journal

Roof Maintenance Master Plan: A Strategy for Preserving a Roof's Useful Lifespan

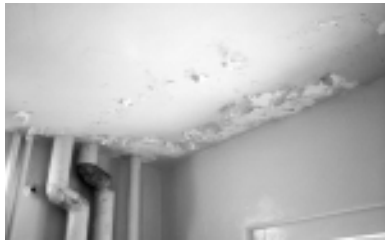
▲ One of the most noticeable and, often, most troublesome signs of a failed roofing system is interior water damage.

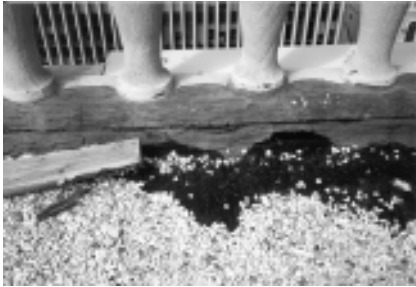
▲ Inappropriate repair measures can do more harm than good. Here, roofing mastic used to patch this balustrade base led to further water retention and deterioration.

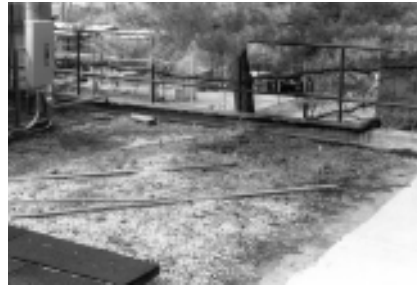
▲ While attractive as landscaping elements, trees can pose problems when allowed to overhang a flat roof for an extended period of time. This tree's shed pinecones and needles retain moisture and provide an ideal climate for bird nesting and organic growth, both of which can severely damage roofing materials.

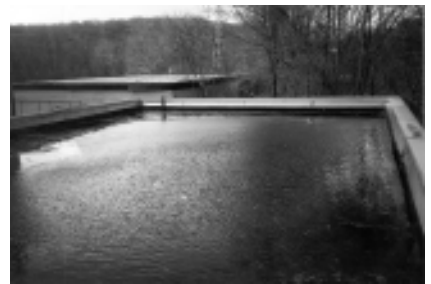
▲ A dramatic example of *ponding*, or water retention on the roof membrane.

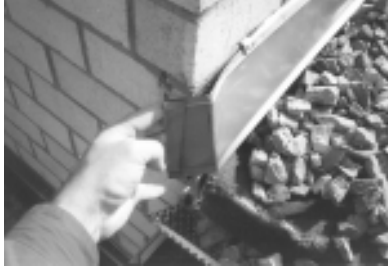
▲ Counterflashing is designed to protect the termination of an up-turned roof base flashing. This counterflashing has dislodged, exposing the base flashing and allowing water to slip behind the assembly near the corner of the wall.

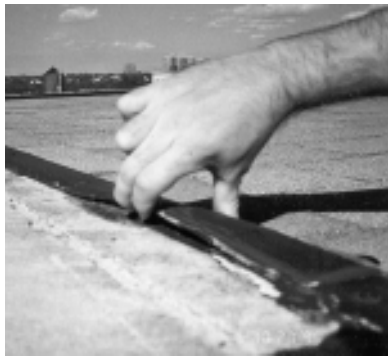
▲ Thermal factors often play a central role in roofing material deterioration. Due to expansion and contraction, this flexible termination bar has buckled between fasteners, leaving openings for water to infiltrate the EPDM roofing system flashings.

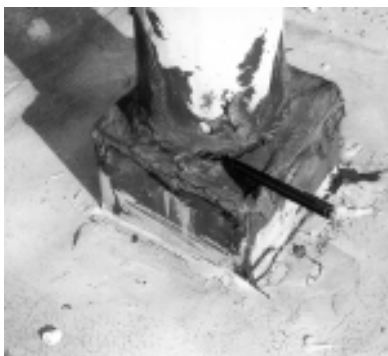
▲ A failed penetration pocket. The pen is inserted into a deep crack, which is a point of water entry.

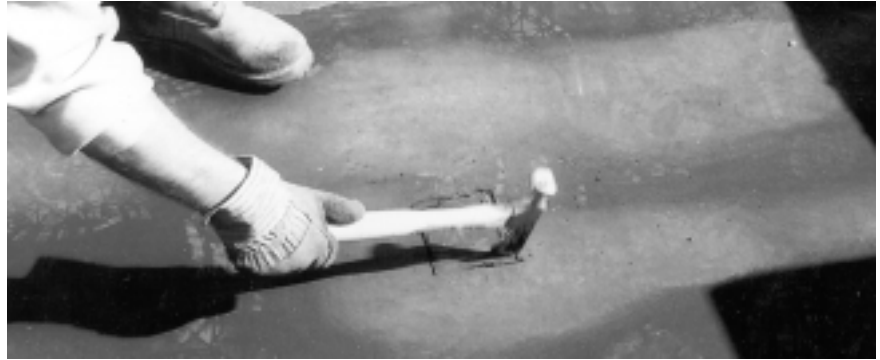
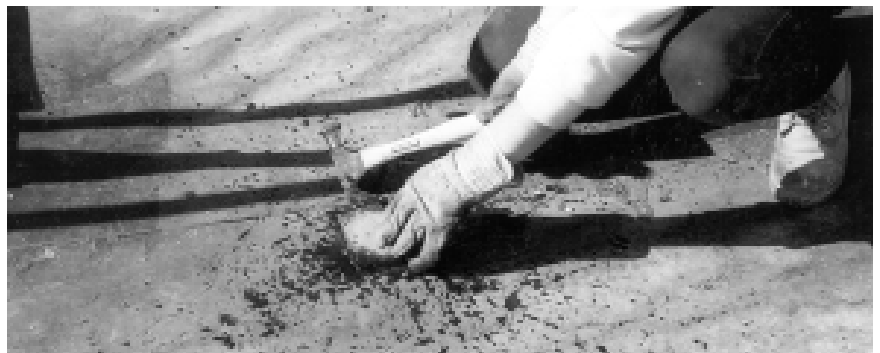
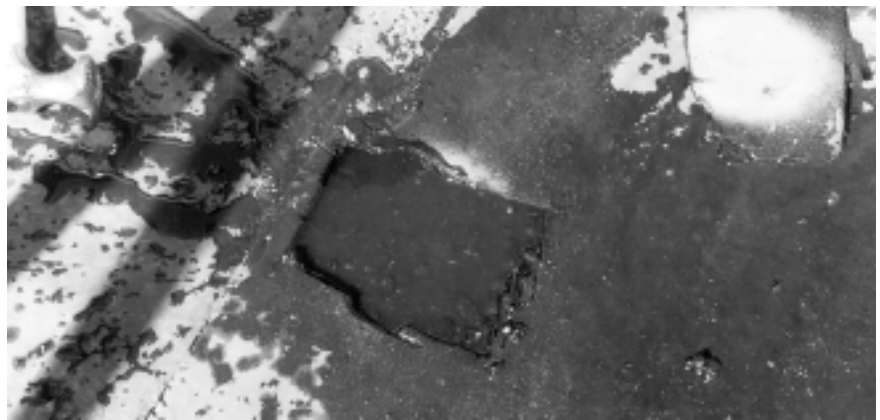
▲ Although a roof may look good on the surface, test probes (roof cuts) can sometimes tell a different story. From top to bottom: here, removing the roofing membrane reveals underlying layers of saturated insulation.

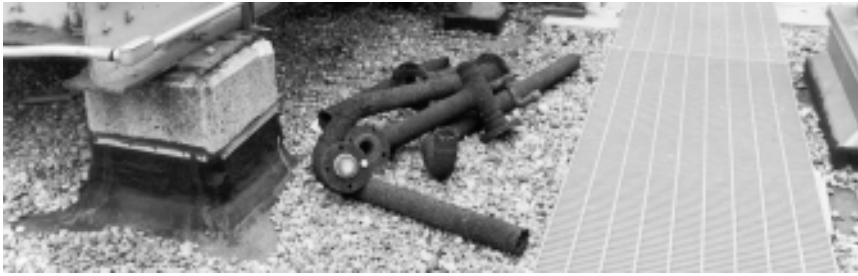
▲ Mechanical debris lies directly on the roof membrane. Not only may this lead to deterioration, but it may also prevent the safe inspection of the roof.

- Are there any conditions that would prevent a safe inspection of the roof?
- Is trash or debris present?
- Does the roof appear to be draining adequately?
