Masonry . . . Care & Treatment

— by Karen L. Warseck

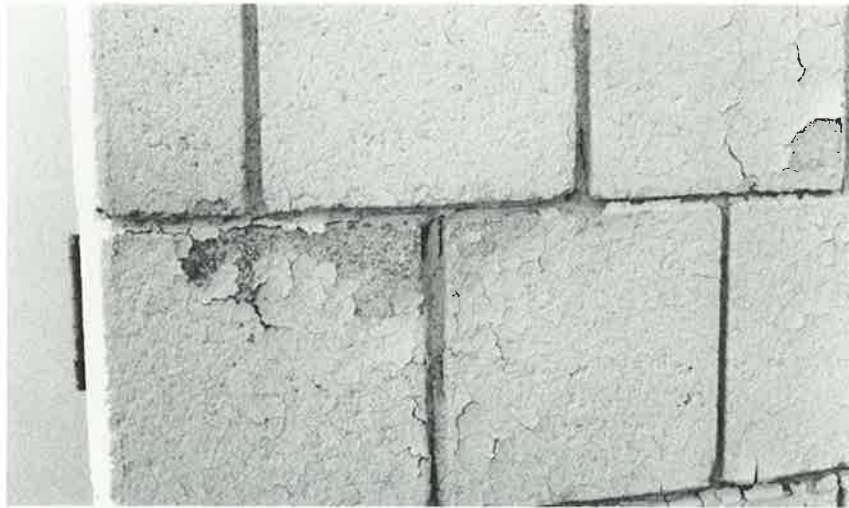
Coating is peeling as a result of water trapped within the masonry wall.

Once the water is in the wall assembly, it becomes imperative to get it back out. If it has been absorbed into porous masonry, it will tend to evaporate naturally. If an impervious waterproofing coating has been applied to a surface, any water which has found its way into the wall assembly will remain trapped. If the water has condensed and accumu-

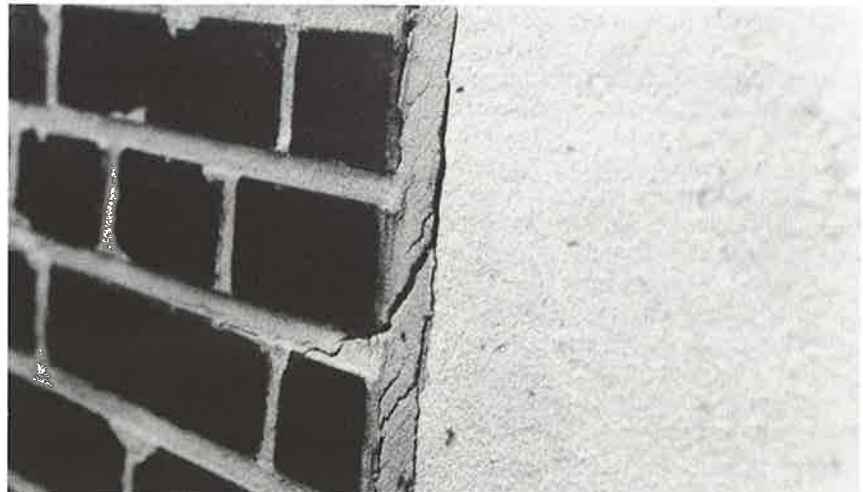
Cracks in the masonry mortar

Even when it *is* the wall that is leaking, the porosity of the masonry material is usually not the cause. Water will find its way through the path of least resistance, open joints or cracks. Cracks may be caused by myriad reasons involving stress, movement and a failure to provide for them. However, the major cause of throughwall leakage is not as obvious – voids in the mortar and/or hairline cracks due to limited bonding between the mortar and the masonry unit itself.

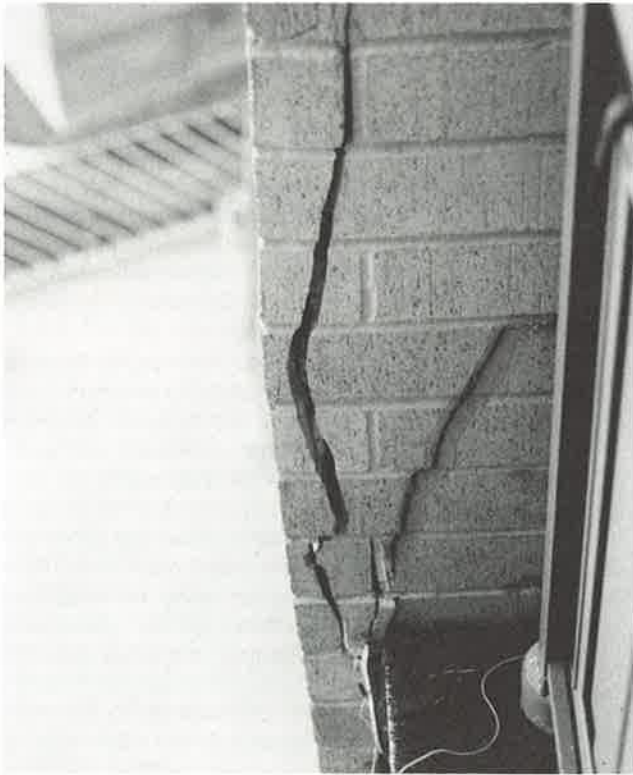
Vertical displacement of brick veneer

Masonry, in general, is a stiff material not prone to flexing. When used in conjunction with a material that is more flexible, the masonry will tend to crack long before its counterpart when subjected to movement or stress. So, for example, if a masonry curtain wall is tied to a flexible steel structure, (unless adequate precautions are designed in and constructed properly) when the frame moves, the
