# Journal

## Caring for Glazed Architectural Terra Cotta

Arthur L. Sanders, AIA and Kara L. Shypula, Assoc. AIA

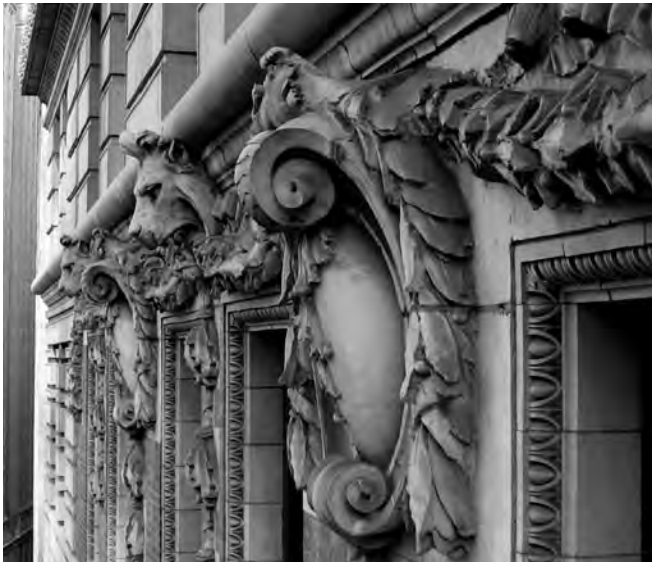
▲ Often finished in imitation of stone, terra cotta can be difficult to recognize and may be mistaken for cast stone, concrete, stone, or brick.

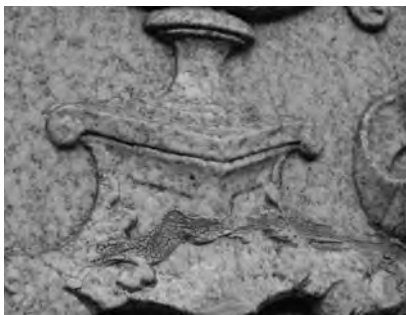
**A** Failed prior repair effort.

Many repairs fail prematurely because they do not address the root cause of distress or failure. Often, repair

materials are not durable and are incompatible with the existing terra cotta, creating a poor visual match and a short-term fix, at best. Where repairs fail, they tend to make deterioration worse.

Poor detailing, including failure to properly anchor the patch to the backup, leads to failure of not only the repair area, but also the surrounding terra cotta. For example, replacement brick and cement stucco are neither watertight nor flexible enough to accommodate movement, so they tend to pull free or crack and spall. Surface-applied sealants are likewise not watertight, and bituminous patches are ineffective and aesthetically unsuited to terra cotta repair. In an effort to keep out water, non-breathable coatings are sometimes applied; these have the effect of trapping water inside the terra cotta, particularly if the source of water entry has not been addressed.

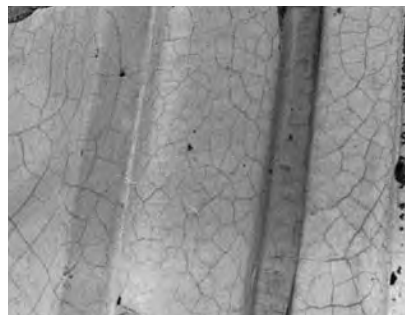
**A** Crazed glazing.

Cyclic wetting/drying and freezing/thawing can lead to glaze deterioration, cracks and spalls in the body of the terra cotta, and fracturing and displacement of the units. *Crazing*, the formation of small random cracks in the glaze, occurs when the terra cotta unit absorbs moisture from the air and expands over many years. When new terra cotta is removed from the kiln, firing has shrunk it to its smallest size; over time, the porous clay grows, and the glaze goes into tension. Once the strength of the glaze has been exceeded, it cracks and shatters, increasing the water absorption of the terra cotta unit and exacerbating water infiltration in a self-perpetuating cycle.

like a good idea, indiscriminate coating of the entire wall is generally inadvisable, as it may trap water and make matters worse. Serious crazing may be treated on a limited scale; however, most glaze crazing does not substantially increase the flow of water into the wall. Unless the source of moisture infiltration is addressed, applying an impervious coating will only serve to prevent outward migration of water from within the assembly.

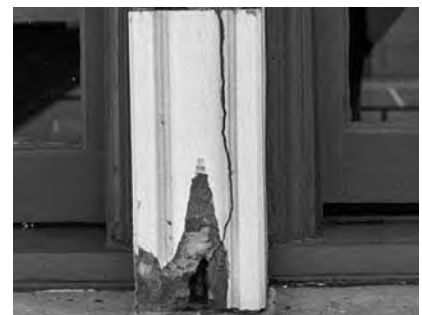
**A** Crack and spall caused by corroded steel.

As water penetrates, it comes in contact with embedded steel anchors and reinforcement. In historic applications, steel was often untreated, making it particularly susceptible to corrosion. As it corrodes, the steel expands, exerting pressure on the surrounding terra cotta and causing cracking and displacement. Embedded steel corrosion may be caused by unmaintained roof drainage systems, which admit water into the cladding assembly.

What makes embedded steel corrosion challenging to treat is that it tends to be difficult to diagnose unless it is severe. By the time symptoms are visible at the surface, corrosion is likely already advanced. Initial outward signs of metal anchoring deterioration might include staining and spalling. Total anchoring failure can result in loose terra cotta units, which are in danger of falling from the building.

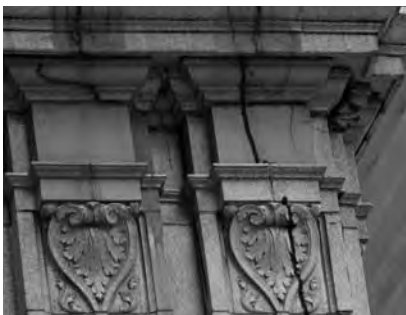
**A** Cracking at building corners.

Large cracks running through multiple units or stories usually indicate problems with embedded structural elements. Rehabilitation often requires removal of pieces to examine and treat defects, such as corroded steel columns.

Before attempting to fix terra cotta damage, causes must be addressed. Eliminating sources of moisture infiltration is critical and may necessitate adding flashings to protect water entry surfaces. For structural problems, including long, vertical cracks at building corners, an engineer may need to evaluate the integrity of the embedded structure before repairs to terra cotta units are made.

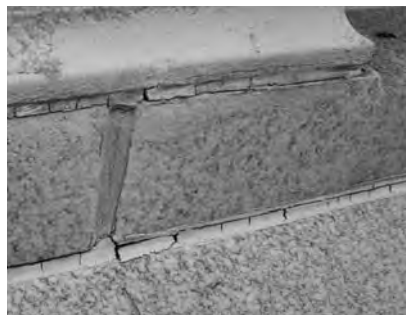
**A** Joint deterioration.

Maintaining mortar joints is very important to the lifespan of the terra cotta. Periodic repointing prevents water entry and inhibits deterioration. It's important to use a mortar with a compressive strength that is lower than that of the adjacent terra cotta, since a hard mortar may prevent the outward migration of water and may cause point loading. Never repoint with sealant, as it impedes moisture movement. Use sealant selectively, such as at joints in horizontal surfaces of copings and sills.

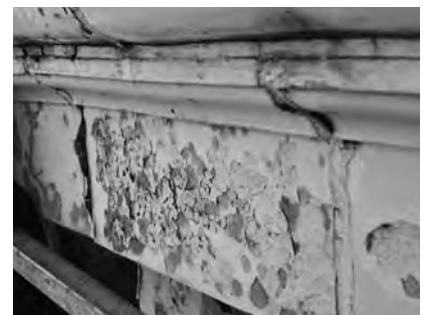
**A** Blistering coating.

For spalled glazing, coat or seal blistered areas to prevent water infiltration, using color-matched products. At lower stories where visual integrity is critical, the unit may need to be

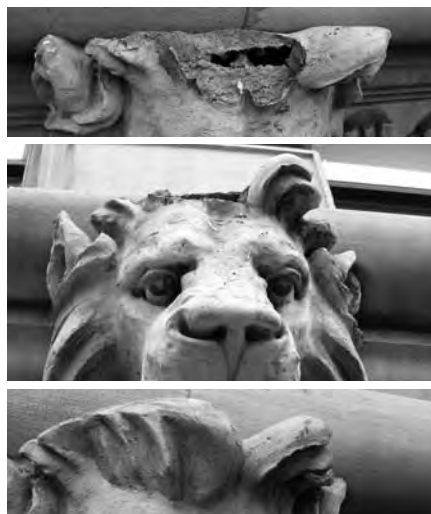
▲ Restoration of spalled terra cotta decorative element.

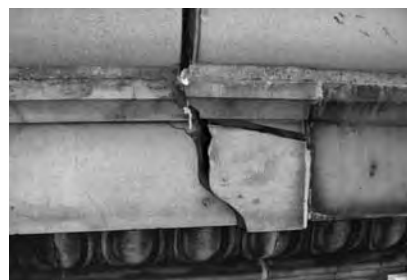
▲ Untreated deterioration can result in hazardous conditions.

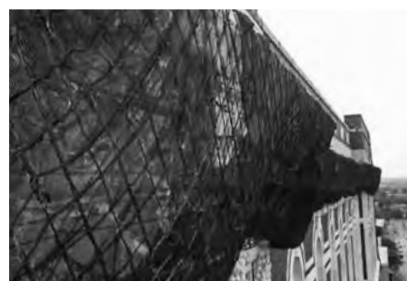
▲ Until permanent repairs are made, netting may be used to secure unstable terra cotta.

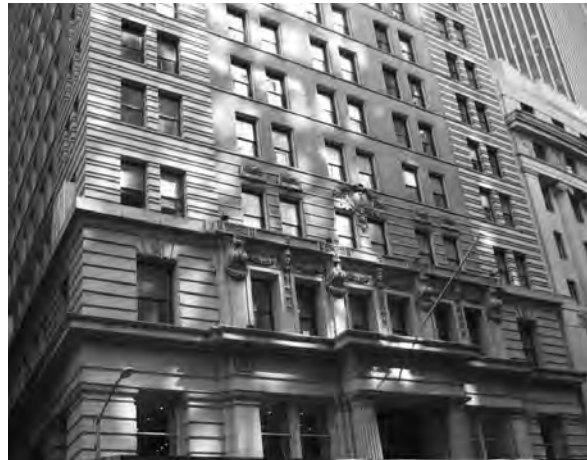
**▲ Broad Exchange Building, 25 Broad Street** in New York, New York. *Landmark Terra Cotta Facade Restoration.*

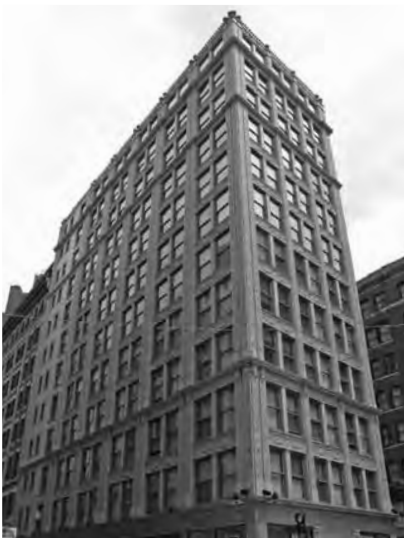
**▲ Chauncy House** in Boston, Massachusetts. *Facade Investigation & Terra Cotta Repair Design.*

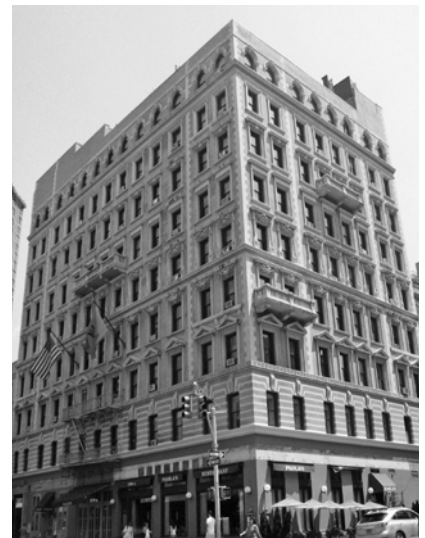
**▲ Hotel Wales** in New York, New York. *Landmark Terra Cotta Repair and Replacement.*
