Journal of building technology
published by Hoffmann
Architects + Engineers,
specialists in the rehabilitation
of building exteriors.

Joint Failures: The Undoing of Double-Tee Parking Garages

Lawrence E. Keenan, AIA, PE

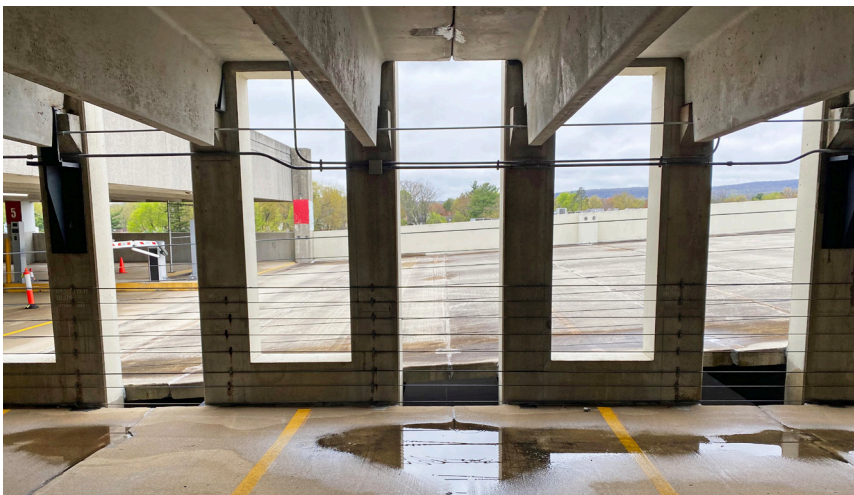
▲ Leaks and spalls might seem like minor nuisances, but they can signal serious structural distress.

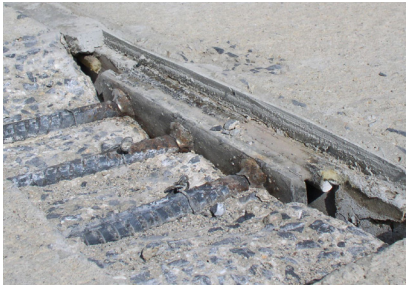
▲ Corrosion of dissimilar metals.

Early connections often consisted of stainless-steel plates welded to regular carbon steel rebar. These two materials are incompatible in a corrosive environment, which causes the carbon steel rebar to corrode at an accelerated rate due to galvanic action. This corrosion can weaken and eventually sever the rebar, or it can travel along the bar and cause an *edge spall* (concrete fracture that breaks away from the surface) exposing the connection to further degradation.

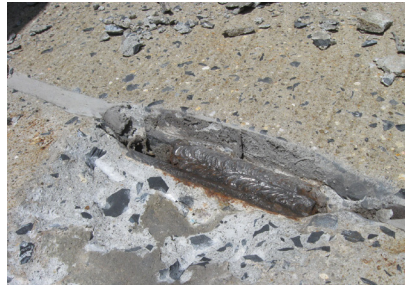
▲ Edge spall due to the heat of welding.

The most common problems in early double-tee garages were leaks at connections, the most serious of which originated at concrete cracks caused by welding of the connection. The plates to which the slug was welded were typically embedded within the concrete, such that they were encased without room for expansion. As the connections were welded, the plates expanded, causing microcracks in the concrete. These cracks would eventually leak, allowing moisture and chlorides to penetrate behind the connection plate. For early connections made of dissimilar metals, this was far more insidious a defect than a simple leak or water stain on a car.

Spalls along the edge of the double-tee flange are typically created by cor-rod-ing rebar at the older style flange connections. Microcracking around the connection due to the heat of welding allows chloride-laden moisture to penetrate down to the steel reinforcing.

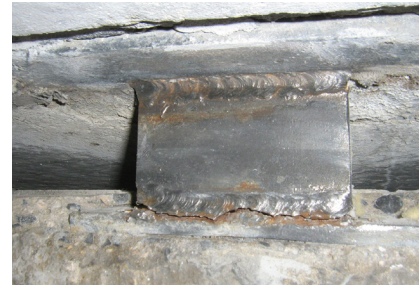
▲ Abrupt failure between tee and shear wall.

In early designs, this slug was located in line with the rebar that was attached to the backside of the plates to allow a smooth transition of tensile force across the joint. However, it also created very rigid connections between the tees and a very rigid deck. As the deck contracted during winter months, this rigidity caused excessive tensile stress to develop between shear walls. This stress caused many connections to abruptly fracture, often with a “bang.”

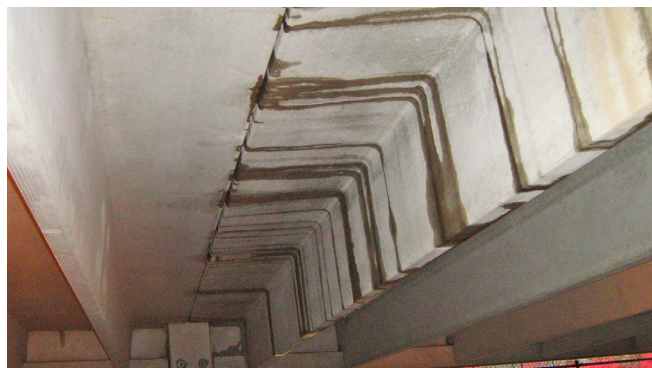
▲ Continuous leaks indicate failed sealant and, possibly, an unzipped joint.

Continuous Leaks: A leak that extends along most or all of a joint may indicate poor adhesion of the sealant, which has simply failed. However, this condition may also signal an “unzipped” joint, where all the connections have fractured. Without connections to limit the movement of the joint, the allowable stress on the sealant is quickly overcome, causing it to fail. It is helpful

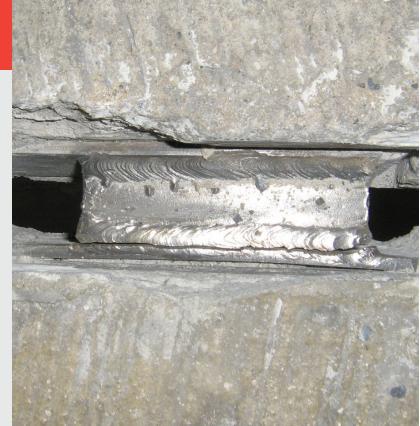
▲ Fractured flange connection caused by cyclical fatigue stress.

Shear connections are primarily designed to withstand loads from seismic events and from passing vehicles. As seismic shear forces are far greater than those created by vehicles, the latter were rarely considered, if at all. Regrettably, this oversight has proven consequential, as the repeated cycling of stress in the welds from garage traffic leads to eventual fatigue failure of the connections. This inherent design flaw is common to all previous and modern connections.

The first connections to fail are located at the center of the deck, where traffic is concentrated. These failures quickly spread along the joint through stress redistribution, until the entire joint is severed and the deck diaphragm destroyed. Such failures are readily identified by movement of the joint as vehicles pass over it. This movement quickly causes the overlying sealant joint to fail, creating a large leak along the length of the joint. Because such deterioration is commonly observed in precast garages, it is often shrugged off as little more than a nuisance. However, it is important to remember that these are seismic connections necessary for the stability of the garage. Loss of connections along a joint is a serious structural defect and a life safety issue.

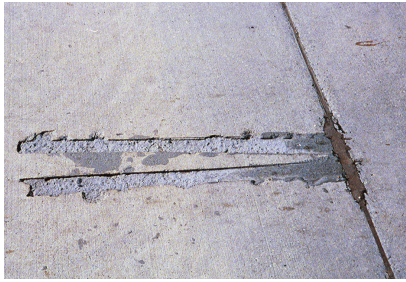
▲ Deteriorating connection repair.

both costly and short-lived. The repair requires concrete patches that are constantly stressed by flexing and movement of the embedded connection, causing them to prematurely fail.

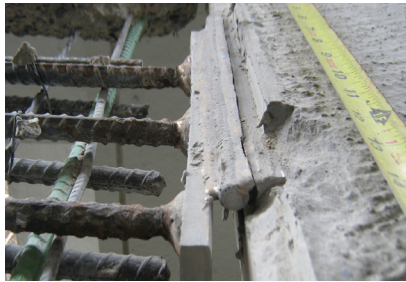
▲ Connection fracture from high slug position.

For some time, it became fashionable to move the slug up to the top of the plates, such that it was not in line with the rebar anchorage. This allowed the assembly to form something of a hinge, permitting the connection to open and close slightly. However, this placed prying forces on the welds, weakening the connections and

Remarkably, this attempt at stress relief was often extended to the chord connection, the sole purpose of which is to transmit large tensile loads. Intentionally forming such a hinge was a fatal defect that destroyed the connection. Their frailty was so pronounced that many of these connections fractured simply due to cold weather. Many garages still exist today with this inherent defect.

This configuration of the slug also had another unintended consequence: it tended to elevate the slug into the sealant joint where it quickly caused the sealant to wear through and leak.

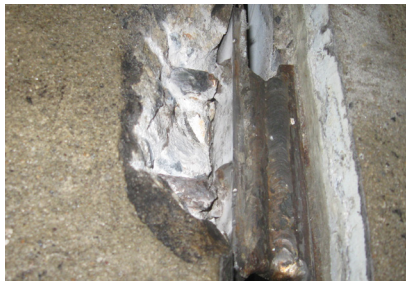
▲ Fractured rebar at flange connection.

Fracture of individual connections can be obvious, such as when concrete is spalled and rebar is visibly broken. However, other connections can be compromised without any visible signs. Fatigue fractures typically occur at center connections first and spread along the joint to the outer connections. Until enough connections have failed, there is no visible movement

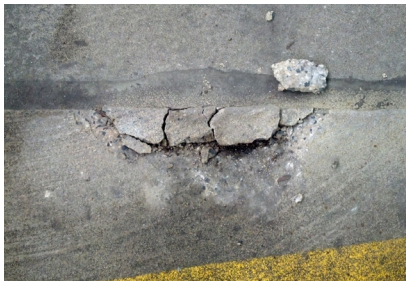
▲ Edge spall.

While they may look innocuous, edge spalls point to a serious condition. This latent defect potentially affects all such connections in the garage. By the time one connection has degraded to spall the concrete, many more have already been irreversibly affected. These connections are numbered in the thousands, so early detection is key to mitigating deterioration and extending the service life of the garage.

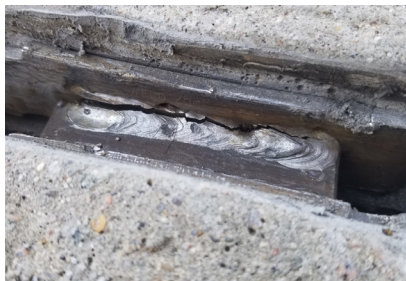
▲ Failed connection due to fatigue stress.

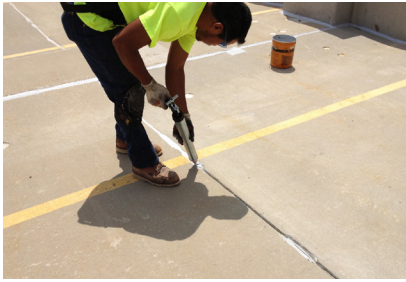
▲ Replacing sealant at a garage's top deck.

Sealant Replacement: A sealant joint replacement project is an expensive endeavor. Installed correctly, this investment can be expected to last 10 to 15 years. However, this range can be greatly extended through periodic inspection and routine maintenance.

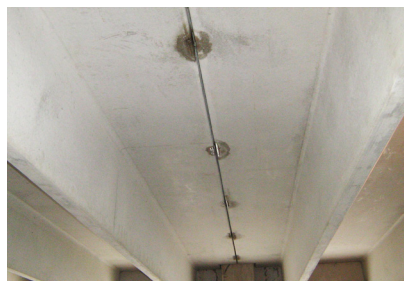
▲ Leaks at connections due to welding.

Intermittent Leaks: Are the leaks located at connections? This can be caused by a poorly performed sealant joint or by slugs intruding on the sealant, either of which should be noticeable from above. If there are no obvious defects in the sealant, the adjacent concrete may have cracked due to welding of the connection. If the connection is the older style, attached to embedded rebar, then this is a serious issue that will cause the connection to degrade and eventually fail. In any case, such defects should be assiduously repaired and maintained.

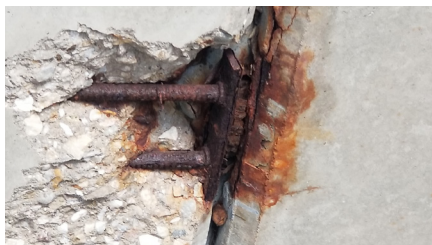
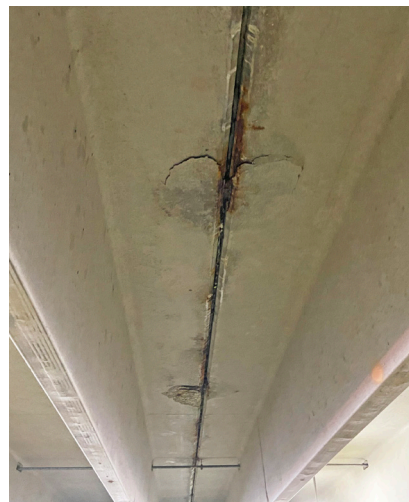
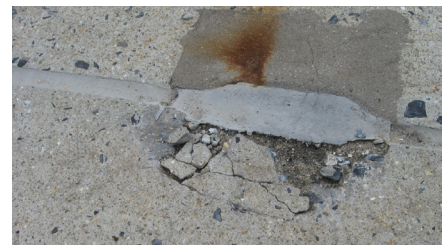
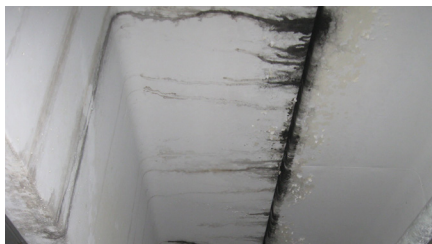
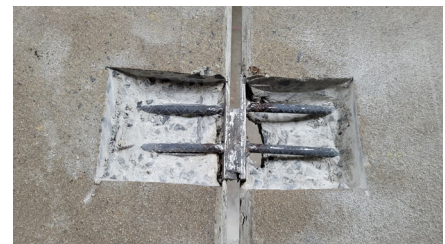
▲ Clockwise from bottom left: Soffit discoloration due to leaks, corrosion at an overhead edge spall, spalled concrete ready to fall, failed patch repair at an edge spall, and repair in progress for dissimilar metal corrosion of reinforcing bars.

Soffit Cleaning: An important part of any sealant joint repair and replacement project is cleaning the water stains on the ceiling below the leaking joint. This is not just an aesthetic concern; it is difficult to locate leaking joints on a deck soffit that has never been cleaned. Conversely, leaking joints are easily detectible on a clean soffit just by the tell-tale water stains.

As with spalls at the drive surface of the deck, overhead spalls are typically caused by corroding rebar at older style connections. The difference is that overhead spalls tend to remain undetected until they fall, creating a hidden overhead hazard. Unfortunately, overhead spalls also do not typically occur in isolation; once one is detected, more will soon follow. Vigilance is then warranted to maintain a safe garage.

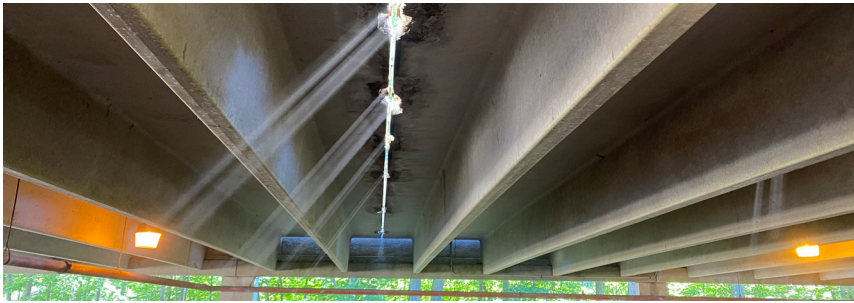
▲ Daylight shines through an open flange-to-flange joint during a connection repair project.
