Hoffmann Architects

Journal of architectural technology published by Hoffmann Architects, specialists in exterior rehabilitation

Wish You Had A Crystal Ball? Projecting Your Building Envelope Maintenance Needs

Richard P. Kadlubowski, AIA

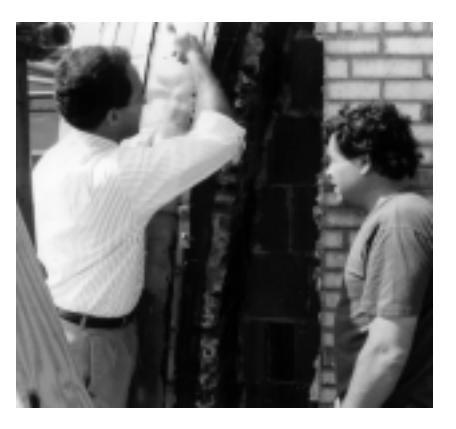
Accurately forecasting building envelope needs requires an in-depth look at current conditions. Here, one of the firm's senior architects (left) investigates deterioration in the masonry wall of a commercial high-rise.

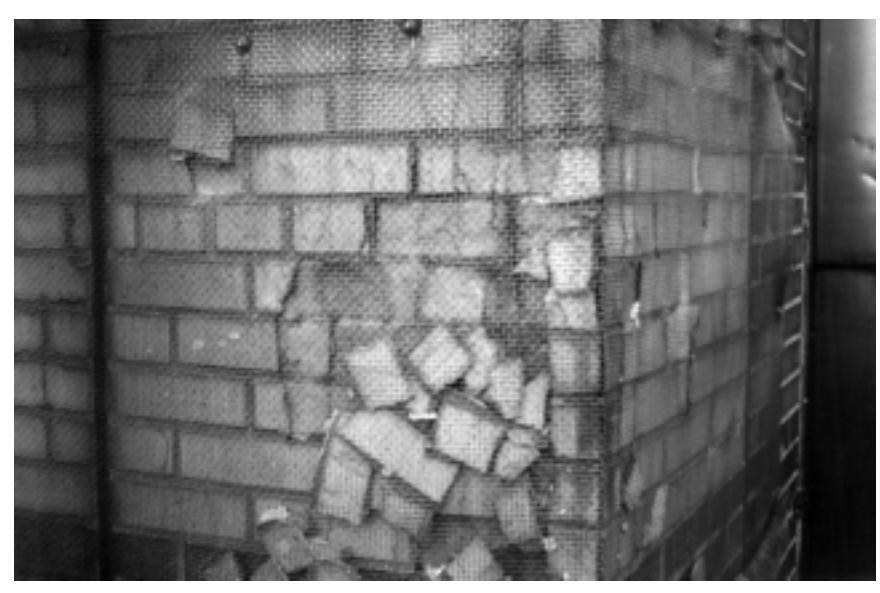
While budget constraints may necessitate stop-gap measures such as this (wire mesh installed to prevent spalled brick from falling multiple stories to the ground below), the underlying cause of the deterioration shouldn't be overlooked. This brick corner and three others like it had gone unrepaired for many years, and ultimately had to be fully reconstructed, including replacement and re-positioning of the steel relieving angles.

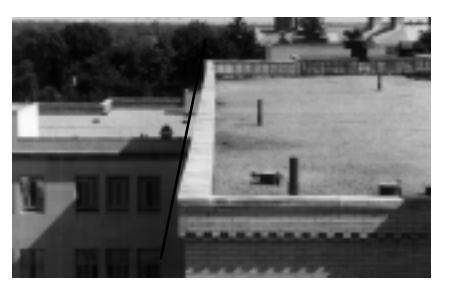
Often, building envelope deterioration problems can be traced to flaws in the original design. Here, the lack of expansion joints was identified as a major factor in the deterioration of this parapet and facade.

With no accommodation for the natural expansion and contraction of the brick face, this parapet wall, over time, began to roll inward. (The proper alignment is indicated by the red line drawn on the photo.)

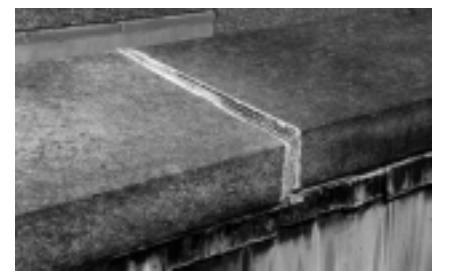
That movement of the parapet wall resulted in displacement of the coping stones, creating in some cases — as shown here — up to a one-half inch differential in the stone surfaces. Aging sealant joints experienced cohesive failure under the stress, and led to openings into the wall, permitting water entry.

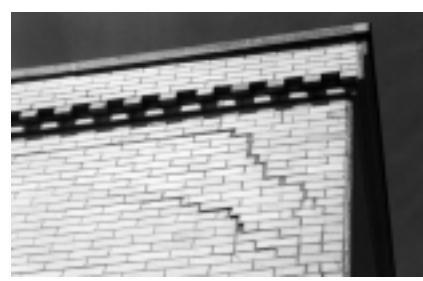
The ongoing stress also caused the displaced brick and sheared mortar joints shown here. Without repair, water may ultimately reach the embedded structural steel, causing rust and expansion, further displacing the brick facade.

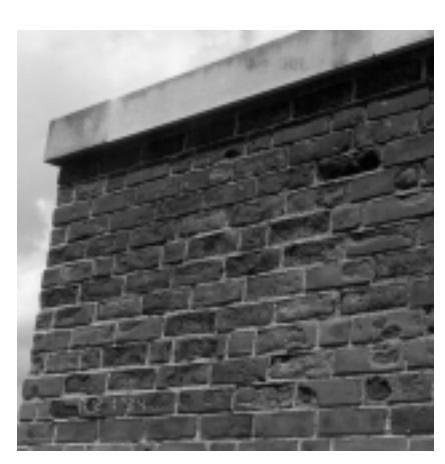
When the face of a brick, or of any other piece of masonry, falls off, the cause is almost always due to moisture within the wall. Left unrepaired, this spalling will lead to increased water penetration, creating further spalling, and finally, to complete deterioration of the bricks shown here and intrusion of water into adjacent brick and the entire wall system.

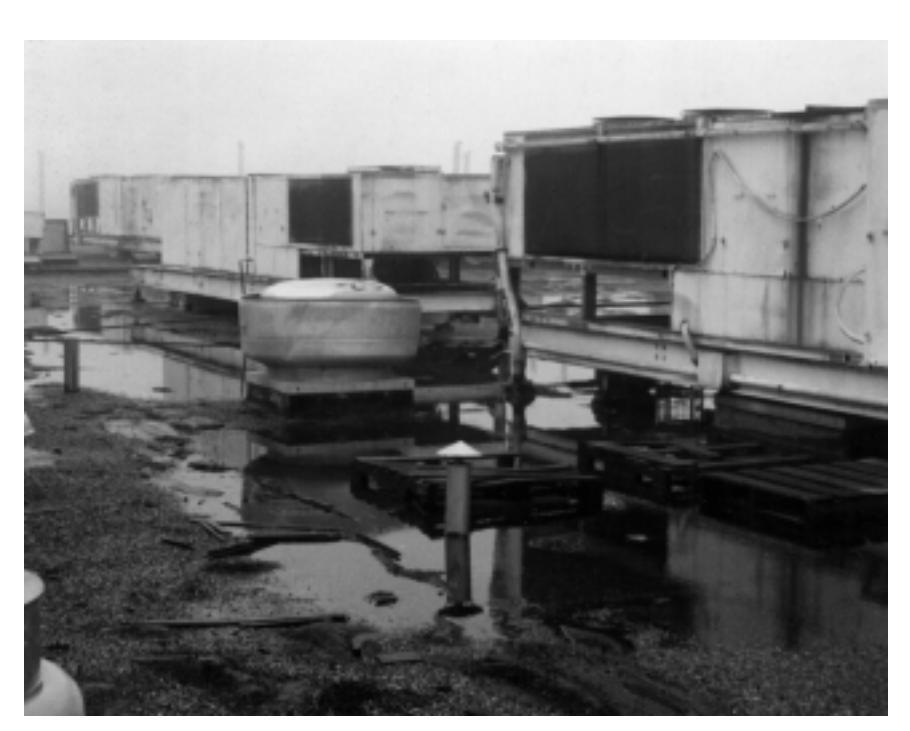
This is what happens when the small details of maintenance and regular inspection are overlooked. In this case, scoured and missing gravel surfacing should have been replaced to provide the necessary UV protection for the built-up roof. Blisters should have been repaired. Areas of ponded water should have been investigated to see if drains were clear or if drainage improvements were needed.

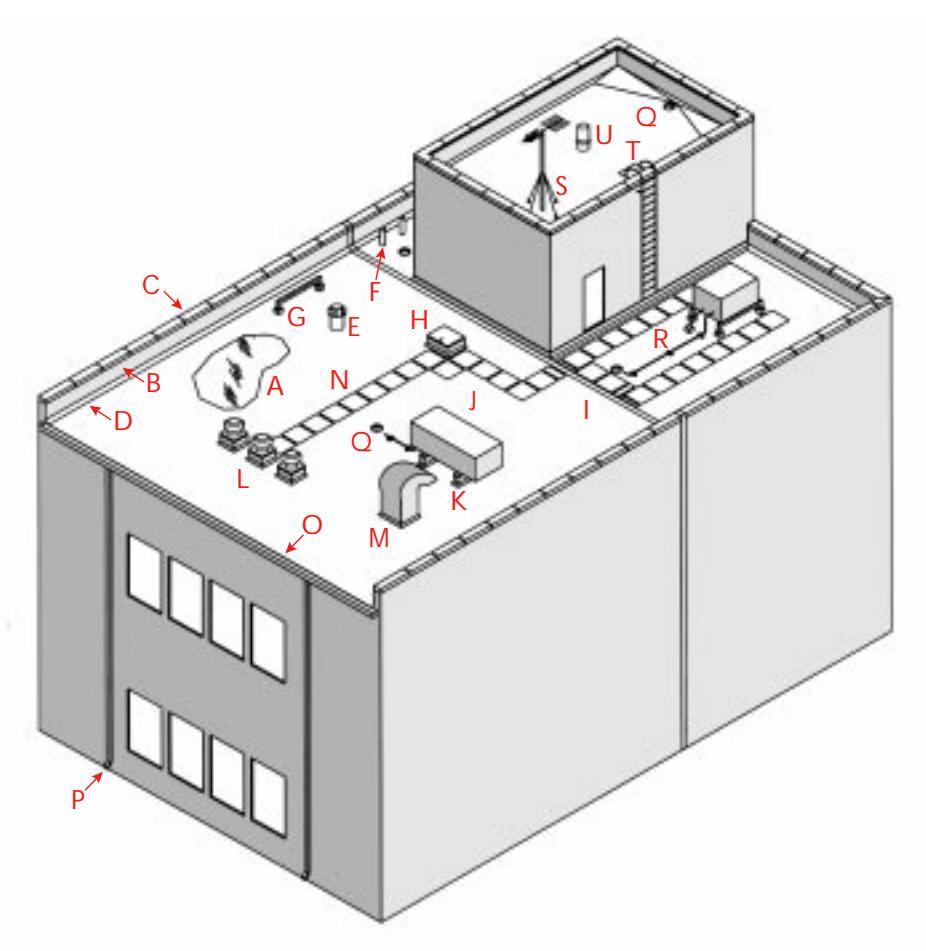
This building isometric shows key trouble spots that should be inspected regularly to help avoid more extensive and costlier deterioration and reduce the need for emergency repairs.

K nowing the roof's "hot spots" the places where deterioration typically occurs — can help reduce the number of emergency roof repairs a building may need. The best way to prevent major roofing problems is to conduct visual inspections every six months and make all needed repairs, large or small, as soon as possible. Put these trouble spots — described below and highlighted in red on the building isometric shown here — at the top of your regular inspection checklist:

• Ponded water (A) — puddles that stay on the roof for more than two days after a rainfall — provides a constant source of water for potential leaks in the field membrane.

• Parapets (B), copings (C), and expansion joints (I) are a major source of leaks. For example, water that gets into the parapet can enter the roof system below the terminations and flashing, and enter the building through points below the roof.

• Bent or loose counterflashing (D) can open the way for water entry into the walls and roof flashings.

• Roof penetrations are prime candidates for water entry and resulting deterioration of the roofing system. The vent (E), vent pipes (F), penetration pocket (G), roof hatch (H), rooftop equipment (J), equipment supports (K), fan unit (L), fan hood (M), pipe supports (R), antenna (S), ladder (T), and hot stack (U) are examples of danger spots.

• Gutters, downspouts, and drains (O, P, and Q) should be kept clean and free of debris to maintain good drainage and eliminate standing water.

• Walkway pads (N) should be present to prevent damage to the roof membrane from foot traffic. ■

- A. Ponded water
- B. Parapet
- C. Coping
- D. Base flashing/counterflashing
- E. Vent
- F. Vent pipes (stacks)
- G. Penetration pocket
- H. Roof hatch
- I. Expansion joint
- J. Rooftop equipment
- K. Equipment support

- L. Fan units
- M. Fan hood
- N. Walkway pads
- O. Gutter
- P. Downspout
- Q. Drain
- R. Pipe supports
- S. Antenna
- T. Ladder
- U. Hot stack

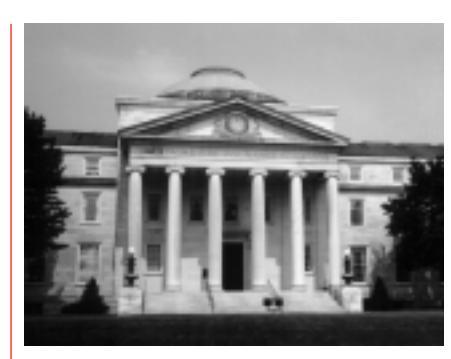
The Hartford's *Master Plan for Facade and Roof Rehabilitation* outlined the repair projects slated for each year, with a schedule for the work and roof plans and facade elevations that detailed areas of work to be performed.

Built in the 1920s, The Hartford's original granite building, with its distinctive copper dome and slate roofs, has been expanded over the years, transforming the complex into a single structure 5-1/2 times the size of its original footprint. Hoffmann Architects surveyed the structure to identify repair and rehabilitation requirements for the roofs and facades. As a result of the survey, the owner embarked on a planned restoration program with a set budget and a four-year time frame. Hoffmann Architects developed a logical progression of work that provided a detailed description of each needed repair and prioritized those repairs based on areas of greatest need.

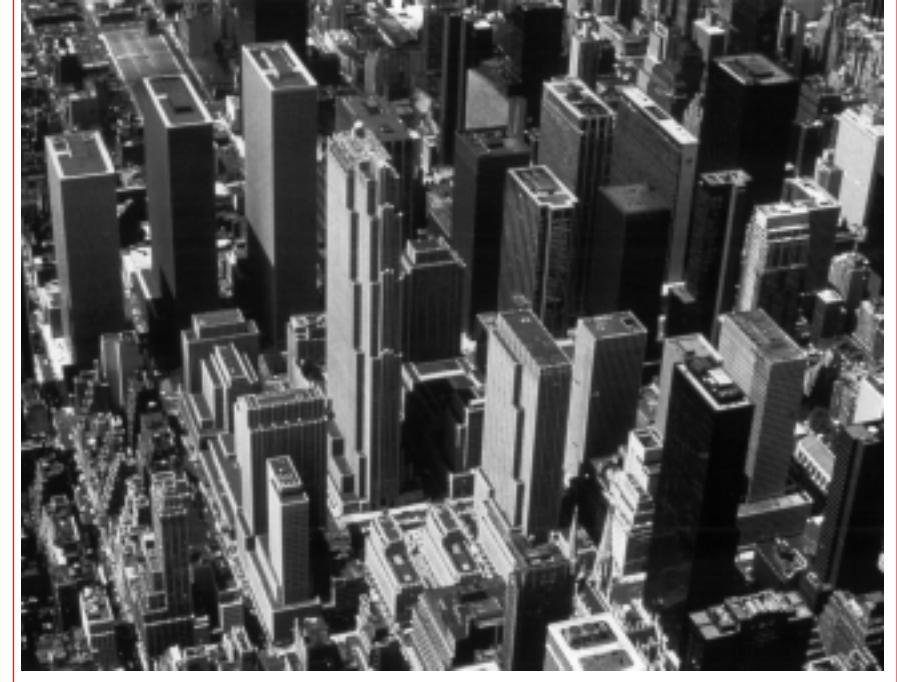
Rockefeller Center's *Exterior Rehabilitation Master Plan* is updated annually to reflect changes in building conditions and document the previous year's repair projects.

Hoffmann Architects developed a comprehensive master plan to help the owner, Rockefeller Center Management Corporation, do just that. The award-winning rehabilitation plan addressed facade and curtain wall restoration, roof replacements, waterproofing, and historic preservation for this National Historic Landmark, which dates to 1931. Based on the firm's in-depth evaluation of existing conditions, the plan set priorities, budgets, and schedules for each building and repair project. With assistance from Hoffmann Architects, the owner has used the plan extensively to select and manage upcoming projects, weighing costs and priorities for the various repair projects against budget considerations.

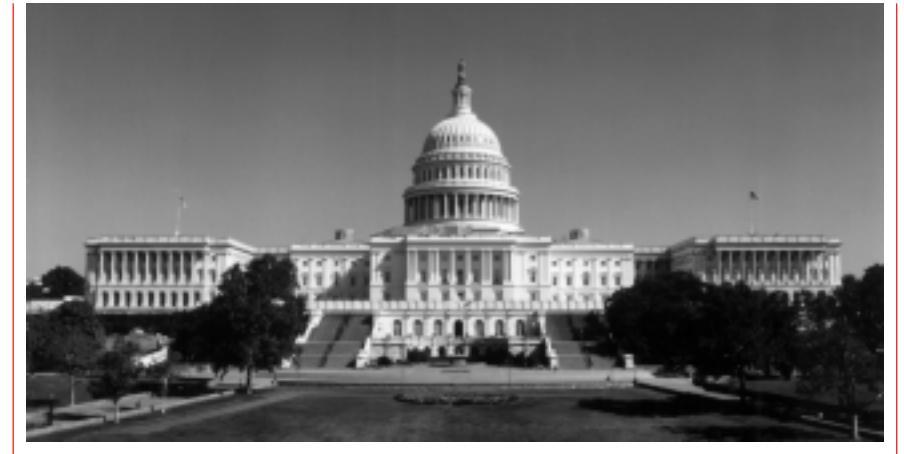
Hoffmann Architects was asked to develop a *Restoration Master Plan* to guide the complex and painstaking restoration of the Dome of the United States Capitol.

Hoffmann Architects was commissioned by The Architect of the Capitol to develop a master plan for the restoration of the cast-iron dome of the United States Capitol, which was completed in 1863. The master plan addresses maintenance, repair, modification, and restoration work for all systems, spaces, and finishes from the floor of the Capitol Rotunda to the top of the Statue of Freedom, as well as adjacent areas. The master plan was the outgrowth of a 1991 award-winning study Hoffmann Architects conducted that investigated the causes of ongoing water infiltration problems at the dome. Since then, some repair work was initiated, based on the firm's design recommendations and contract documents. During the course of this work, however, it was discovered that adjoining spaces would be affected by the repairs and that protection for the work would have to expand into areas where no work was previously planned. To that end, the master plan helped identify and coordinate all repair work. Much

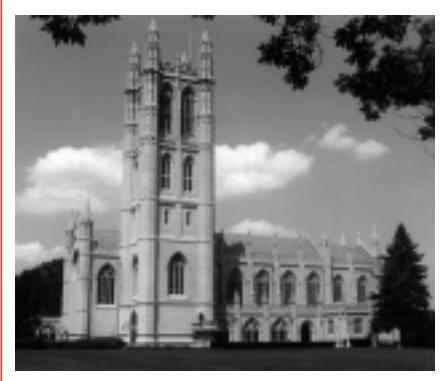
Trinity College's *Rehabilitation Master Plan* included documentation of existing conditions, a schedule of repair based on priority and budget constraints, and associated cost estimates for each segment of the work.

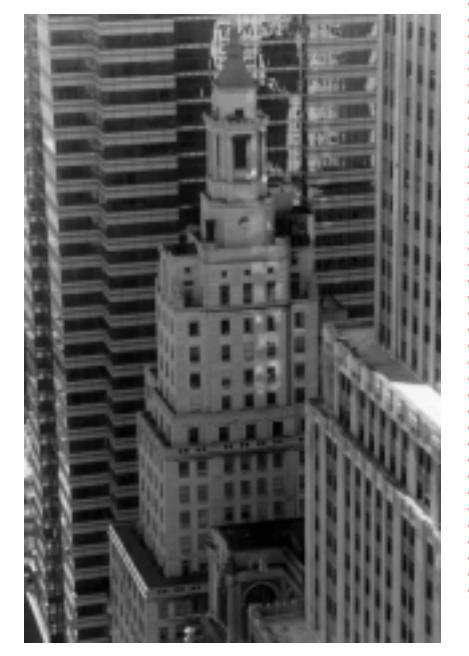
The complexity of the multiple facade rehabilitation needs at The Bank of New York prompted the creation of an in-depth master plan to guide the phased restoration work.

Faced with numerous deterioration problems at the facades and roofs of this 52-story structure, built in 1932, and its 30-story annex addition, The Bank of New York commissioned Hoffmann Architects to conduct an exterior conditions survey and develop a master plan for exterior restoration. The master plan delineated a five-year phased construction program of roof and window replacement, facade and mortar repair, and facade cleaning. Some cost economies were gained by organizing the work to avoid duplication of the protective sidewalk bridging needed at various stages of the work.
