# JOURNAL

First Issue 1997 Volume 15 Number 1

## Copper Roofing: An Enduring Link Between Past and Future

**Arthur L. Sanders, AIA**

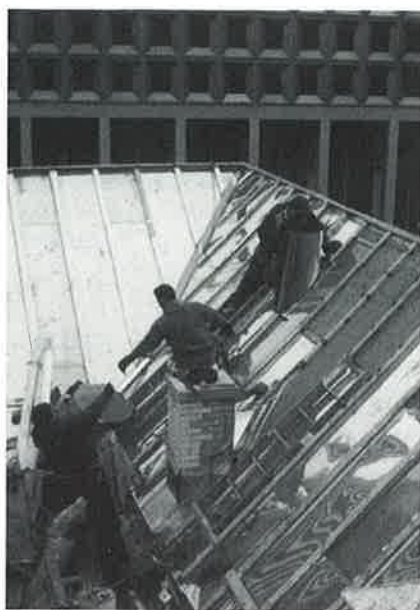
Installation of a batten seam copper roof on a New York City high-rise office building.

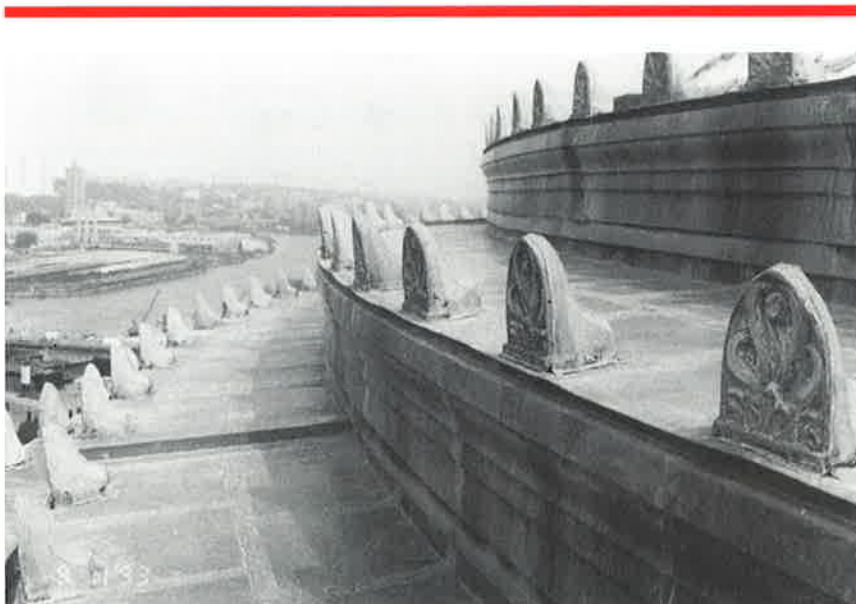
A previous attempt to solder over these failed flat seam joints was not successful.

In most situations, deteriorated copper should be removed and replaced with new material, as patching is not usually feasible or reliable. Attempting to re-solder seams, for example, will serve only to aggravate the problem of failed seams. Whether installing a new copper roof or replacing an old one, the following recommendations will help ensure the best performance:

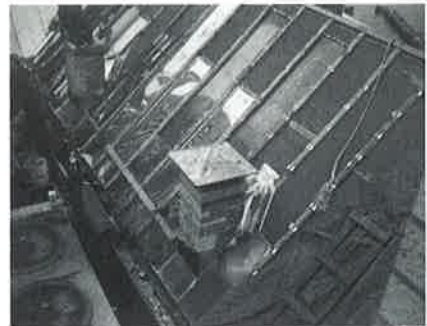
Standard industry details must often be customized to specific field conditions.

A roof is only as good as it's designed to be, and copper roofing is no exception. Detailing must be exacting, and go beyond industry standard details to address specific field conditions to achieve the best result. For copper roofing, it's vital to create details that shed, rather than trap, water. The following section looks at some of copper's specific problem areas and ways to avoid these during installation or repair.

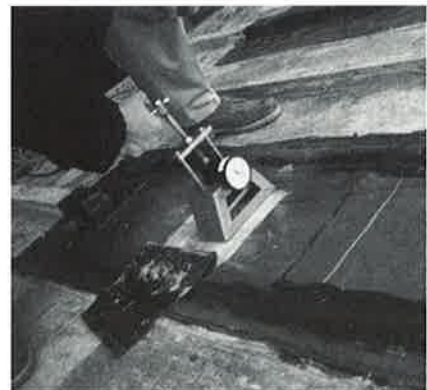
The substrate must be tested for pull-out resistance to determine the most appropriate fasteners.

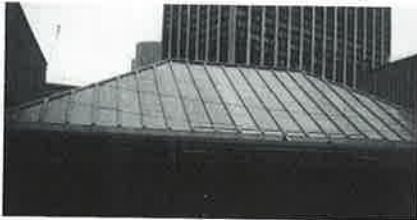
The finished batten seam roof provides strong visual lines.

creation of unique shapes. Batten seams are created by using copper panels, set parallel to the roof slope, which are separated by a wood batten. This batten provides the framework for the distinctive box shape of the seam. The batten cap provides water-tightness while accommodating expansion.

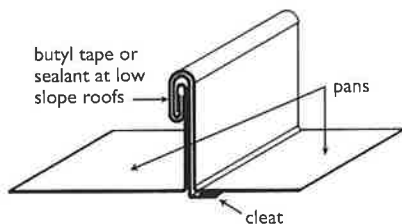
Standing Seam

Batten Seam

Flat Seam

Illustration B: Each of the three seams above is best suited to a specific roof condition or design.

There are three basic types of copper roof designs, with each offering a specific benefit to meet a given field condition or design intent. Illustrations of the seam types used in these roof designs are shown on page 6.

*Flat seam roofs* are unique to copper and are usually found on a low-pitch roof (below 1"-in-12") or on curved surfaces, such as domes and barrel vaults. Flat seams are either *flat-locked* or *soldered*, depending on the roof slope. Typically, the greater the slope, (continued on page 8)

The *standing seam roof* is either field-formed or constructed of pre-formed panels of 18" to 24" widths which are placed parallel to the roof slope and joined to other panels using a double-locked standing seam.

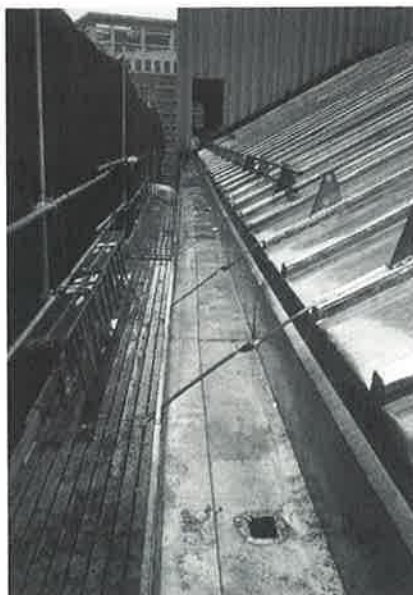
A batten seam roof edge with hung gutter and snow guards.

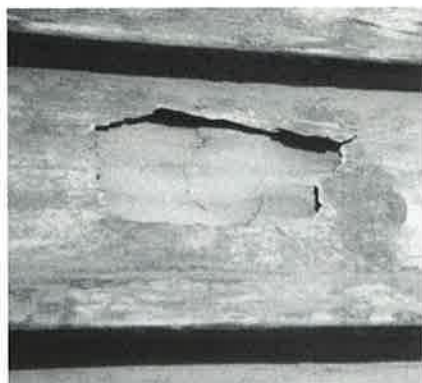
This copper roof failed — after 70 years of service and acid rain.

- Copper is susceptible to corrosion from contact with alkalis, ammonia, some bituminous roofing cements, masonry cleaners, and acidic rainwater (run-off water in contact with moss, lichen, algae, wood shingles, or airborne sulfur dioxide). While the copper patina provides some level of protection from acidic moisture, copper roof valleys, gutters, and skylight frames are particularly susceptible to its damaging effects. That's because moisture tends to linger in these vulnerable areas, giving the acid more time to act on the copper.
