Journal

Copper Roofing: The Original Green Roof

Juan Kuriyama, AIA and William Hayes, Assoc. AIA

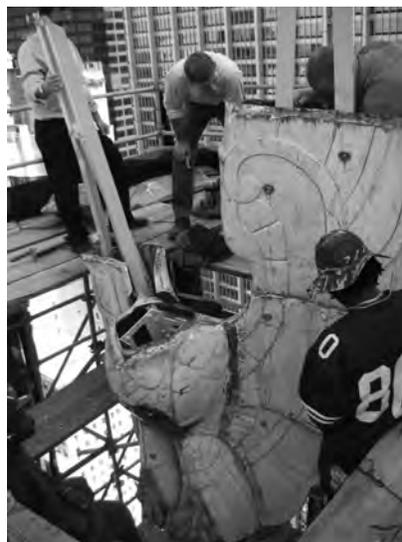
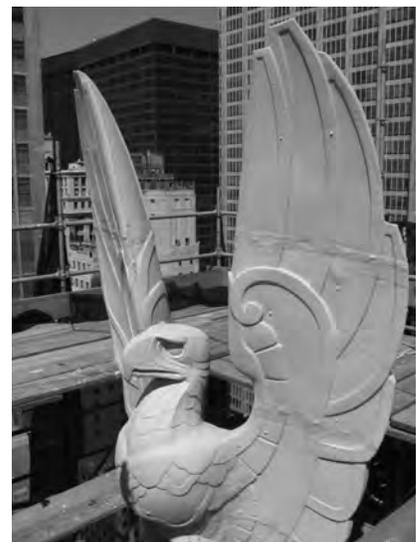
▲ Beyond roofing, copper is also used for ornamentation. Restoration of this copper eagle atop a 1929 high-rise involved off-site and on-site repair, cleaning, and reconstruction.

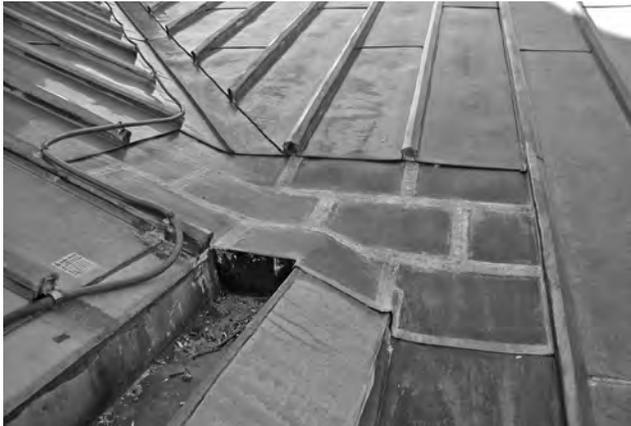
▲ Unusual conditions, such as this combination of soldered flat-seam roofing with steep-slope batten-seam, demand customized designs.

Unique to copper roofs, flat seam construction is generally reserved for low-slope roofs or curved surfaces, such as domes or vaults. Cold-rolled copper sheets are folded over at adjacent sides, with copper cleats installed in the seams. Typically, the longitudinal seams are continuous, whereas transverse seams are staggered. For slopes of 3"-in-12" or less, the flat-locked seams are soldered to improve water-tightness.

With its characteristic box-shaped seams, batten seam construction is commonly used on domes, barrel vaults, and cupolas to create a dramatic roof line. Like standing seam roofs, batten seam construction positions copper pans parallel to the roof slope.

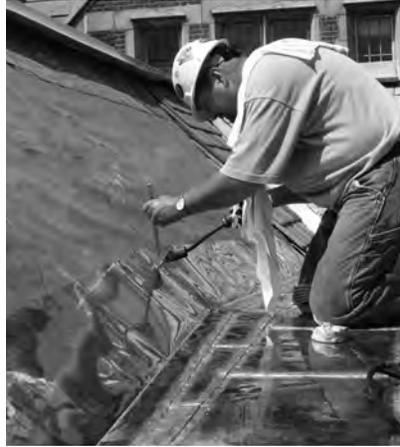
▲ Application of lead-tin solder to a flat-seam copper roof.

With proper design and detailing, sealants are generally unnecessary on copper roofs. The lifespan of copper is significantly longer than that of most sealants. If sealant is used on a copper roof, it must be routinely inspected, maintained, and replaced, adding substantially to maintenance demands. Where appropriate, such as on low-slope flat-seam roofs, solder should be used rather than sealant. For rehabilitation applications, it is preferable to open the seam, remove the existing solder, and re-form and solder the joint.

Solder is not the solution to all copper repair problems, however. Because the coefficient of expansion for lead-tin solder is different from that of copper, solder used to fill stress cracks will eventually break away. If cracking and metal fatigue are widespread, it may be time to consider roof replacement.
