Journal

Windows:

An Integral Part of the Building Envelope

Juan Kuriyama, AIA and Bradley Carmichael, EIT

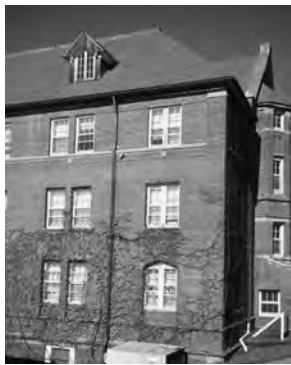
Double-hung

Single or double hung. Two sashes that slide vertically in adjacent planes. "Single hung" refers to one operable sash, "double hung" to two. Taller openings may have triple hung windows. Although familiar to many homeowners, this window type is also widely used on high rises, due to its ease of operation and good wind resistance.

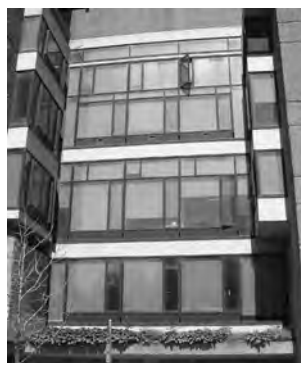
Casement

Casement. One or more sashes that swing outboard or inboard from the vertical frames. Although common on residential applications, consideration must be taken with high-rise commercial use, because the sash and hardware have lower wind pressure tolerance.

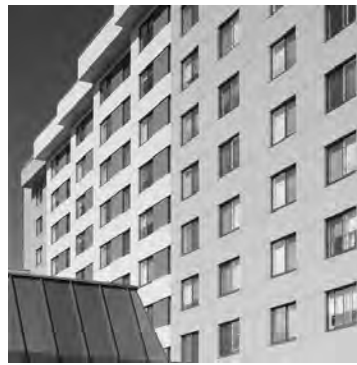
Sliding

Sliding. Operate like their single- or double-hung cousins, but slide horizontally, rather than vertically. Maintenance of track hardware to remove dust or accumulated particles is critical for proper operation.

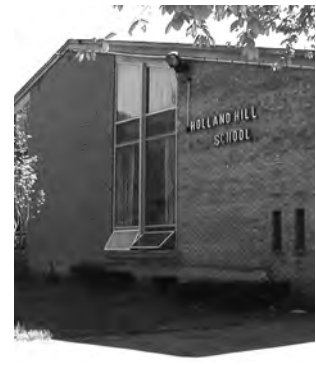
Awning

Awning. One or more sashes that swing outboard from the upper frame. Their name derives from the weather protection offered by the window in the open position, when it creates a canopy-like projection above the opening.

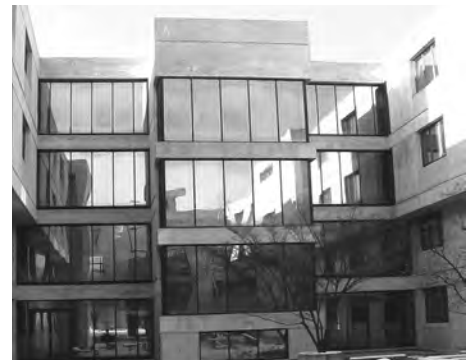
**Fixed**

Fixed. Do not need operable hardware, and so achieve the maximum glass area for a given opening. Also known, more familiarly, as “picture windows.”

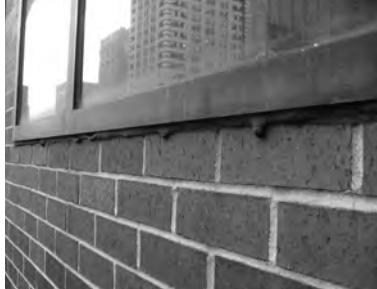
Sealant failure at window exterior.

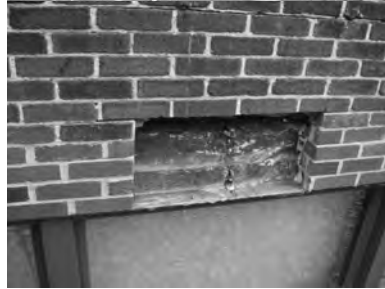
Damaged flashing at window head.

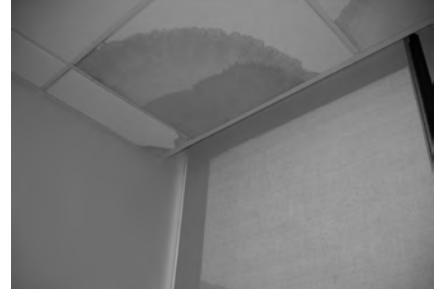
Water intrusion and interior damage.

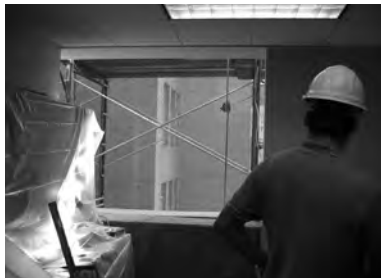
Window removed; wall opening ready for replacement window installation.

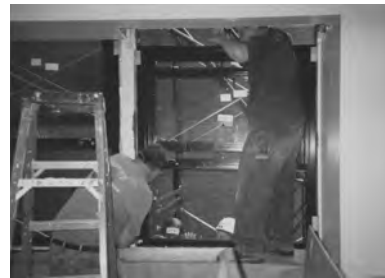
Installation of replacement windows.

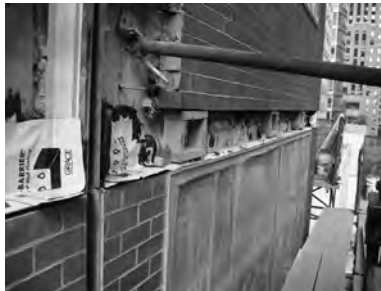
Installation of new flashing at window head.

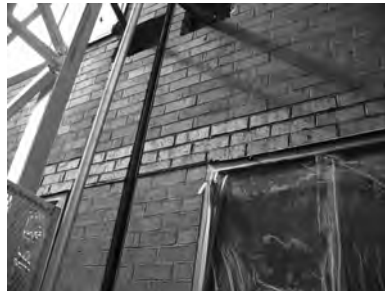
Reconstruction of brick exterior wall after flashing replacement.
