Journal of architectural  
technology published by  
Hoffmann Architects, Inc.,  
specialists in the rehabilitation  
of building exteriors.

## Brick Maintenance and Repair for Historic and Landmark Structures

Arthur L. Sanders, AIA and Kevin Magness, AIA

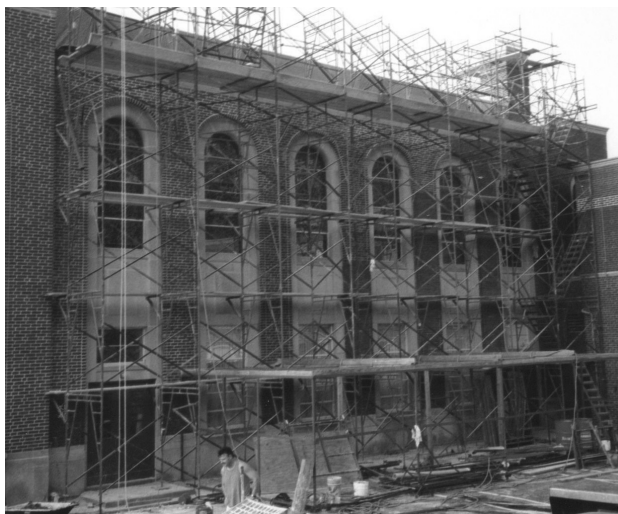
▲ Thoughtful organization of repair work will minimize disruption and costs associated with erecting scaffolding and construction equipment.

If budgeting permits, it makes economic sense to do all needed repairs at the same time to avoid incurring additional set-up costs. Scaffolding, sidewalk bridging, and other protective measures are expensive to take down and resurrect, and tenants will experience less disruption with only one construction

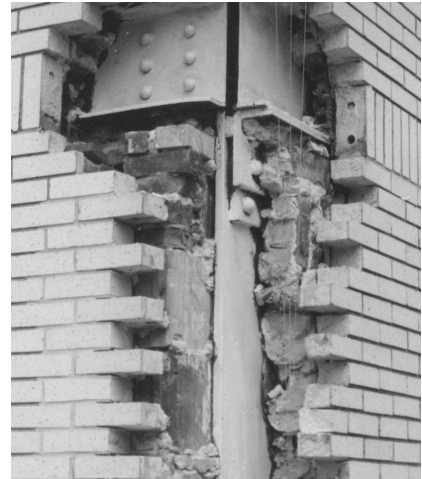
▲ Addressing the root causes of masonry distress avoids wasting time and money on duplicate repairs. Here, replacing rusting steel supports before rebuilding the face brick provides a long-lasting solution.

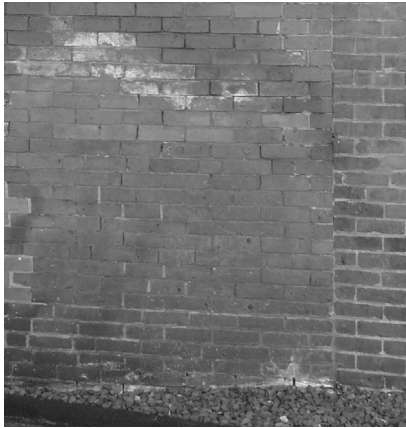
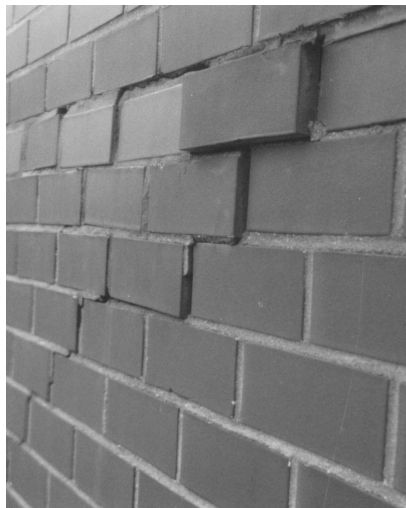
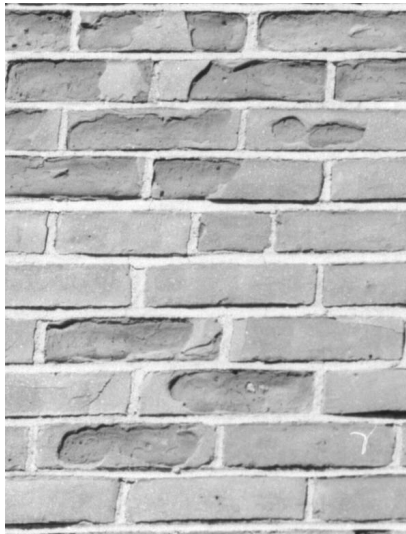
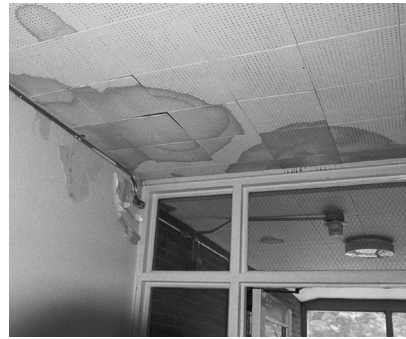
**A** Signs and symptoms of masonry distress include: (starting at left, top to bottom) efflorescence, displaced brick, surface spalling, (at right, top to bottom) interior water damage, deteriorated mortar, and cracking at building corners.

- efflorescence (a powdery residue on the brick surface; results from water-soluble salt deposits)
- spalling (missing or loose pieces of brick face)
- mortar joint deterioration (look for mortar that has softened, broken apart, or cracked)
- loose, cracked, or displaced bricks
- visible moisture damage (building interior or exterior)
- mold or plant growth on masonry surfaces

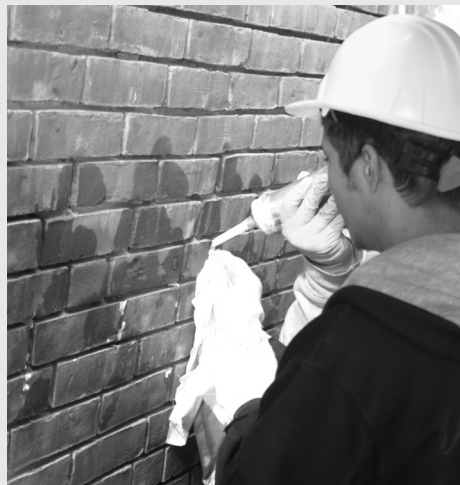
▲ Workers inject mortar into the thin joints of a historic building.

Once mortar has been selected and the joint prepared, mortar should be prehydrated and then packed into the joint in thin layers. Because most mortar shrinkage occurs during the hardening process, allowing each layer time to harden before the next is applied minimizes overall shrinkage.

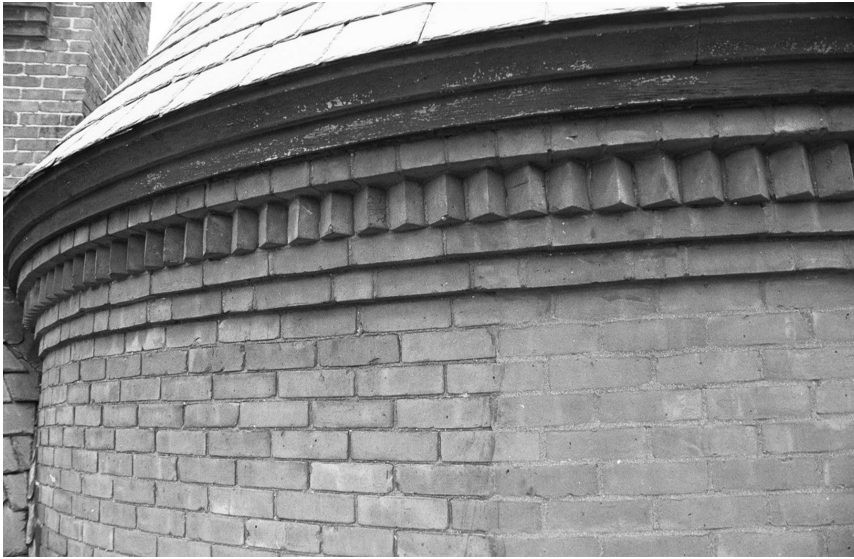
**A** Failing to match the width and tooling profile of mortar joints when repointing can result in dramatic differences between original and newly repointed sections.

To maintain the aesthetic quality of a historic or landmark building, it is necessary to examine the original techniques used in masonry construction. Pointing styles on both horizontal and vertical joints must be carefully noted, as these may differ, as might those on the different facades. Replicating original techniques as closely as possible will minimize visual discrepancies between newly repointed sections and those with original mortar intact.

When mortar is firm, joints should be tooled to the original profile. This is especially important if only portions of a wall area are to be repointed. If old bricks have worn, rounded edges, it's best to recess the final mortar slightly from the brick face. Not only does this treatment keep new joints from appearing wider than existing ones, it also avoids creating thin feather-edges which can break off easily and so admit water.
