Copper Roofing: The Original Green Roof

By Juan Kuriyama, AIA

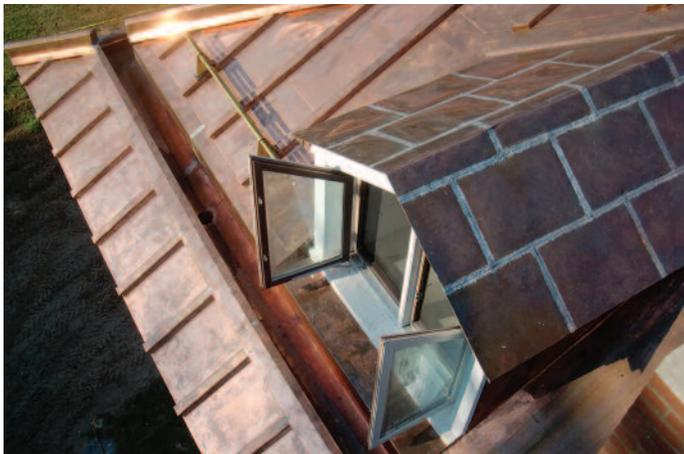
Known for its striking appearance, copper is also a strong environmental choice, given its longevity, recyclability, and low embodied energy.

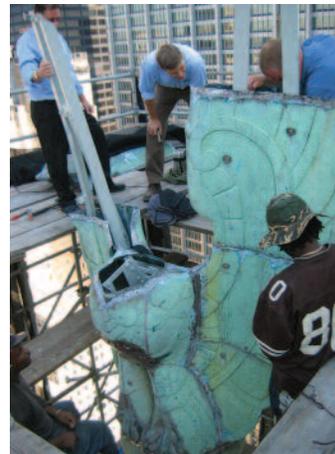
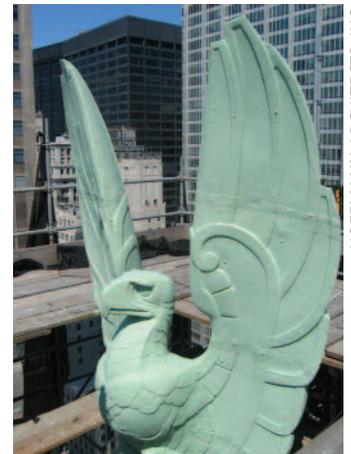
Beyond roofing, copper is also used for ornamentation. Restoration of this copper eagle atop a 1929 highrise involved offsite and onsite repair, cleaning, and reconstruction.

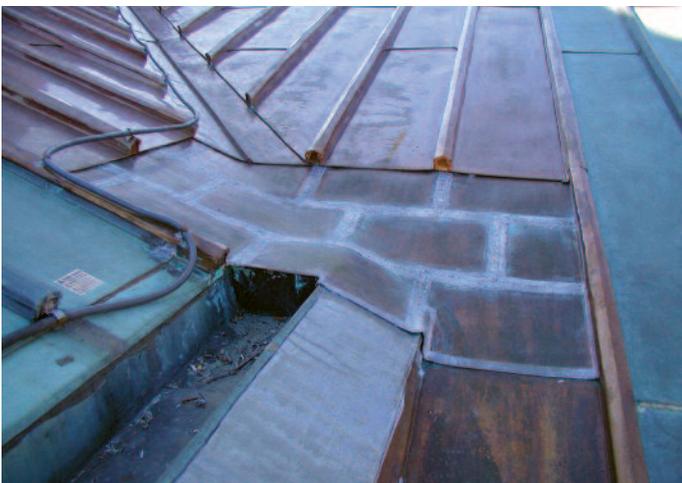
Unusual conditions, such as this combination of soldered flat-seam roofing with steep-slope batten-seam, demand customized designs.

Flat Seam

Unique to copper roofs, flat-seam construction is generally reserved for low-slope roofs or curved surfaces, such as domes or vaults. Cold-rolled copper sheets are folded over at adjacent sides, with copper cleats installed in the seams. Typically, the longitudinal seams are continuous, whereas transverse seams are staggered. For slopes of 3”-in-12” or less, the flat-locked seams are soldered to improve water-tightness.

Batten Seam

With its characteristic box-shaped seams, batten-seam construction is commonly used on domes, barrel vaults, and cupolas to create a dramatic roof line. Like standing-seam roofs, batten-seam construction positions copper pans parallel to the roof slope. Panels are separated by

wood battens, which are covered with copper batten caps that are loose-locked to adjacent pans to accommodate expansion and contraction.

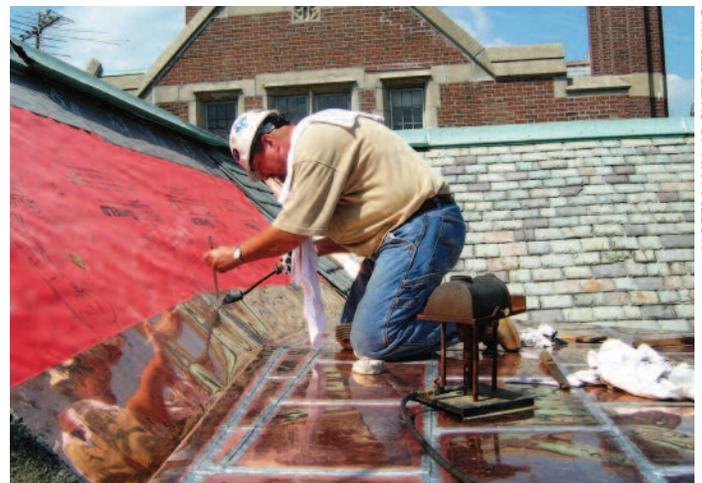
Application of lead-tin solder to a flat-seam copper roof.

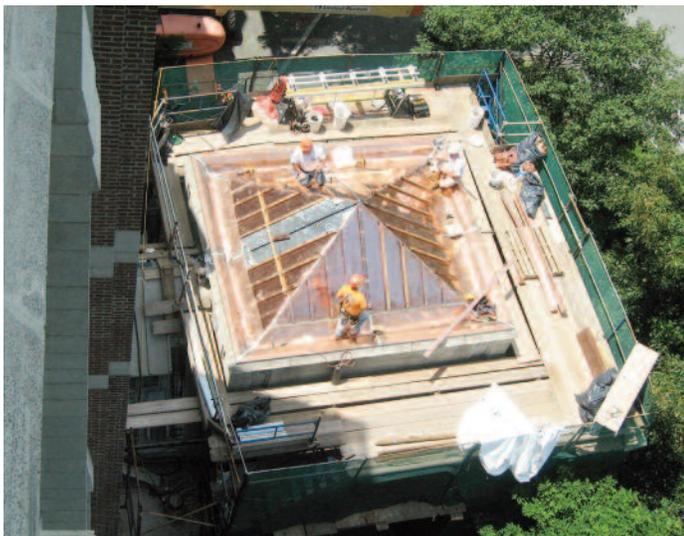
A long-lasting and durable metal, copper can withstand many years of service.

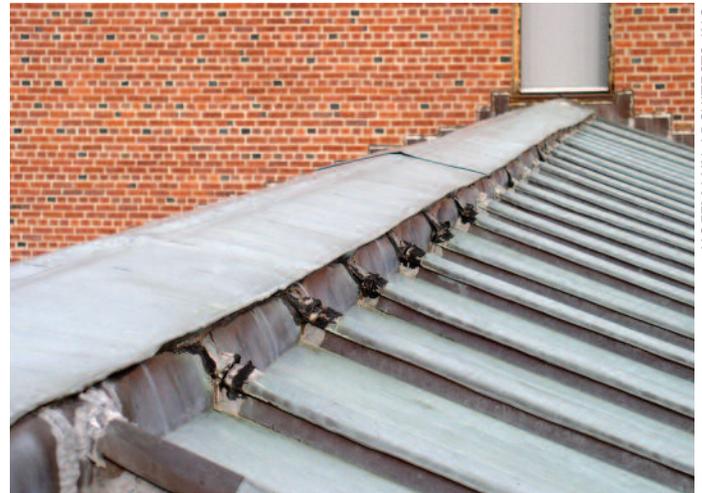
Incompatible materials and inappropriate repairs can substantially shorten the lifespan of a copper roof.

The good news is that all of the above sources of premature failure are avoidable. Unfortunately, incorrect design, poor detailing, incompatible materials, and inexpert repairs can substantially shorten the lifespan of a copper roof.

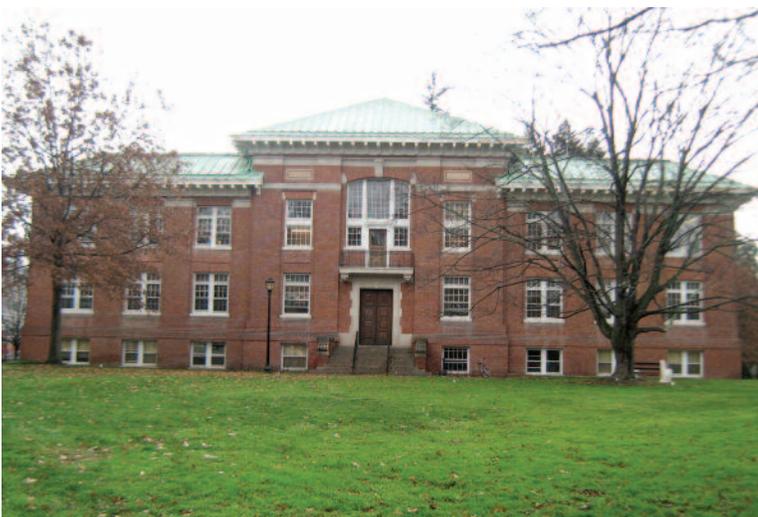
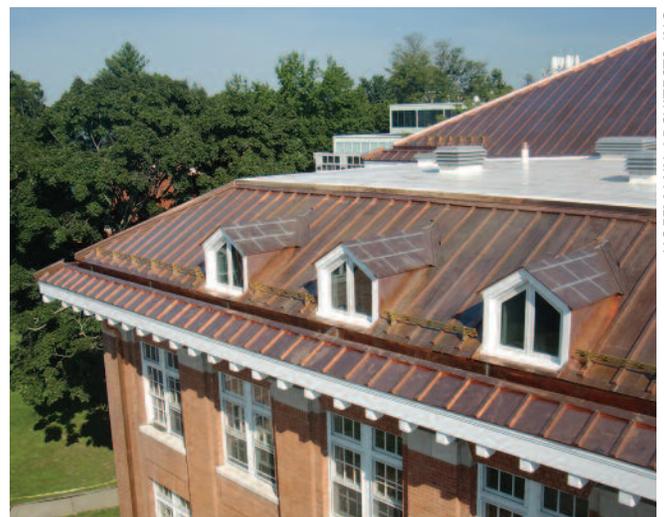
Unfortunately, copper roofs don't last forever—especially when inappropriate repairs and atmospheric pollution conspire to degrade the roof prematurely. Copper roof replacement returned this 1909 neoclassical academic building to its original appearance.

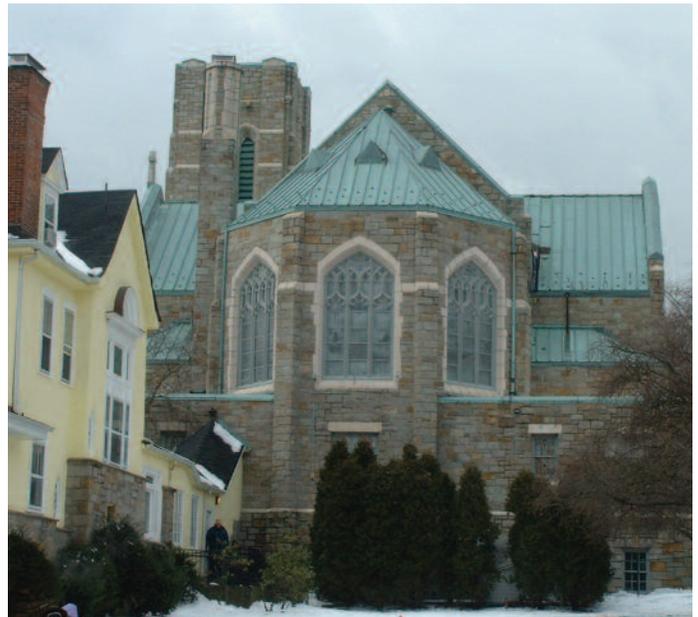
Restoration of the historical copper roof on this 1928 English Country Gothic church served the needs of the structure while meeting budgetary, scheduling, and aesthetic objectives.

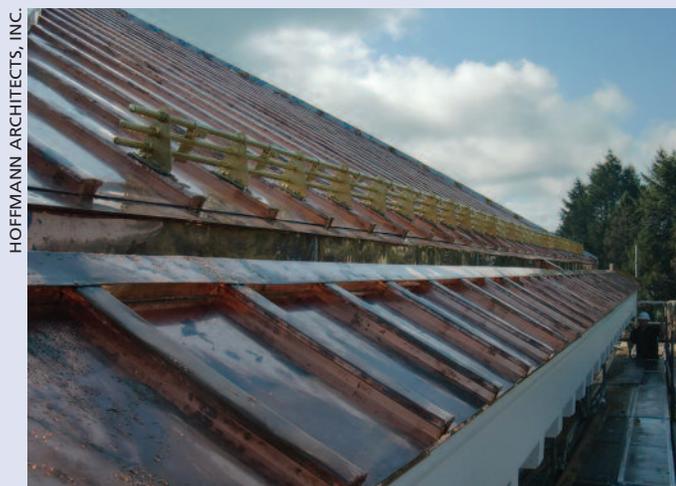
Studies suggest that more research is needed to evaluate systems for treating stormwater runoff at copper roofs.

Research is also currently underway to determine the effectiveness of onsite stormwater treatment systems, such as rain gardens, that filter runoff naturally. As runoff flows through these systems, free copper ions bind to conduits and organic debris, reducing the bioavailable copper concentration. Runoff that might have toxic levels of copper at the roof downspout may not be hazardous once it reaches the watershed.

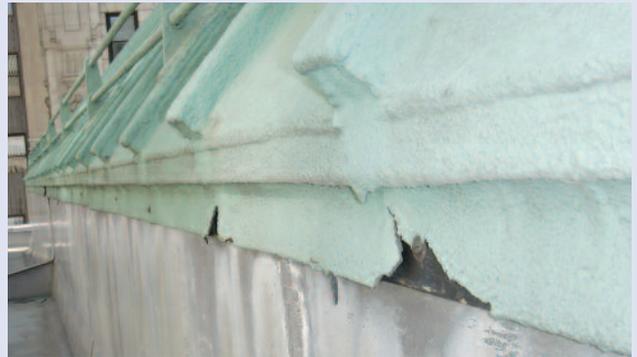
Copper roof coatings may do more harm than good—and, once in place, they may prove difficult or impossible to remove.

Copper roof rehabilitation is expensive. When faced with the choice between replacing a copper roof, at a cost of hundreds of thousands of dollars, or applying a coating over the existing copper to eke out a few more years of life, many owners opt to defer the problem. The trouble with this mindset is that it is a case of “throwing good money after bad”: the owner winds up paying for coating (and recoating) and, likely, repairs to a leaky building interior—on top of eventually replacing the failed roof.

Coating a copper roof creates an ongoing maintenance demand. While a copper roof might last a century, the lifespan of a typical coating is roughly ten years, necessitating frequent recoating and even more frequent touch-ups. Rather than protecting the copper, coatings can actually accelerate corrosion, as moisture becomes trapped between the coating and the metal. Because coating removal destroys the finish of the copper, it's difficult to return to an uncoated state. Once a copper roof has been coated, there's often no going back.

At a tiny fraction of the price of a new roof, coating has a definite appeal as a temporary fix. But before hiring a contractor to coat a copper roof, consider that, far from temporary, coatings can create permanent problems. The price may not be right, after all.

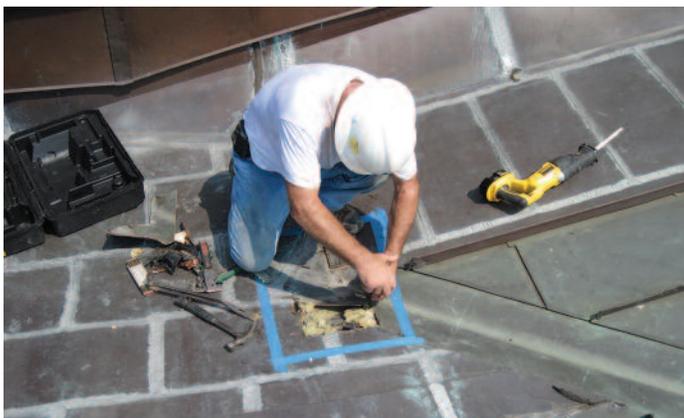
As part of a copper roof investigation, test probes may be recommended to evaluate concealed conditions.

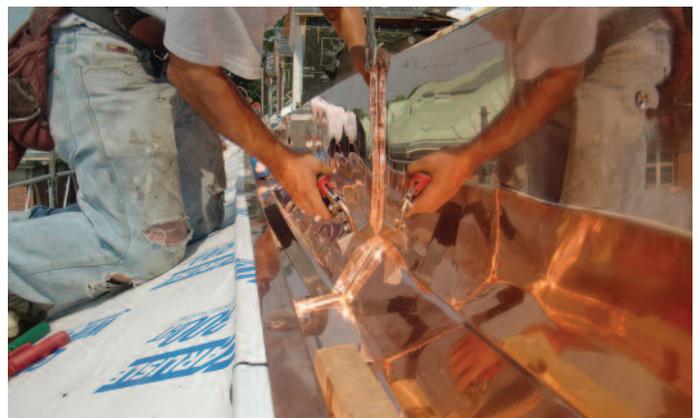
Skilled hand detailing, such as forming cleats, is essential to proper copper roof installation.

Typically, copper roofing is constructed using 16- or 20-ounce cold-rolled copper sheets in 18- to 24-inch widths. Wind uplift, roof pitch, and type of roof system dictate the ounce weight and dimensions of the copper sheets, which are pre-formed or field-formed into pans. “Short pans” are ten feet long or less, while “long pans” are over ten feet. When using long pans, it’s important to accommodate additional expansion at the ends of the pans when determining cleat design and spacing.
